## FAILURE ANALYSIS OF DISCOLORED ENIG PADS IN THE MANUFACTURING ENVIRONMENT

<sup>1</sup>Crane Aerospace & Electronics

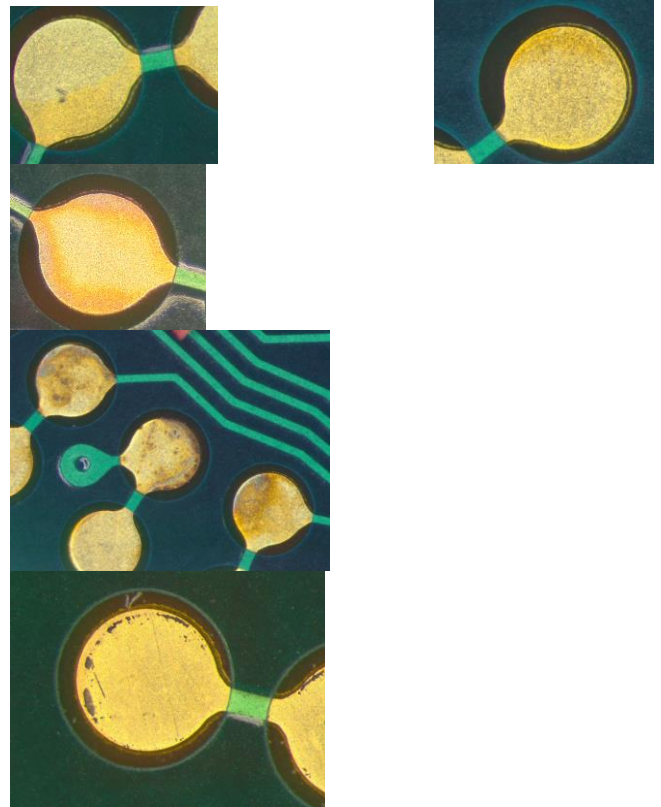
The IQA inspection does not include any ENIG structure examination, as it is understood that adequate process controls are in place at the supplier's fabrication site to ensure good plating. When the quality of ENIG is compromised and microstructural defects not identified early in the supply chain process, the seemingly benign anomalies get compounded with each subsequent manufacturing step of the assembly. Recently, numerous PCBs with acceptable plating thicknesses exhibited ENIG pad problems in our factory. The pads on the secondary side of the PCBs showed varying degrees of surface discoloration ranging from light yellow and orange through dark red and grey (Fig. 1a-d). Some boards also showed corrosive

pitting (Fig. 1e).

Figure 1: ENIG pad surface discoloration a) yellow, b) orange, c) red, d) grey, e) pitting.

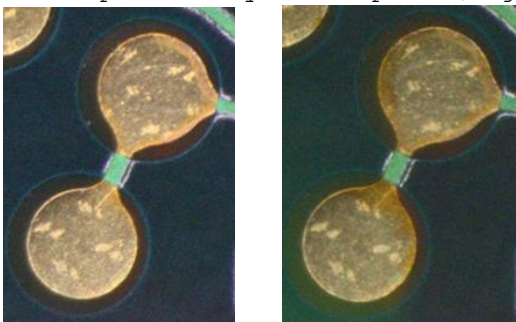
We tested the effects of thermal treatment on the ENIG pads using an accelerated aging test. Five randomly selected complete assemblies were subjected to a 36 hour air bake at 150°C. Some pads exhibited a darkening of a pre-existing discoloration (Fig. 3), while new discoloration appeared on other previously clean pads (Fig. 4).

Figure 3: Pads before and after thermal aging (16x).

These results indicate that exposure of the ENIG pads to elevated temperatures may result in changes to the pads' surface appearance.

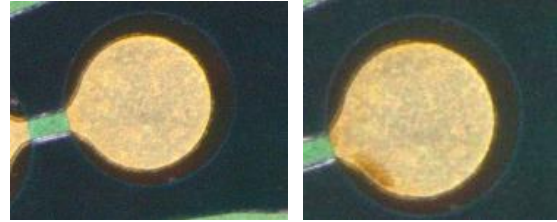
Figure 4: Pad before and after thermal aging (16x).

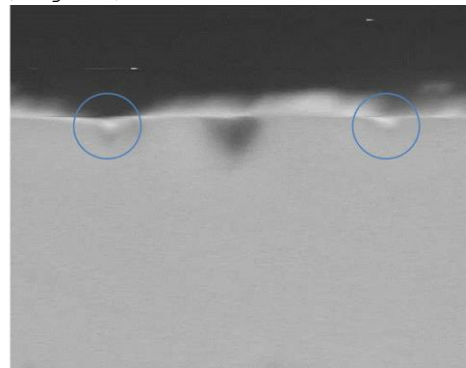
Another experiment was set up to simulate exposure of the ENIG pads to the water soluble flux used during soldering of the pads on primary side. Solder flux was dispensed onto part of the board, which was then placed on a hotplate at 150°C for 5 minutes to activate the flux, then spray-cleaned with deionized water, followed by air baking at 125°C for 24 hours. When inspected with a microscope at 60x, no discoloration was observed, however cross sections of these same solder pads showed Ni etching with some of the etched locations exhibiting gold spikes (Fig. 5).

Figure 5: Cross-section of flux-cleaned sample with Ni etching (dark spot) and Au spikes (circled).

Exposure to the flux used in the soldering process did not appear to cause discoloration since no further discoloration was seen after this step. While cross sections showed Ni etching, the presence of Au spikes indicated that etching had occurred in the Au plating bath. Since Ni etching was present before the part was flux-exposed and it is not possible to cross section the pad before exposure, it was not possible to determine if the flux also etched the Ni. Similarly to soldering flux, cleaning was not the cause of discoloration because no discoloration was seen after exposure to the cleaning chemistry.

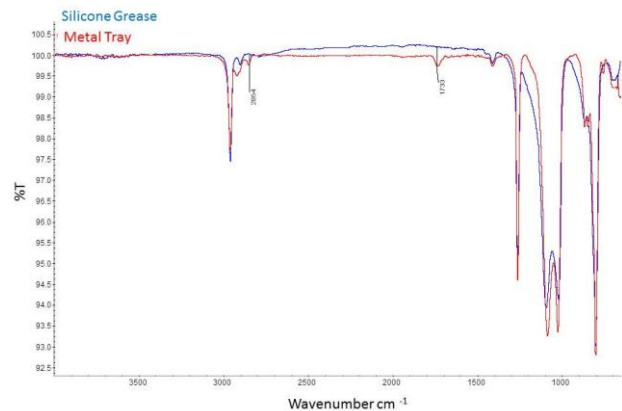
Figure 6: FTIR results comparing the material on the metal transport tray to a silicone residue profile.

The EDS found particles containing elements used in stainless steel and aluminum fixturing such as Fe, Cr, Mn, Ni and Al. Particles containing elements common to electronic assemblies such as C, O, Sn, Pb, Ag, Si and Cu silicon were also detected. The FTIR found materials such as silicones attributed to an RTV material (Fig 6), organic acids (fluxes/plastics), and polyamide (polymers/plastics) materials, all common to an electronics manufacturing facility.

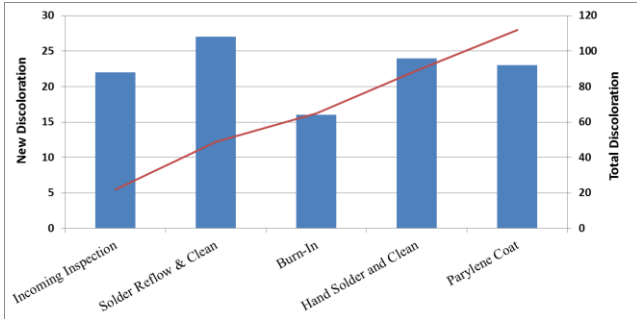
To understand and quantify escalation of discoloration through the assembly process, a monitored build of 66 EAs was processed following standard production processes but with additional inspection and photo documentation steps. Photos were taken in four quadrants for each EA resulting in 264 opportunities for discoloration. The largest percent of defect accumulation was observed at steps involving soldering and cleaning operations, followed by parylene coating, the incoming inspection and burn-in (Fig. 7).

Figure 7: Accumulation of pad discoloration throughout the assembly process.

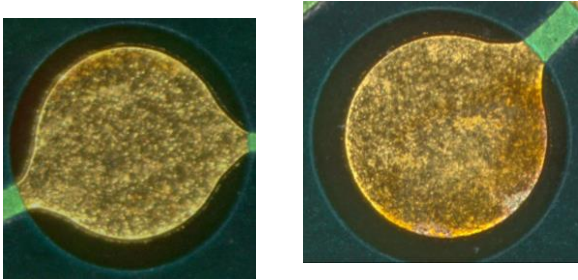
Discoloration intensity varied at different assembly steps but was most pronounced after the parylene outplant processing step. An example of the process-dependent pad surface changes is shown in Fig. 8.

Figure 8: Typical discoloration after hand solder (left) and after parylene coating step (right).

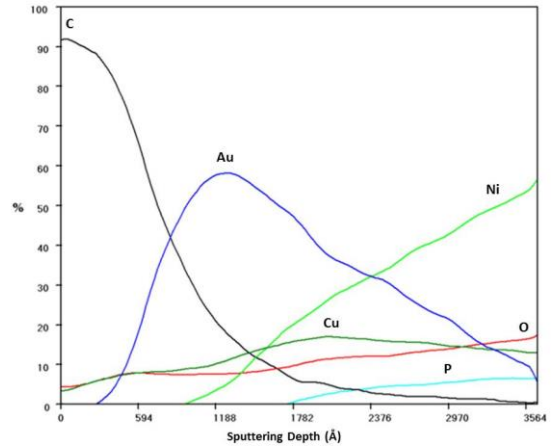
performed by depth profiling at an Argon sputter etch rate of 50Å/minute. AES spectrum of a discolored Sample 1 (Fig. 9) shows a significant amount of O and Cu detected on top of the Au layer and seemingly inside the Au coat. High levels of Cu and O are also detected inside the profile for Ni, indicating substantial amounts of NiO associated with the Ni coating. Oxygen can be associated with Cu in the form of CuO as well.

Figure 9: AES of a discolored Sample 1.

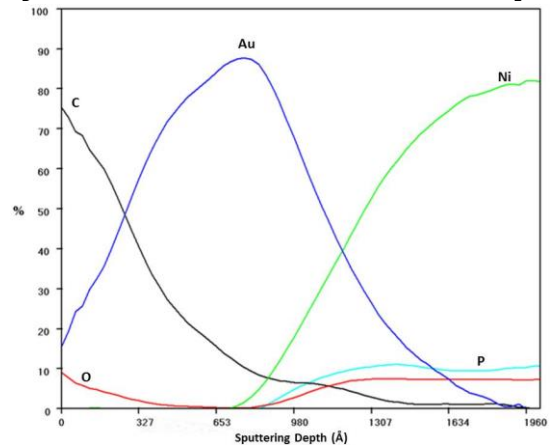
Figure 10: AES of a non-discolored Sample 2.

The non-discolored Sample 2 has Ni and O species but not Cu. (Fig. 10) The Au coverage on or at the sub-surface is scattered (maximum 40-60% in Sample 1 and 50-90% in Sample 2), instead of having an expected 100% surface coverage. The Au and Ni interface should be well defined and square in profile (similarly to profile in Fig. 11), which would indicate uniform and distinct ENIG layers, but instead it is broad and substantially overlapping in both discolored and non-discolored

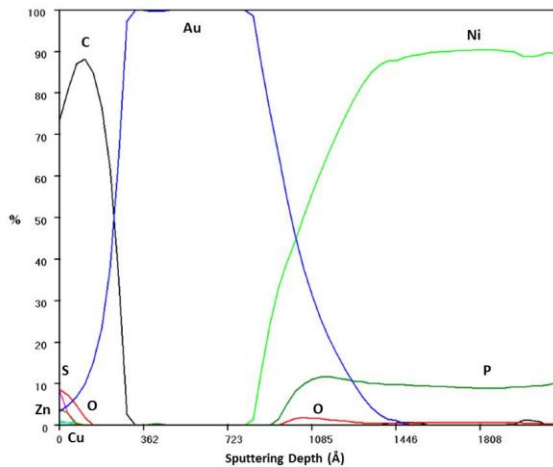
Samples 1 and 2, respectively. The profile of a second non-discolored Sample 3 (Fig. 11) is the closest to the expected Auger spectra for ENIG plating, where Au covers 100% of the surface (~300-800Å; 1-3µin) and has a more condensed profile that is distinguishable from the clearly defined Ni peak. The presence of a carbonaceous layer on top of the Au coating in all samples, or Zn and S in Sample 3 is assumed to be from handling or other surface contamination.

Figure 11: AES of a non-discolored (exemplar) Sample 3.

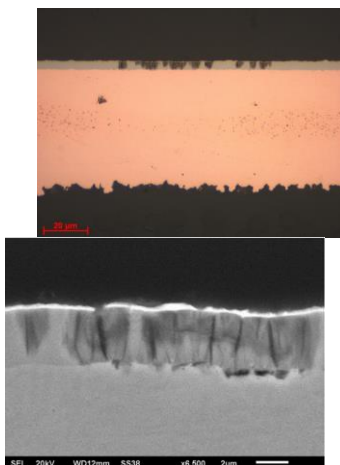
Figure 12: Cross-section of a discolored Sample 1: a) micrograph, b) SEM .

The fissures in the discolored Sample 1 (Fig. 12) were found to span the entire Ni coating thickness, which was just under 3.7 µm (~140 µin), while the fissure density in the non-discolored Samples 2 and 3 was a little lower (Fig. 13, 14). Defective structure in the Ni layer, was to a varying degree found in all tested samples. Moreover, the base Cu appeared to be disturbed in its upper section in a discolored Sample 1. In addition, Au showed variation, including gaps, exposing bare Ni and its nodule boundaries.

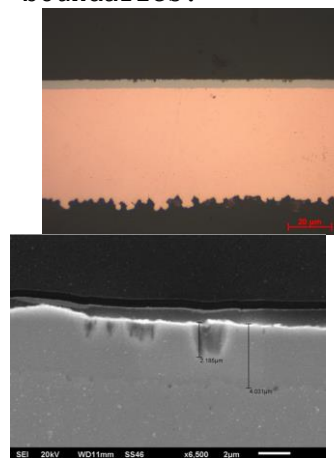
Figure 13: Cross-section of a non-discolored Sample 2: a) micrograph, b) SEM.

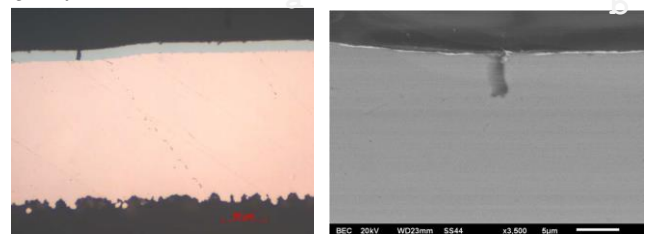
Figure 14: Cross-section of a non-discolored Sample 3: a) micrograph and b) SEM.

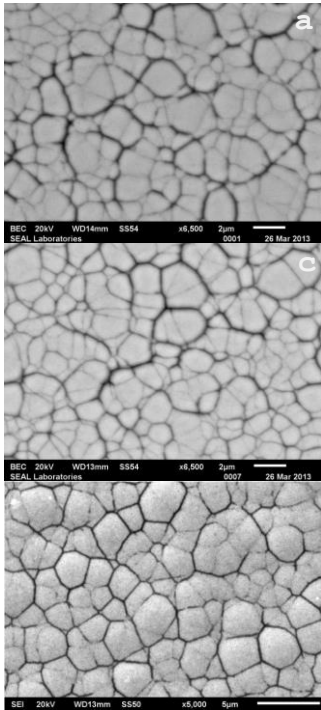
considered representatives of the pad conditions equivalent to those seen in Auger and cross-sectional analysis. Several pad locations were inspected using SEM and the results were consistent with those shown below. Fig. 15 shows SEM micrographs with mixed-size Ni grains, pad topography and flawed open Ni nodule boundary structures. This correlates to the SEM micrographs of cross-sections that show deep crevasses along the Ni nodules. The wide open Ni boundaries are visible not only in the discolored Sample 4 (Fig. 15a), but also in the non-discolored Samples 5 and 3 (Fig. 15 b, c). All samples exhibit a defective Ni coating, regardless of the visual color of the pad's surface.

Figure 15: a) discolored Sample 4, b) non-discolored Sample 5, c) non-discolored Sample 3.

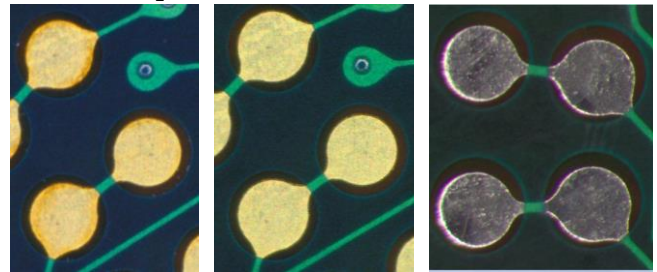
Figure 16: a) Pads before, b) after flux clean, c) after tinning.

**Pad Tinning:** To mitigate the effects of discoloration at the electronic assembly level, a tinning process was implemented to prevent nickel plating oxidation. First, the discoloration (Fig. 16a) was removed by cleaning the pads with flux to remove the oxides (Fig. 16b). The pads were then immediately tinned with solder Sn63 to prevent re-oxidation of the surface (Fig. 16c). The solder pads were then visually inspected for wetting of the solder to the ENIG pad. This verified the integrity of the nickel to solder layer.
