A Case Study of the Reliability of Copper Bond Wires In Plastic Encapsulated Integrated Circuits

Ken Turner
Hi-Rel Laboratories
6116 N Freya
Spokane, WA 99217
Ph: 509-325-5800
Email: Ken.Turner@hrlabs.com

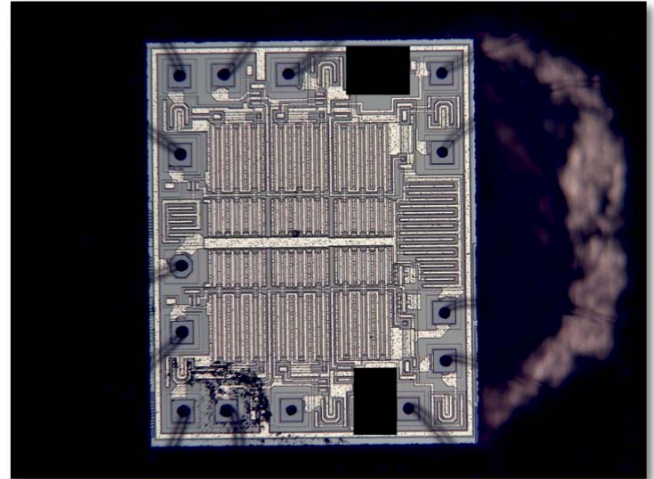
integrity of the wires. Decapsulation was performed on one sample using this method and optical inspection of the die bonds revealed no anomalies that would contribute to the observed failure.

Figure 3. Optical image of the chemically decapsulated sample.

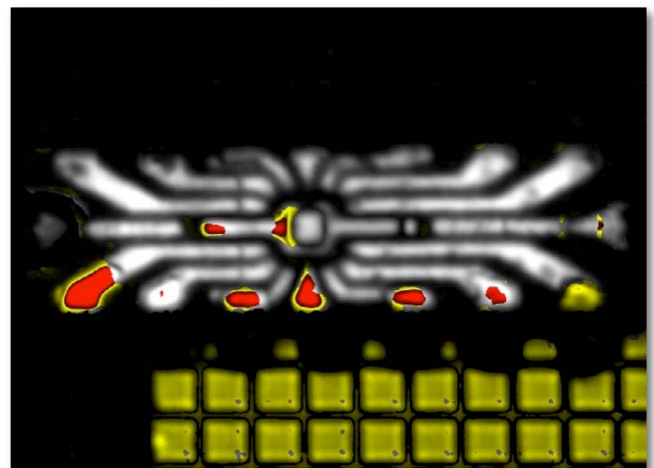
CSAM was performed on the five remaining samples to inspect for any delamination that could result in the failure of the devices. Each sample exhibited varying degrees of delamination between the lead frame and the encapsulant, including water ingress into the wire bonded area in each of the components. Figure 4 depicts delamination on pins 1, 3, 4, 5, 6 and 7.

Figure 4. CSAM image of a representative sample. The red areas indicate significant delamination.

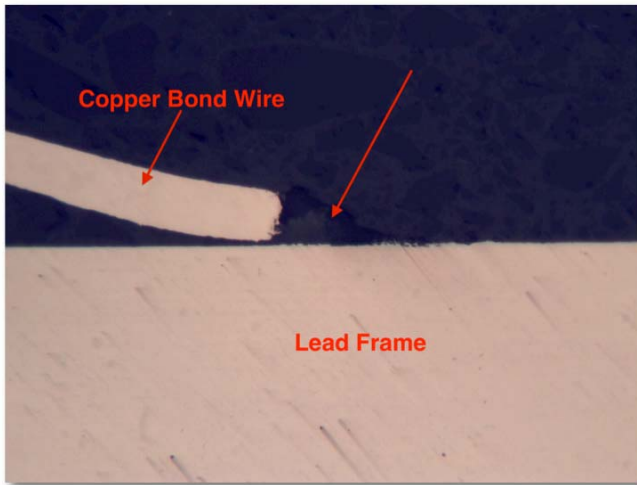
Cross-section analysis was then performed on two of the samples into the suspected stitch bonds. Microscopic inspection found that the copper stitch bond had been entirely consumed by corrosion in both samples (figure 5). Inspection of a non-failed wire bond revealed that the bond was intact, but with the onset of corrosion (figure 6).

Figure 5. Cross-section image of a failed copper stitch bond at the lead frame. The arrow indicates where the bond had corroded.

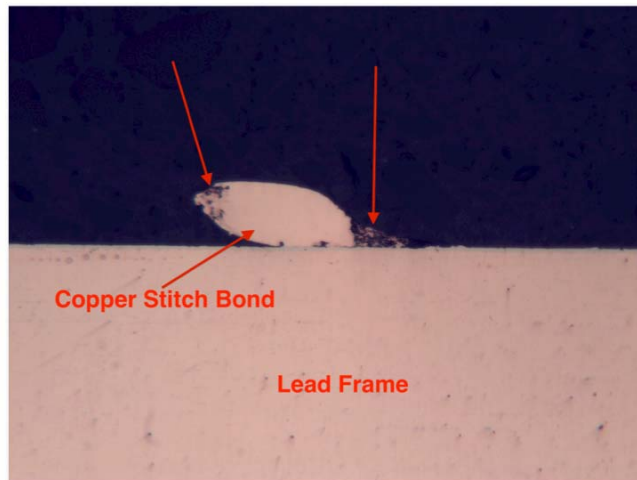
Figure 6. Cross-section image of a non-failed stitch bond. Note the onset of corrosion.

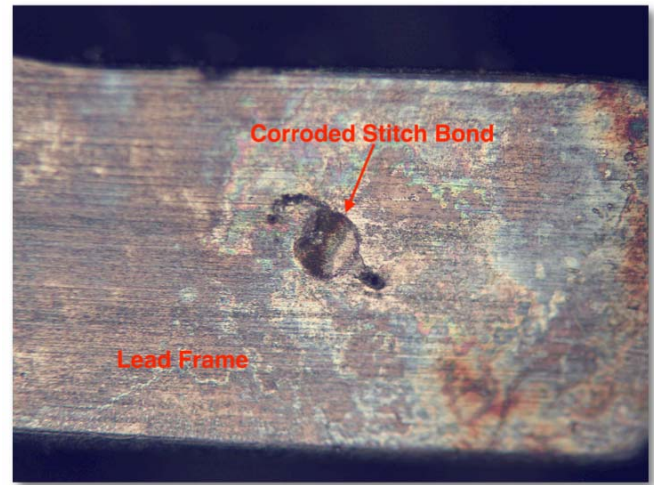
Figure 11. Optical micrograph of a failed lead after the mechanical removal of the lead from the package.

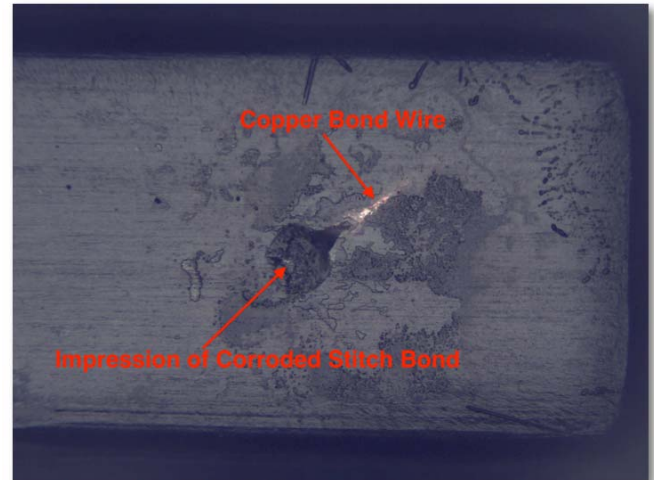
Figure 12. Optical micrograph of the underside of the encapsulant corresponding with the lead in figure 11.

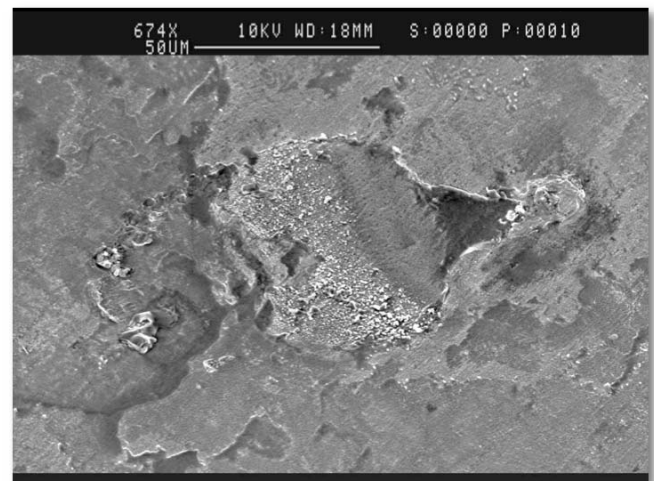
Figure 13. SEM image of the corroded stitch bond in figure 11. Note that the majority of the copper has been consumed.

Optical microscope and scanning electron microscope (SEM) inspection were performed on the failed leads and corrosion similar to that noted during cross-sectioning was found in each sample. Energy dispersive spectroscopy (EDS) of the corroded stitch bonds found substantial levels of chlorine contamination. It was also noted that the lead was plated with gold (Au).

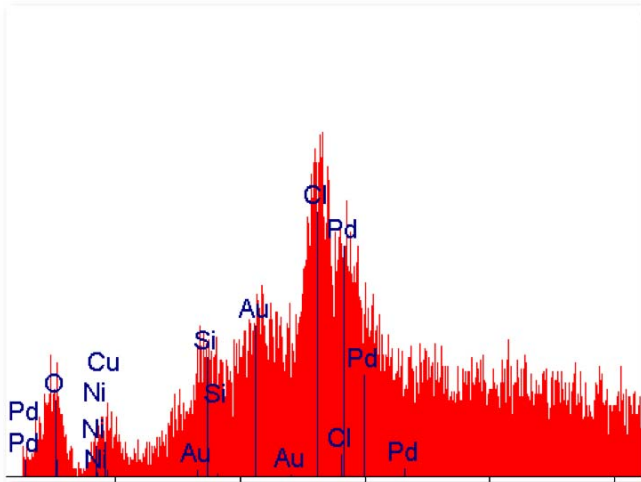
Figure 14. EDS spectrum of the corroded stitch bond at 10 kV. Note the chlorine (Cl).

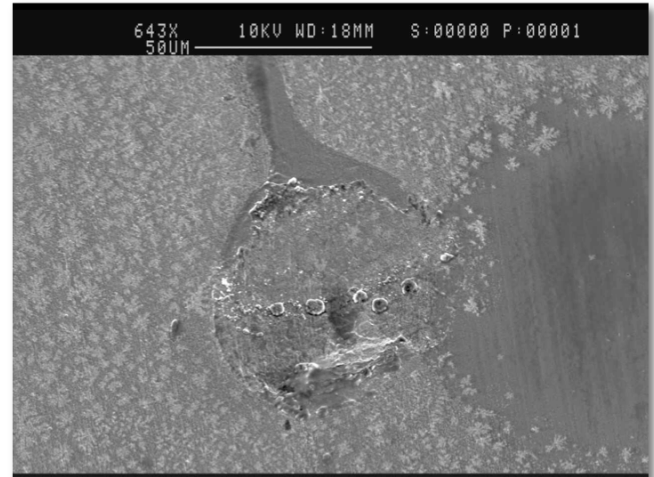
CSAM of the additional samples revealed similar levels of delamination in each device. Optical and SEM inspection of the failed/suspect leads found chlorine contamination along the lead frame as noted in the previous analysis and each device with copper wire bonds exhibited corrosion of the stitch bonds. The gold wire bonded devices were not affected by the chlorine contamination.

Figure 15. SEM image of the corroded stitch bond from sample 1b. Note that the majority of the copper has been consumed when compared to the stitch bond in figure 16.

The failure analysis determined that the integrated circuits used in the application were delaminated during manufacturing or the assembly process. The delamination allowed the chlorine contamination to propagate along the delaminated interface to the wire bonded area. The chlorine alone would result in the corrosion of the copper bond wire, however, due to the gold plating of the lead, the galvanic coupling of the gold (+) and copper (-) accelerated the corrosion of the copper wire bond [4].

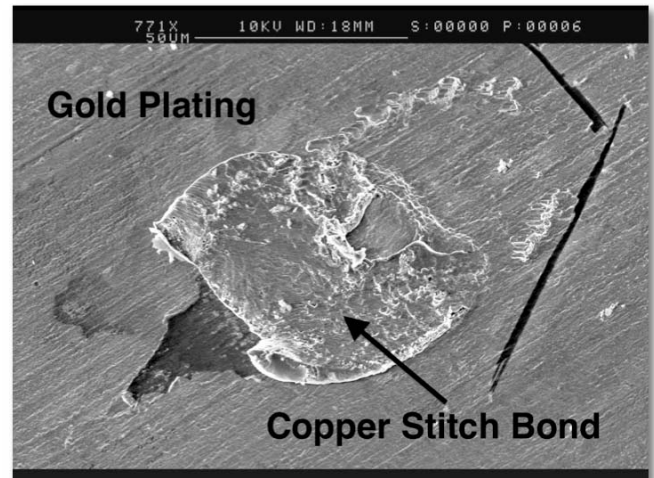
Figure 16. SEM image of the onset of corrosion to the copper stitch bond in sample 4.

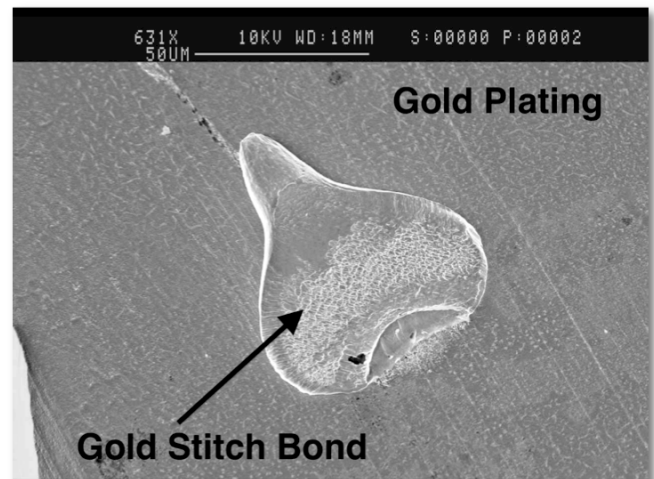
Figure 17. SEM image of the gold stitch bond in sample 2. Note that the stitch bond is not corroded.

In the older, gold wire bonded devices the delamination and contamination was still present, but did not result in the failure of the component due to both the chemical resistance of the gold, and the zero potential difference between the wire bond and the lead plating [4].
