# Copper Crystal Structures in Plated Microvias. Their Recrystallisation and a Means to Identify Joints at Risk of Premature Failure

T. Bernhard, R. Massey, K. Klaeden, S. Zarwell, S. Kempa, E. Steinhäuser, S. Dieter, F. Brüning  
Atotech GmbH  
Erasmusstrasse 20  
10553 Berlin, Germany  
Email: [roger.massey@atotech.com](mailto:roger.massey@atotech.com)

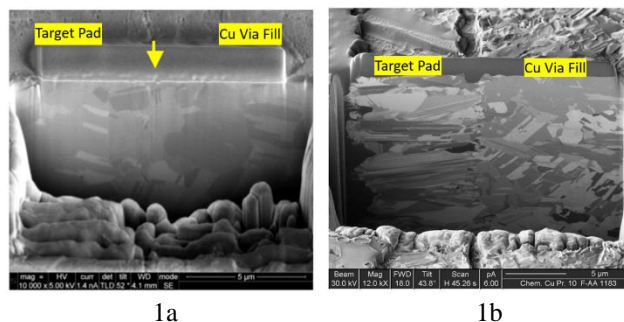
Figure 1.

Figure 1 shows the typical structures noted in BMVs during routine failure analysis, with figure 1a exhibiting a fully epitaxial structure with no clear delineation between the target pad and the plated Cu, while figure 1b shows a clearly visible interface. As the epitaxial structure is considered "ideal" with no obvious defects, it is taken that this would offer a higher level of structural integrity compared to that shown in Fig 1b, and so would also have a higher level of overall joint reliability.

SEM images showing typical microstructures a) fully epitaxial and b) none epitaxial with clear boundary between the target pad and the via plating

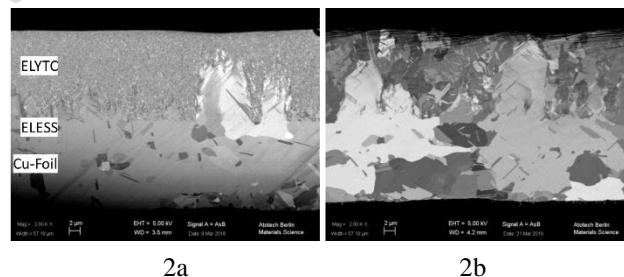
Figure 2.

Figure 2a shows a typical cross section for samples where recrystallization was suspended immediately following plating operations. The plated layer is shown towards the upper part of the image and it is evident that due to the cryogenic treatment, the ELYTC Cu retains its initial but meta-stable, fine grained “amorphous” structure<sup>[5]</sup>. Towards the lower portion of the plated layers, there is clear evidence that a Cu diffusion based recrystallisation has begun<sup>[6]</sup>, and where this has occurred, the grain structure follows that of the underlying layer. As such, the structure as a whole is epitaxial to the RA Cu foil and there is no clear delineation across any of the plated interfaces.

In Figure 2b, where the sample has been annealed, we can see that the final Cu structure has now fully developed and again is entirely epitaxial across all interfaces. As the Cu diffusion or “recrystallisation” front is thought to initiate at the Cu foil-ELESS interface, and then proceed vertically towards and through the ELYTC plated layer, it can be described as moving in a “bottom-up” manner, and hence, we refer to this final microstructure as having undergone “bottom-up recrystallisation” For such a structure to occur, it is suggested that all the interfaces between the substrate and each of the plated layers must be sufficiently clean and with a low level of organic contaminants, such that the “recrystallisation front” can pass unhindered through the entire plated structure.

SEM images showing cryogenically suspended recrystallisation a) immediately after plating and b) after thermal anneal showing “bottom up recrystallisation”

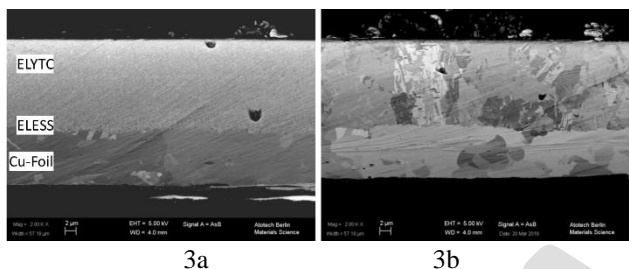
Figure 3.

If we now consider the images in Figure 3, where an alternative stabilizer component was used during the ELESS Cu deposition. Immediately after plating (Fig 3a) while the “as plated” amorphous ELYTC Cu is still present, there is no evidence of early epitaxy as seen in Fig 2a, and there is also a clearly identifiable change in the grain structure

approximate to the location of the ELESS Cu layer. Even after the additional annealing step to facilitate final recrystallisation, the delineation remains, and there is no evidence of significant epitaxy occurring across any of the Cu foil to plated Cu interfaces. In order for such a structure to occur, it is offered that there has been a factor of significance that has reduced the ability of the diffusion front to travel in a “bottom-up” manner, and we subsequently assume that the ELESS and ELYTC Cu have recrystallized in a self-contained manner that is independent to the underlying layer, and so, it could be considered that the overall recrystallisation pattern occurs in a “top-down” mechanism.

SEM images showing cryogenically suspended recrystallisation a) immediately after plating and b) after thermal anneal showing “top-down recrystallisation”

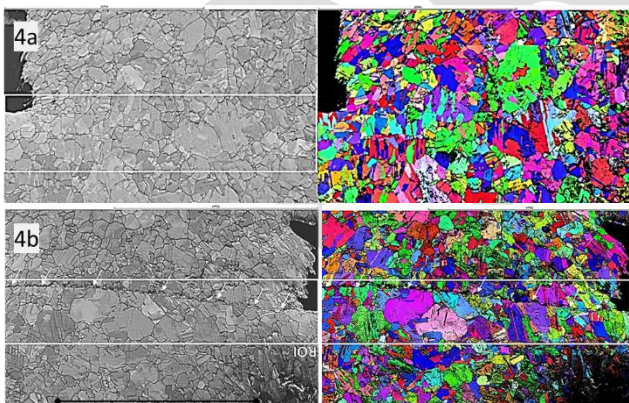
Figure 4.

EBSD band contrast (left) and diffraction (right) images showing micro-structures after thermal exposure typical of a) “bottom up” and b) “top down” recrystallisation in TVs

As expected, there is a discernable relationship between the crystal structure across the BMV interfaces and their respective reliability performance. The “bottom-up”

epitaxial structures (Fig 4a) showed no failures during testing, while the “top-down” delineated samples (Fig 4b) had mechanical failure, with cracks propagating close to, or along the point of delineation, which also corresponds to an area of high grain boundary alignment. (Figure 5)

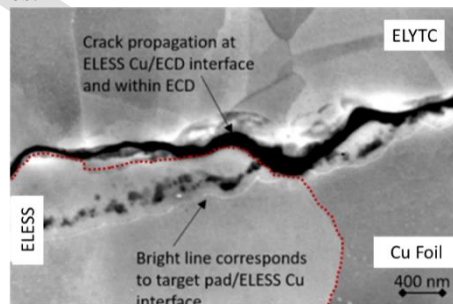
Figure 6.

If the region of failure is inspected more closely (Figure 6) it is interesting to note that the crack has not only propagated within the initial 500-1000nm of the ELYTC plated layer, but that it also follows the grain boundaries in preference to an epitaxial, but nano voided ELESS-ELYTC Cu interface, which, it would be reasonable to assume, was an area of significant structural weakness. This implies that the cohesion across aligned grain boundaries can be appreciably weaker than epitaxial areas containing significant and aligned nanovoids. So, we could conclude that a BMV containing a fully epitaxial micro structure would offer better reliability performance compared to one with one or more discernable interfaces with significant aligned grain boundaries.

Electropolished SEM image of the crack path showing failure along aligned grain boundaries in preference to an area of nano voided plated interface.

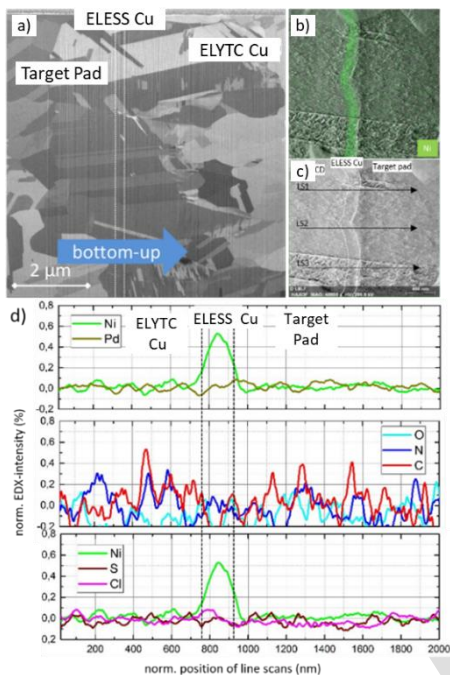
Figure 7.

- a) FIB/SEM image of epitaxial interface in a stacked BMV
- b) TEM image showing ELESS Cu location based on Ni detection
- c) positions of performed EDX line scans
- d) averaged EDX intensities of the elemental line scans in c)

The dramatic increase in the Ni content is expected, and should be associated with its use as a refining element common to ELESS Cu deposits. As such, the Ni can be used to determine the location of the ELESS Cu layer within the overall structure. The other elements (C, N, S, Cl), which are typical to either additives in plating electrolytes, or would indicate an organic surface contamination, all remain low and could be considered to be at an acceptable background level, as they clearly have no detrimental effect on the proposed “bottom-up” recrystallisation. The general process of this “bottom-up” recrystallisation is described schematically in Figure 8

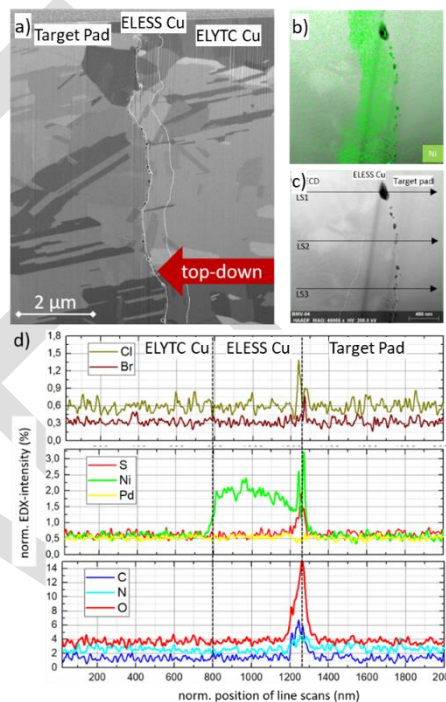
Figure 9.

- a) FIB/SEM image of epitaxial interface in a stacked BMV
- b) TEM image showing ELESS Cu location based on Ni detection
- c) positions of performed EDX line scans
- d) averaged EDX intensities of the elemental line scans in c)

Again, using Ni as the indicator for the ELESS layer, its location can be determined, and here it is evident that the ELESS Cu layer has a structure that is epitaxial to the ELYTC Cu, and not to the structure of the underlying Cu foil. This would suggest that movement of the grain boundary diffusion front was retarded and unable to pass from the Cu foil into the ELESS Cu layer, yet was free to do so downwards from the overlying ELYTC Cu.

The EDX line scans, across the same ELESS – ELYTC Cu interface show appreciable increases for a number of elements (Ni, Cl, Br, S, C, N, O) giving a strong indication of a high level of contamination of the target pad surface prior to ELESS Cu deposition. In this case, the Br is taken to be associated with the epoxy resin system and indicates

inadequate cleaning. While the unusually high Ni, S, Cl & N content suggest a level of ELESS liquid entrapment associated with the resin residues.

Here we can conclude that an appreciable level of surface contamination, from desmear and rinse water residues were present on the target pad, and were of sufficient concentration to hinder grain boundary diffusion from the Cu foil into the ELESS Cu layer and the diffusion front was suspended at this interface. Subsequently the recrystallisation of the ELESS and ELYTC Cu occurred independently of the target pad, and so can be described as “top-down” in manner.

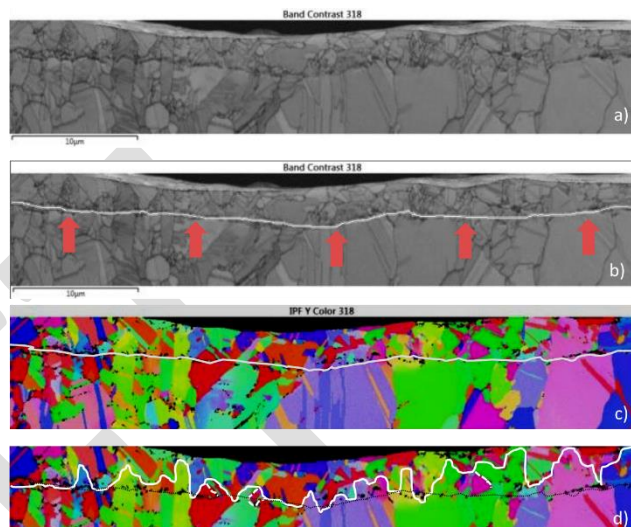
Figure 11

Steps for determining Normalized Crack Length

In the example shown in Figure 11. The IL and TCL were determined to be 52 $\mu$ m and 82  $\mu$ m respectively, with the calculated NCL being 1.6.
