# Soldering defects on immersion tin and the impact of the tin-oxide layer

# Introduction

## Immersion Sn

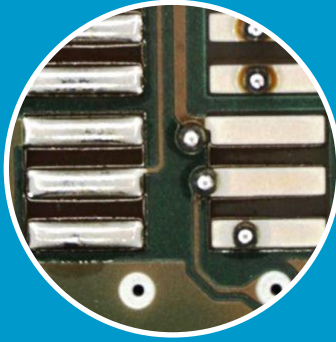
## Non-wetting

Caused by a physical barrier between the surfaces to be joined

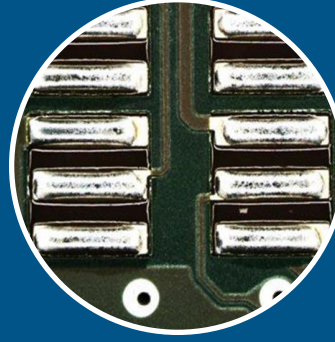
## Dewetting

molten solder has coated and then receded, maybe caused by inadequate cleaning or inhomogeneous oxidation

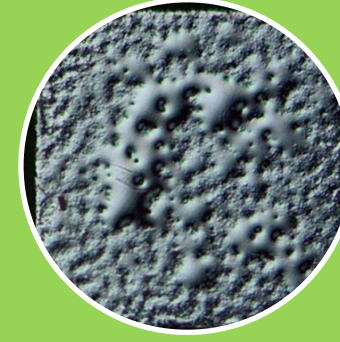
Self Dewetting appears when oxide layer is damaged and cracks during 2nd reflow

**Root causes:** 1) residues on Copper  
2) contamination on Tin  
3) evaporation of Volatiles from the solder mask

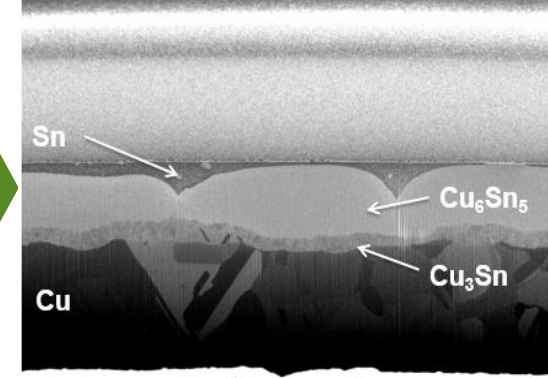
## FIB after 2x reflow

Potential defect:  
Sn-Oxide layer breaks and liquid tin penetrates to the surface

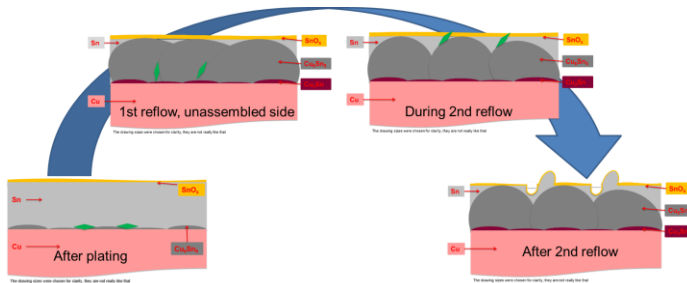
## 1) Residues on Copper

- Residues on Cu surface impact soldering performance

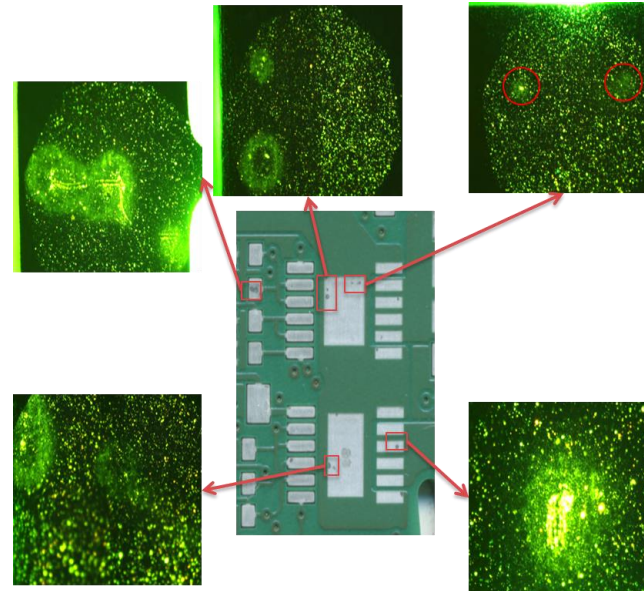
## 2) Contamination on Tin

- Molten areas show high fluorescence
- Clear correlation between shape of melting and fluorescence residues

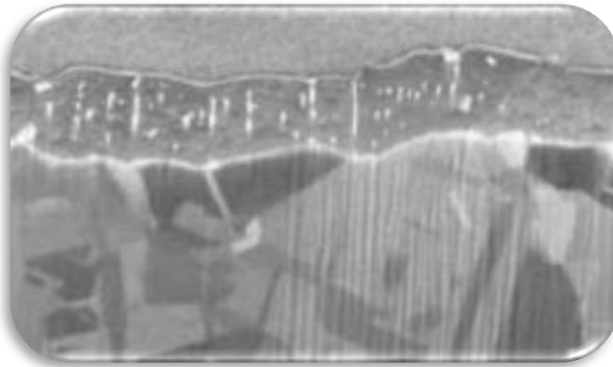
Shiny Tin – 1xRF (LF,  $O_2 < 1000\text{ppm}$ )

To prevent dark and shiny tin appearance after reflow oxide layer should be strong and even

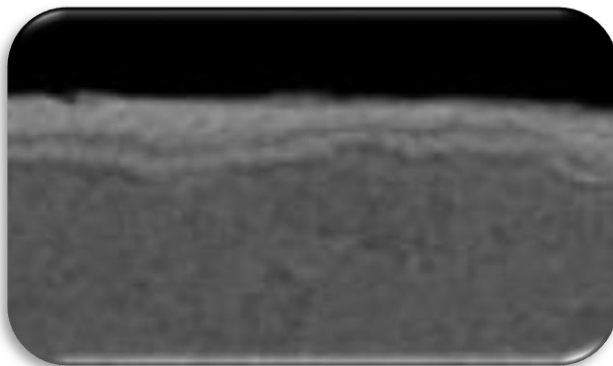
Cross section of shiny tin surface 1xRF (LF,  $O_2 < 1000\text{ppm}$ )  
Very flat surface  $S_Q < 100\text{nm}$

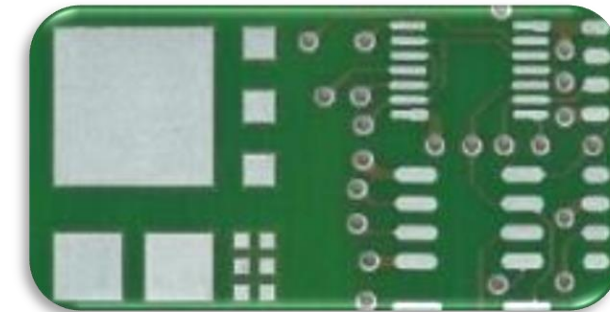
Not Shiny / Molten Tin

White and bright color of Tin  
- light is recognized by detector

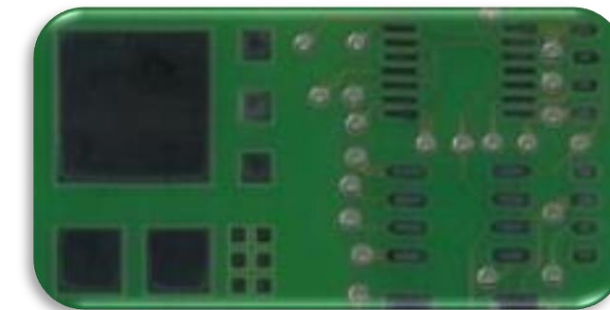
100% Shiny / Molten Tin

Tin in scanned image appears dark  
-light is not being recognized by detector

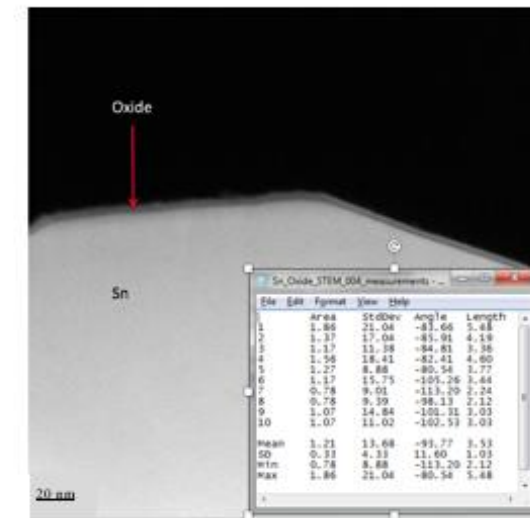
HAADF  
STEM  
(Sn Surface in  
region 2)

Average oxide  
thickness in this  
area is 3.5 nm.

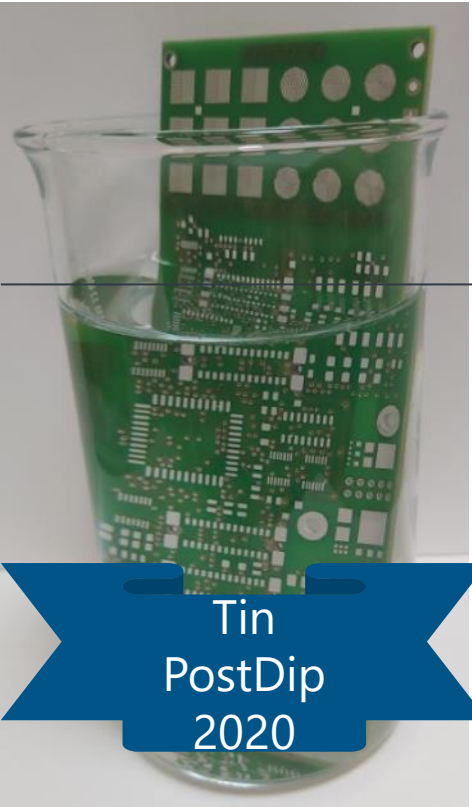
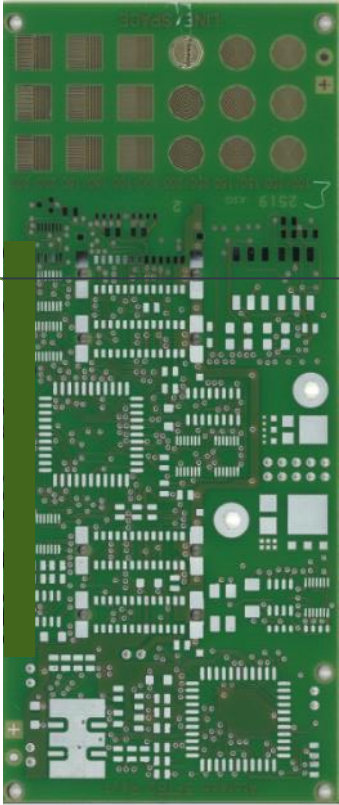
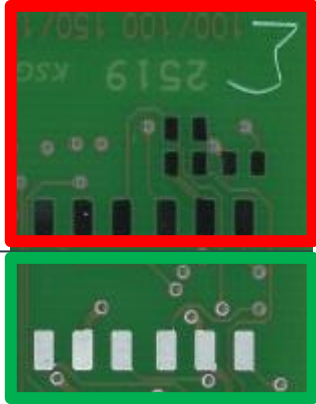
- Increased oxide layer thickness leads prevents self de-wetting and discoloration

Dark, shiny tin  
SnOxide < 1.0nm

White and bright Tin  
SnOxide > 2.0 nm

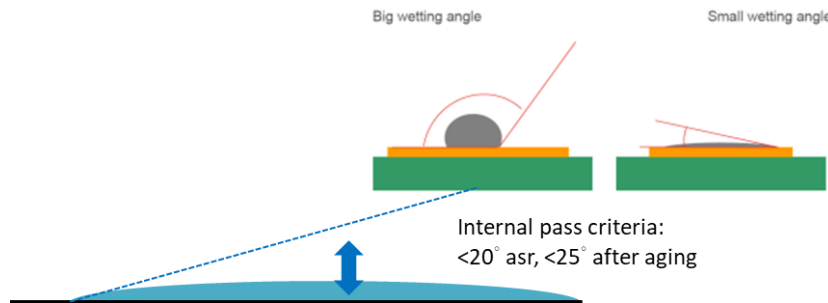
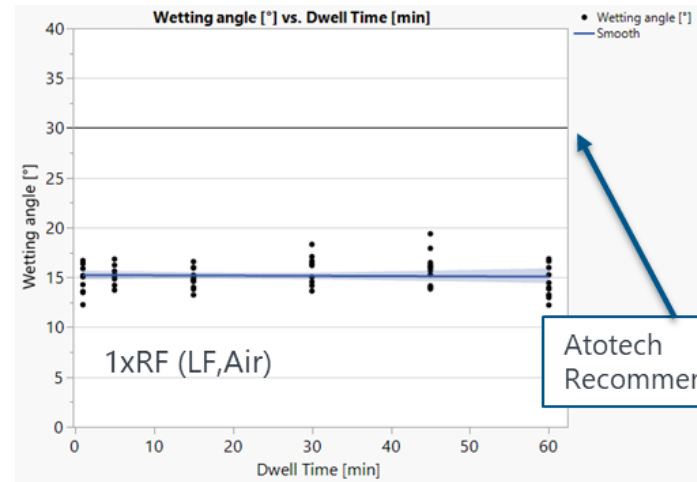
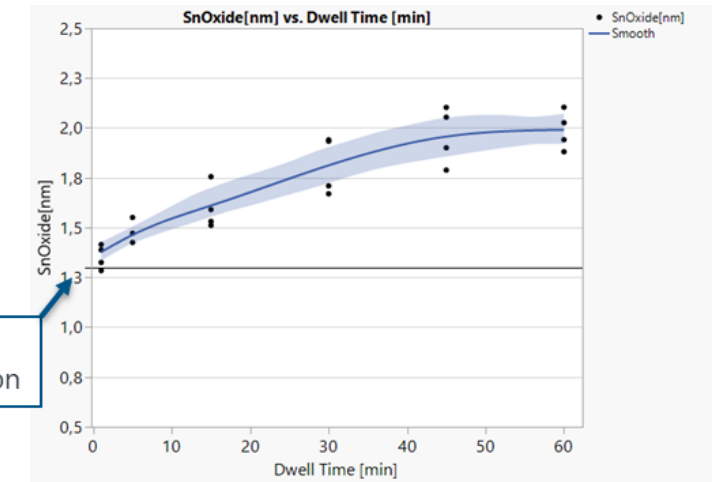
PD2020 with different dwell time 1-60min with temp.=65°C and PD2020 K = 10mL/L

Oxide formation has no negative impact on solder wetting performance

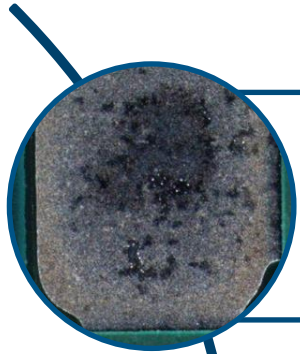
Weak oxide layer and contaminations increase the risk for self de-wetting

Temperature/time have low impact, Vacuum packing inhibits oxide layer formation

Chemical post-treatment enhances oxide formation and prevents shiny tin, consequently, risk of self de-wetting
