## Component Quality Defects: Identification, Investigation & Remediation

D. Michael Flint  
Department of Defense  
9300 Savage Road, Suite 6597  
Fort Meade, Maryland 20755  
301-688-7195  
david.m.flint@ugov.gov

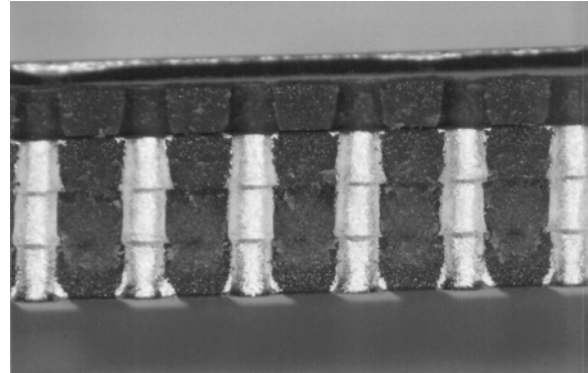
Visual inspection of the perfluorocarbon bombed devices showed perfluorocarbon leaking from the sides of the package when pressure was applied to the lid, thus indicating that at least some of the leak test failures were not due to compromises in the solder seal, but instead to the package itself. In the most severe cases, separation between the castellations was readily evident under a magnified view.

Failure analysis of the hermeticity failures showed two distinct failure modes. The first mode is shown in Figure 1, where a visually distinct separation can be seen in between the top castellations where the vertical lead plating ends. This mode of failure was seen on gross leak failures only, with a gross leak failure being defined as having a leak rate of less than  $1 \times 10^{-5}$  cc-atm/sec of He as calculated using OLT testing.

**Figure 1: Gross leak hermeticity failures were predominantly due to separation in between castellations. This image shows complete separation of the top layer.**

1. The nominal lead gold plating thickness was increased from 2.54  $\mu\text{m}$  to 3.05  $\mu\text{m}$ .
2. The array layout was changed to change the shape of the plating through holes in order to increase the flow of plating solution in these areas.

3. The sampling rate plan for hermeticity was increased.
  - a. A process change has not yet been implemented to correct the root cause, but is being investigated.

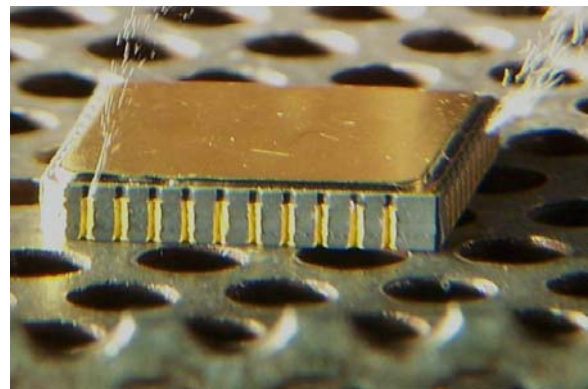
The second failure mode was found on both gross and fine leak failures where the hermeticity was compromised between the package castellations only at the lead seal. The ceramic regions separating the leads visually appear to be solidly connected. Bubble leak testing was used to locate the source of the leaks, which can be seen in Figure 2. SEM images were also taken in an attempt to pinpoint the source of the castellation leaks; however, as can be seen in Figure 3, there is no readily identifiable compromise in those locations.

**Figure 2: Bubble leak testing picture showing leakage from castellations only at the lead seal.**

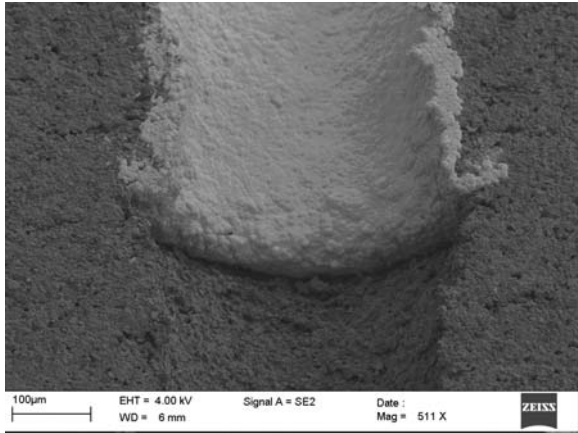
**Figure 3: SEM image of location of leaking castellation showed no observable hermeticity compromise.**

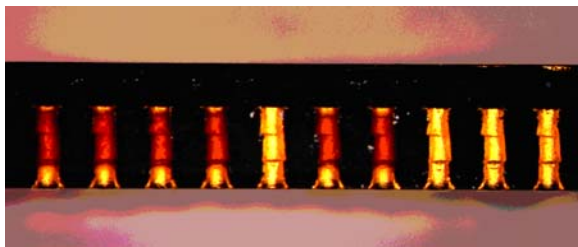
The second issue investigated was discoloration found on package leads at final visual inspection. This discoloration was found on varying numbers of leads per package in addition to bond fingers internal to the package cavity. This discolored gold was proven to be an unsolderable surface in addition to an unbondable surface for aluminum wedge bonds.

A visual image of the lead discoloration is shown in Figure 4 as it was found at assembly final visual inspection. Upon finding this defect, the process was broken up and visual inspections were performed at each step in order to determine where in the assembly process this defect was being created. We found that this discoloration would only occur on the leads after two or even all three heat cycles seen throughout the assembly process with the highest peak temperature reaching 410 C. No one heat cycle alone caused this visual defect, but was found to be a cumulative process. For this reason, an internal screening plan could not be implemented due to the large time commitment in addition to the potential reliability impact on temperature cycling these packages.

**Figure 4: The observed discoloration was analyzed and found to be nickel oxide.**

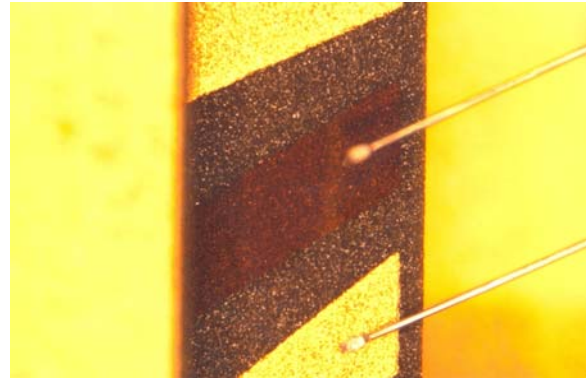
It should be noted, that only one heat cycle was needed for the same defect to occur on the package bond fingers as seen in Figure 5. This manifestation was rarely seen and is only mentioned for completeness and evidence of the encompassing nature of the root problem.

**Figure 5: Nickel oxides were also found on bond fingers in the package cavity.**

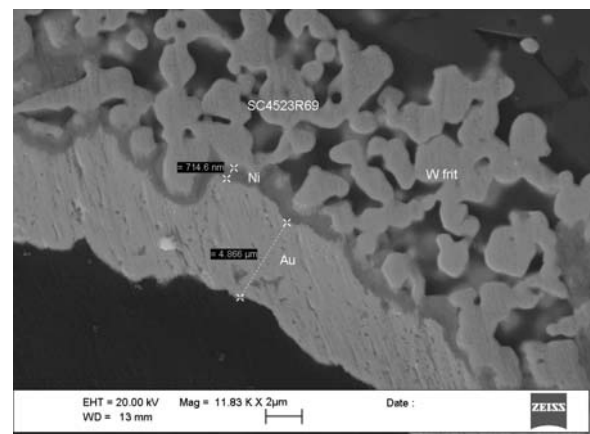
A cross sectional view of a non-oxidized lead is shown in Figure 6. A full thickness gold layer ( $\sim 4.8 \mu\text{m}$ ) can be seen on top of a discrete and identifiable nickel layer. This is in contrast to the discolored lead seen in cross section in Figure 7 where the gold layer is extremely thin (.65  $\mu\text{m}$ ) and there is no defined nickel layer.

**Figure 6: Higher magnification SEM image showing in spec Au plating thickness on a lead.**

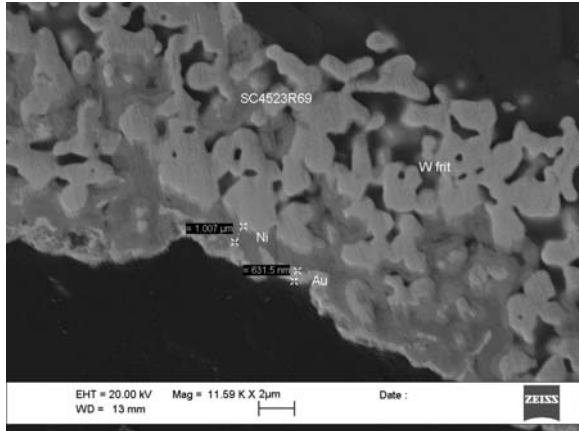
Cross-sectioning and SEM imaging revealed that the gold plating thickness was inconsistent, even between leads on the same package. On leads whose appearance remained golden, the gold thickness was within spec according to the manufacturer's drawing ( $\geq 2.54 \mu\text{m}$ ) and varied from 2.5 -5.0  $\mu\text{m}$ ; however, on those leads that were discolored, the gold thickness was found to be well below the manufacturer's spec and varied from .5 – 1.5  $\mu\text{m}$ . Thin gold plating did not provide sufficient protection to the underlying nickel layer and allowed the nickel to diffuse and oxidize during the heating cycles of the assembly processes.

**Figure 7: This SEM image shows a very thin Au layer and an indistinguishable Ni layer.**
