## Reliability Impact of Defects in Lead-Free BGA Solder Joints – A Systematic Study

Anurag Bansal, Kuo-Chuan Liu, Jie Xue, and Dave Towne  
Cisco Systems, Inc.  
170 W. Tasman Drive, San Jose, CA 95134, USA  
anurbans@cisco.com

*In this study, a systematic DOE approach has been adopted to study the long term reliability impact of lead free solder joint defects. A novel test vehicle was developed wherein daisy chain lead-free 0.8 mm pitch 60-ball BGA components were assembled on single and double-sided MiniDIMM cards. In addition to a normal production process, a variety of latent solder joint defects were intentionally introduced under controlled conditions. The types of defects introduced may stem from PCB design, PCB fabrication, solder paste printing, component placement, reflow, cleaning, and handling operations. Several defects were manufactured at two levels of severity. The cards were subjected to board level thermal cycling test from 0 to 100 °C, and the daisy chain resistances were continuously monitored during the test. The results showed that several types of latent defects had a very detrimental impact on long term reliability, while some of the other defects did not

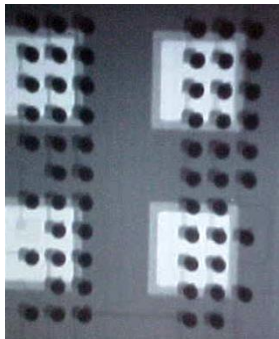
(iv) *Misaligned BGA (Code I)*: This type of defect could be caused due to improper fiducial marks, improper programming of pick and place equipment or improper handling of the PCB after component placement but prior to reflow. The pick and place equipment was programmed to intentionally offset the component placement. The offset was 50% (for level 1) or 70% (for level 2) of the pad diameter along the diagonal direction (see figure 2).

I – 70% Misalignment

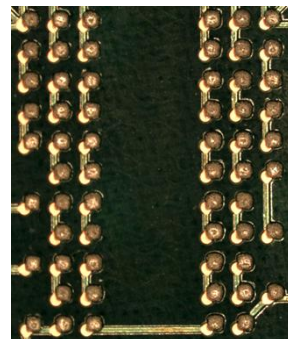
(v) *Mis-registered Solder Paste (Code J)*: This defect could result from defective stencil or PCB design, or improperly handling the PCB or stencil prior to screen printing. The defects were created on a PCB level by intentionally offsetting the stencil by 50% (for level 1) or 70% (for level 2) of the pad diameter along the diagonal direction (see figure 2).

J -70% Misregistration

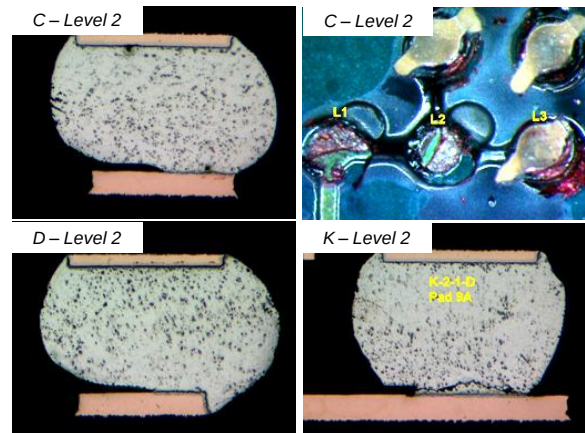
**Figure 4 - Defective Solder Joints after Cross-section and Dye and Pry**

Figure 4 shows examples of marginal solder joints (defect codes C, D, and K) observed from cross-sections and dye and pry. As expected, the failures were at the corner solder joints near the PCB pad interface. The ATC testing was still continuing at the time of this publication. The results after 4625 cycles are summarized in Tables 2 and 3 below for single sided and double sided card assembly.

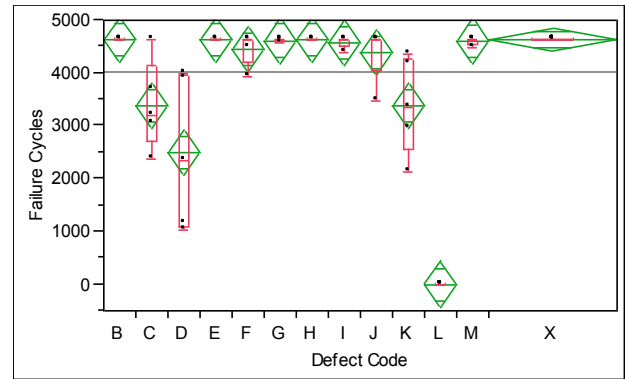
**Figure 5 - Scatter plot of Single Sided Card Failures, Defect Level 1**

For single sided cards, defect code L (low peak temperature) was clearly the worst. While these devices had normal resistance after assembly, they failed within 3 thermal cycles. Subsequent visual observation revealed that the solder paste in some of the joints had only partially melted. Pad contaminating defects D (silk screen) and C (solder

mask) were the next most devastating, especially defect D with level 2 (silk screen with 70% pad coverage). Defect code K (low solder paste volume) was also very damaging. The effects of other types of defects cannot be statistically separated from the control (code X) samples.

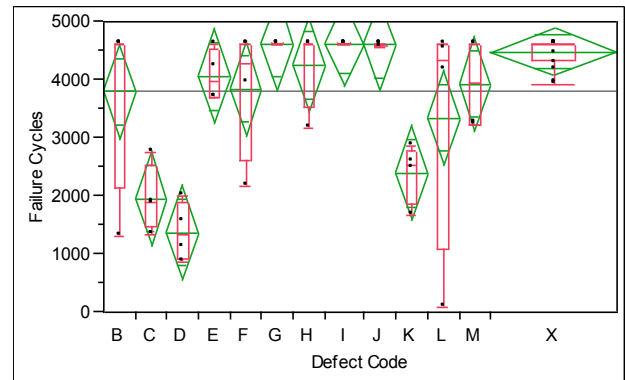
**Figure 7 - Scatter plot of Double Sided Card Failures, Defect Level 1**

For the double sided cards also, based on the first failure point and the scatter plots, defect code L (low peak reflow temperature) was the worst. This was followed by defect code D (silk screen contamination) which was particularly damaging at level 2. The next worst defect was code C (solder mask contamination), followed by defect code K (low solder paste volume). Based on a single failure, the next worst failure was the mechanically bent module (code B). This was followed by code F (partially exposed OSP pads). Based on limited sampling, codes M (high peak reflow temperature) and H (reworked components) also had some detrimental impact on reliability. At this time the effects of other defect codes could not be statistically separated from the control samples.
