## Silver Epoxy Filled Via Analysis for High Reliability RF MCM Microelectronics

Joe Kreuzpaintner, Karen Wooldridge, Donna Gerrity, Bill Clark, & Hector Deju  
HARRIS GCSD  
2400 Palm Bay Rd  
Palm Bay, FL 32905  
321-729-2588, jkreuz01@harris.com

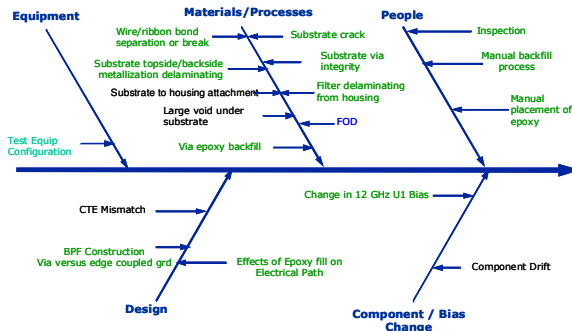
Figure 1. Fishbone Analysis Diagram

-55°C to 125°C. Two additional products within the production lot showed similar RF power degradation anomalies on other channels. An investigation into the root cause was initiated that resulted in the generation of the fishbone diagram shown in Figure 1.

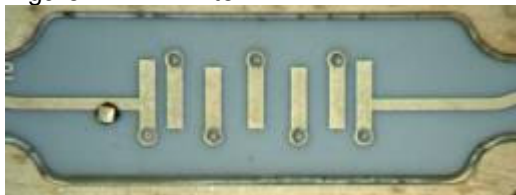
Figure 2. BPF Filter

observed when the filter pole ground vias were manually probed with an insulating tip; the filter is shown in Figure 2.

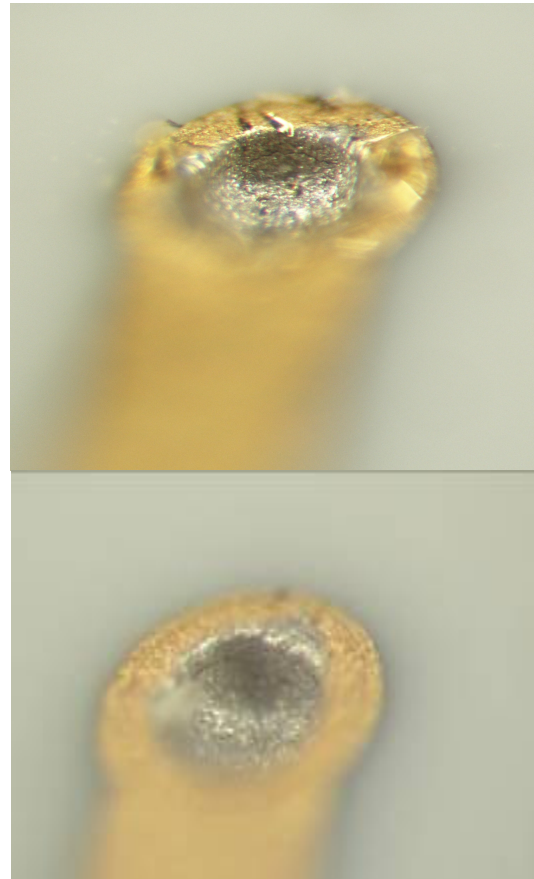
Figure 3. Via filled with Silver Epoxy

This RF power value was similar to data collected from the initial product “turn on”. In addition, this RF power value did not return to previously observed “out of family” output readings. Therefore, the band pass filter (BPF) was identified as the source of reduced RF power in the assembly; photos of the via topside is shown in Figure 3.

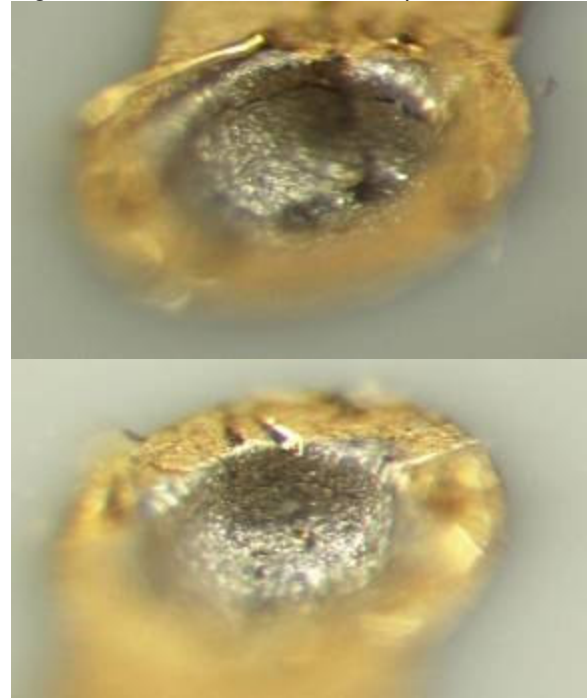
Figure 7. Failed BPF filter vias top side view

The BPF filter showing the "out of family" RF power loss was removed from the RF module and cross sectioned, Figures 7 and 8. The via fill exhibited hair line cracks near the top of the epoxy fill. After completing the cross-section, it was evident that the metallization separated from the via wall, Figure 8.

The root cause of the RF power degradation was identified as a crack/separation within the via metallization at the top of the epoxy fill/cure line. FEA modeling was used to determine any reliability risks and to better understand the loading conditions associated with the interaction of the epoxy fill with the via metallization.

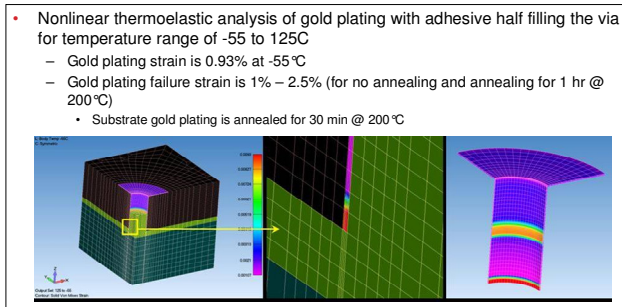
Figure 12. FEM of Via with 50% epoxy fill

The results of the FEM indicated that a 100% epoxy filled via can produce strains on the gold via metallization that exceed a 1% to 2.5% range. Relatively thin plated gold metallization can crack when thermally induced strains exceed the stated range. The vias that failed were epoxy filled to a value exceeding 75%.

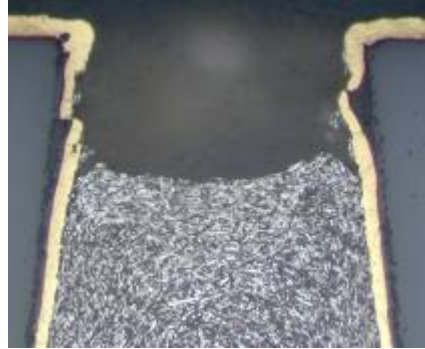
Figure 15. Post Temperature Cycling Via Fill &lt;75%

Multiple cross-sectioning locations (25%, 50%, 75% into via) of each via was performed to verify Figure 9. Mechanical properties of gold film that the crack or break in the via metallization could be observed. A total of 22 vias out 100 via sectioned failed. The results indicated that any via filled with silver epoxy >40% caused the via metallization to exceed its elongation limits resulting in a fracture of the via metallization. Figures 15 and 16 show the examples of the failures in the via metallization.

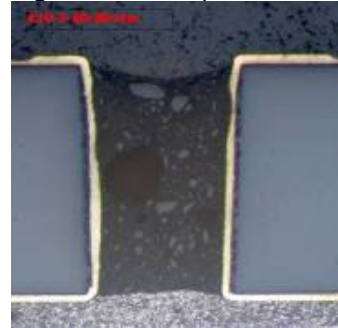
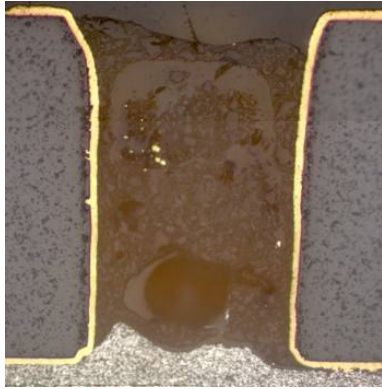
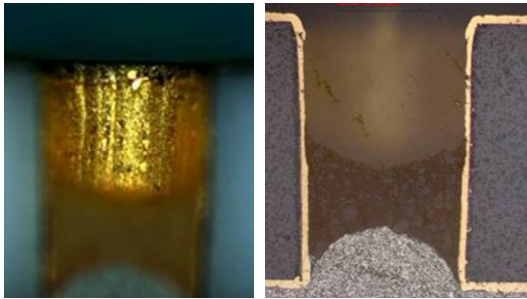
The samples were subjected to 116 temperature cycles, -55 to 125C, followed by 300C bake for 1hour, and then cross sectioned to examine the via metallization. All the samples passed and examples of the cross sections are shown in Figures 17, 18, and 19.

The selection of a “via plugging material” to prevent epoxy squeeze-out onto the top surface of a substrate must consider the thermal expansion of the material and aim to match the CTE of the substrate material (alumina). The selected material must be tested using representative coupons to ensure that the vias will survive the mission environments of the application over the life of the product. Understanding and validating the affect of via plug materials on the reliability of gold plated via structures is an essential part of the design and production of high reliability electronics for space applications.
