## Relationship of Cu Oxidation and Hardness towards Cratering in Wirebonding

Lee Chai Ying, Lee Cher Chia & Lim Chee Chian  
Infineon Technologies Melaka Malaysia

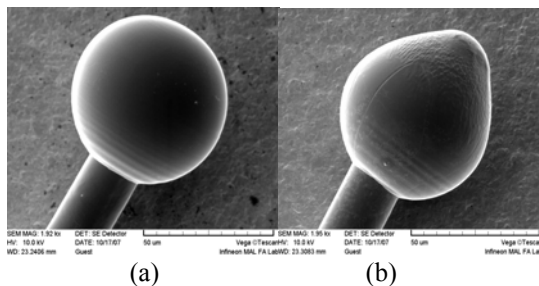
**Fig. 1 SEM Images for (a) non oxidized FAB that shown spherical round shape and smooth surface and (b) oxidized FAB which gives pointed shape ball and scaly surface.**

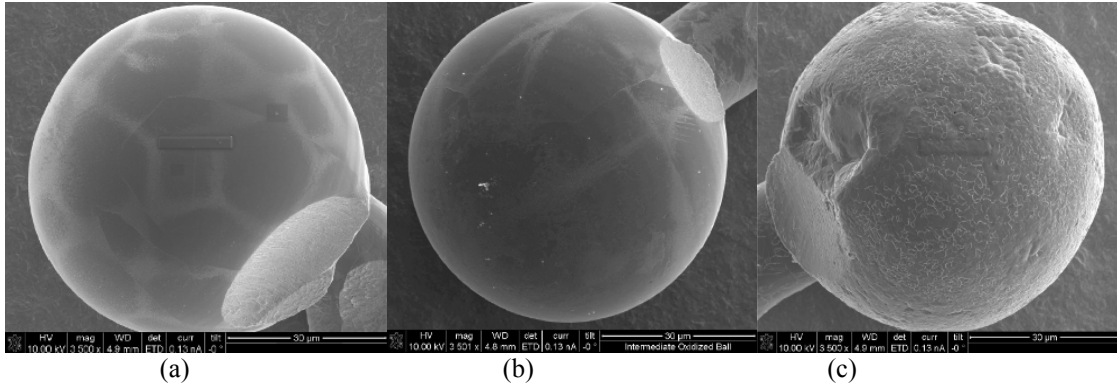
Fig. 2 shows the overview of the 3 samples with different oxidation rates before FIB bombardment. Visible and clear grain structure on non oxidized FAB can be seen. On the other hand, the scaly surface of intermediate and oxidized FABs also reveal with smaller grain structure as compared to non oxidized FAB.

**Fig. 2 SEM/FIB images prior to TEM inspection on 3 FAB samples at different oxidation rates: (a) non oxidized FAB, (b) intermediate oxidized FAB and (c) oxidized FAB.**

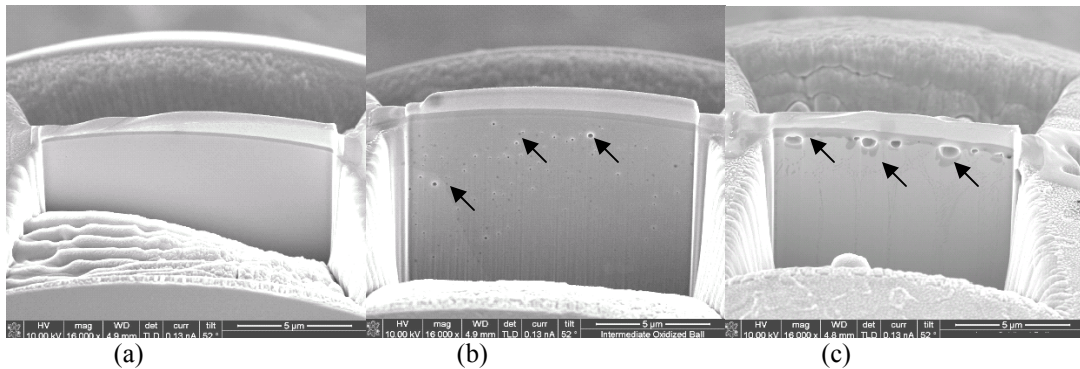
After targeted at the selected piece on the FABs, FIB bombardment was carried out and revealed the cross sectioned fragments (or pre-lamella for TEM inspection) that gave valuable observation and information as shown in Fig. 3. Non oxidized FAB shows very clean surface that is as smooth as the top surface can be observed in Fig. 3(a). In Fig. 3(b) is the intermediate oxidized FAB where several air traps were going upwards to the surface was observed. These air traps are believed due to the insufficient protective environment provided during the FAB formation. The air traps were combined into bigger air trap in not spherical shape and surfaced themselves to the outer part of the oxidized FAB as can be seen in Fig. 3(c). This phenomenon may because of the environment equilibrium during the unprotective FAB formation process. Besides oxidation layer, stripes formation was also observed underneath the oxidation layer as shown in Fig. 3(c).

**Fig. 3 Pre-lamella images after FIB cross sectioning: (a) non oxidized FAB, (b) intermediate oxidized FAB and (c) oxidized FAB.**

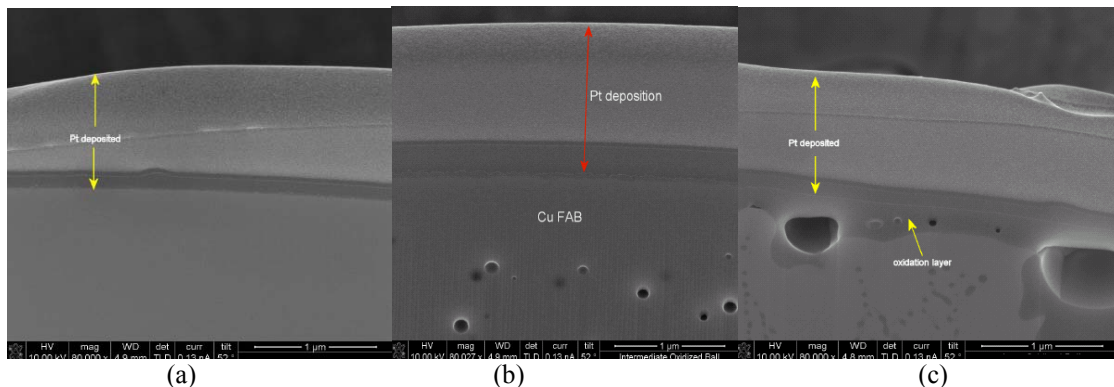
In higher magnification of 80,000x, there was a detectable copper oxidation layer found underneath the platinum protective layer in intermediate oxidized FAB and oxidized FAB. No oxidation layer detected in non oxidized FAB. The zoom-in images of the detectable oxidation layer of the FABs are shown in Fig. 4. Measurement on the FABs copper oxidation layers had been done under TEM inspection. The oxidation thickness reported for intermediate oxidized FAB is in the range of 60 to 70 nm while oxidized FAB is between 190 to 240nm. The measured images on the oxidation layers were reported in Fig. 5.

**Fig.4 80,000x magnification images under SEM/FIB observation on the visible oxidation layer on FABs: (a) non oxidized FAB, (b) intermediate oxidized FAB and (c) oxidized FAB.**

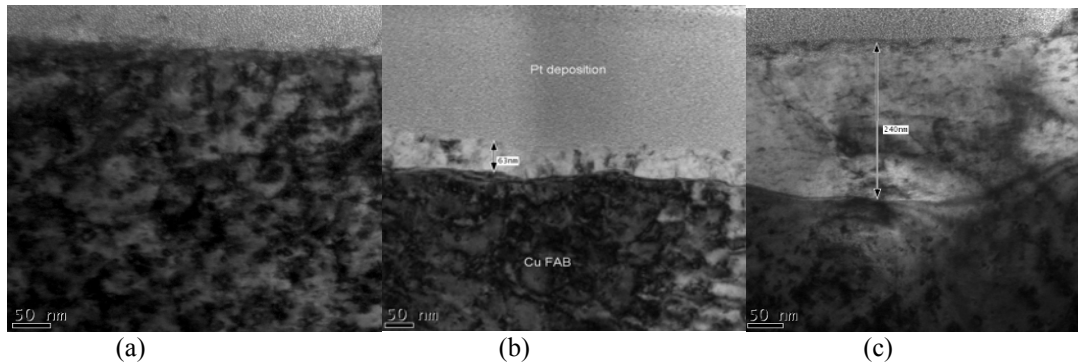
**Fig. 5 Copper oxidation layer measurement for FABs under TEM inspection: (a) non oxidized FAB with no detectable oxidation layer, (b) intermediate oxidized FAB with 60-70nm oxidation thickness and (c) oxidized FAB with 190-240nm oxidation thickness.**

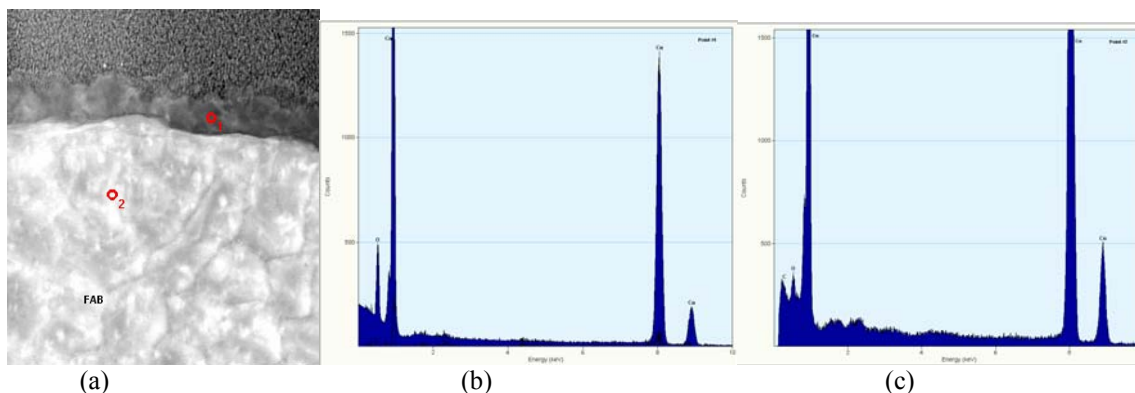
of the TEM system configurations which is known as scanning transmission electron microscopy (STEM) conducted in dark field. As shown in Fig. 6, two elements of copper and oxygen found on EDX analysis point 1 and only copper was detected in the copper bulk area at point 2. The carbon and oxygen elements found in point 2 could cause by sample preparation contamination, where the quantitative amount of elements detected was insignificant.

**Fig.6 Identification of elements at the oxidation layer: (a) STEM images which shown the EDX analysis points taken on Point 1 and Point 2, (b) EDX spectrum on Point 1 and (c) EDX spectrum on Point 2.**

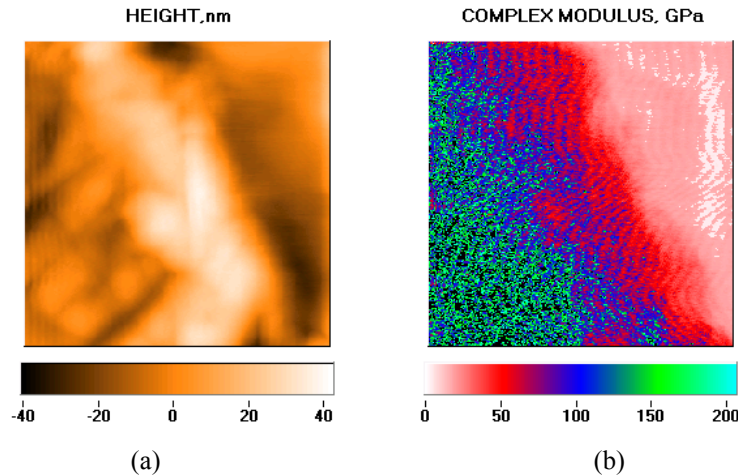
**Fig. 7** A 2  $\mu\text{m}$  x 2  $\mu\text{m}$  area of the edge of the oxidized FAB with the bulk copper area is at the left bottom part of the image: (a) a topographical *in-situ* image and (b) the corresponding Modulus Map.

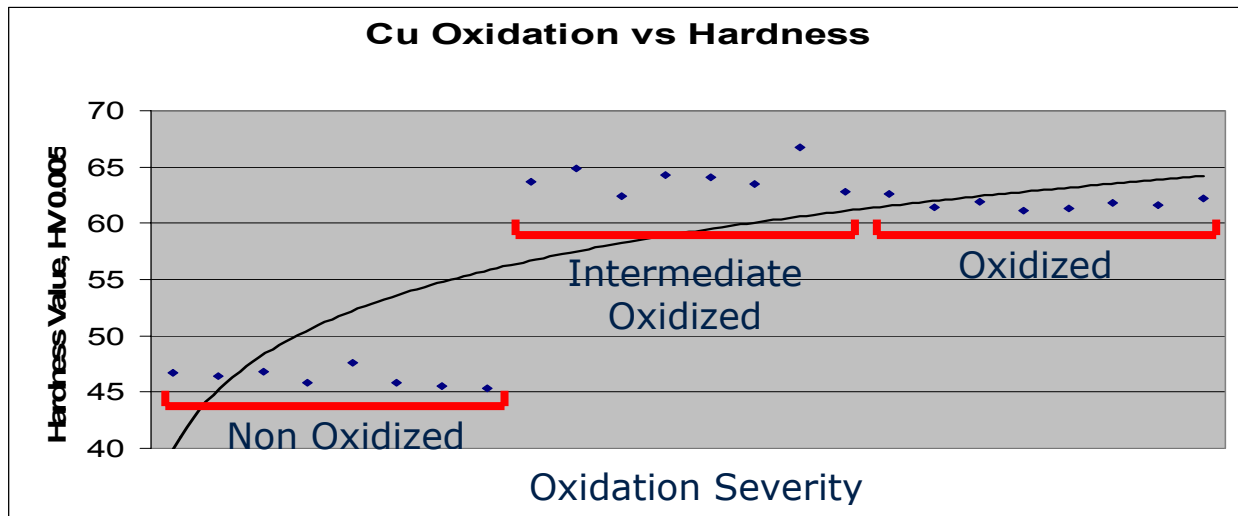
As shown in Fig. 8, a logarithmic relationship was plotted between the copper oxidation and its responsive hardness value. From this relationship, hardness value increased once oxidized and stayed stable regardless of oxidation rate. Non oxidized FAB has lower hardness value compared to oxidized group of FABs (intermediate oxidized and oxidized gave almost the same hardness value).

**Fig. 8** Logarithmic relationship of copper oxidation and hardness.

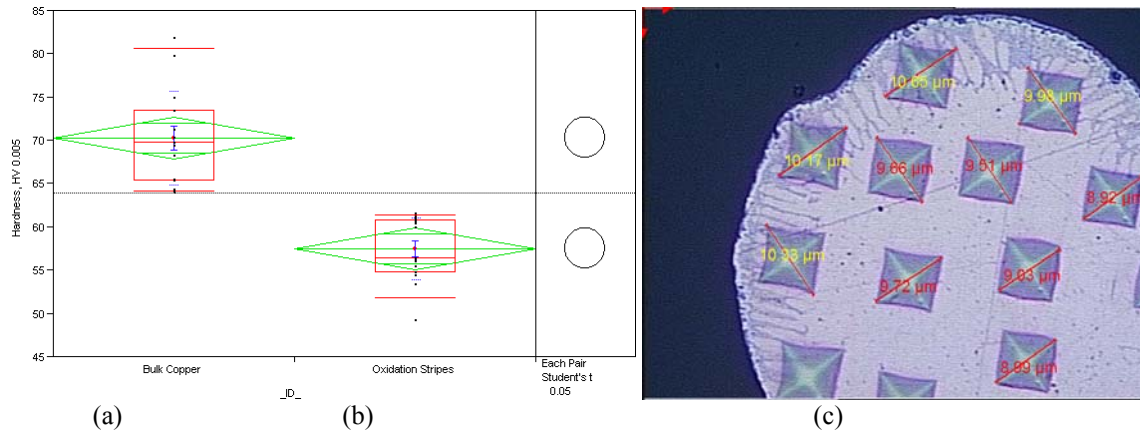
To further verify the copper oxidation is less stiff than the bulk oxidized copper, microhardness test was repeated at the stripes formation area and the hardness values assured that the nanoindentation statement is true. The validation of the data was given in Fig. 9. The diamond shapes indented at the oxidation stripes were found bigger (therefore, softer) than the bulk copper indenter's diamond shapes.

**Fig. 9** Vickers hardness values to further verify the nanoindentation result: (a) bulk copper, (b) oxidation stripes and (c) Microindention diamond image.

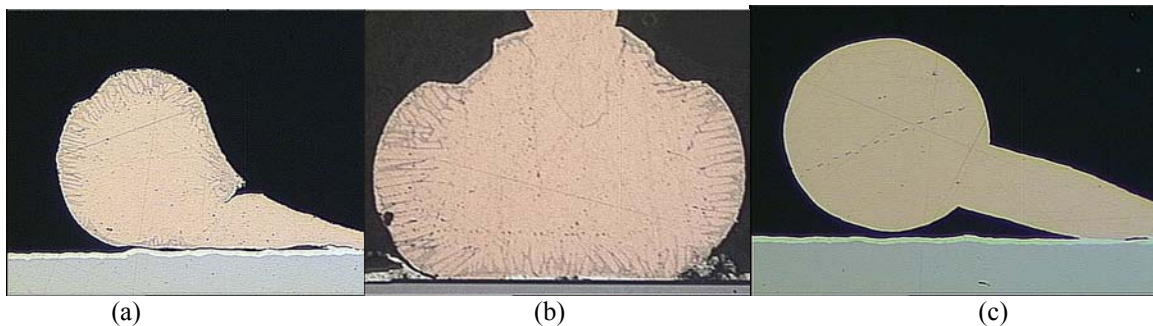
In the hardness test sample preparation, all the samples need to be mechanical cross sectioned and an interesting observation was discovered, as shown in Fig. 10. Stripes formation found and this observation was similar to the TEM inspection as shown in Fig. 3(c).

As compared to non oxidized sample, no stripes would be detected as shown in Fig. 10 (c). Therefore, cross section could be a new, less expensive and convenient failure analysis method to detect copper wire oxidation.

**Fig. 10** Cross section optical images of FABs and bonded ball that showing stripes formation in oxidized samples: (a) oxidized FAB, (b) bonded oxidized ballbond and (c) non oxidized FAB.

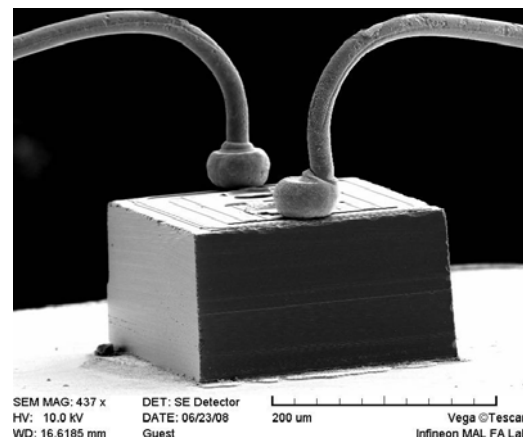
reliability test and requires preconditioning prior to perform the test. The test condition performed was according to JEDEC JESD22-A104 Condition H. In this test, oxidized samples still able to sustain in preconditioning and started to fail after 300

temperature cycles. The failure electrical parameters were HFE and VBESAT.

After failure analysis verification, lifted ballbonds detected (as shown in Fig. 11) which shown the poor intermetallic growth of Cu/Al. This observation implies that oxidized ballbond is bondable; however even without cratering, it is unable to withstand wire related stress test.

**Fig. 11** Lifted ballbond after TC 300x of oxidized samples.

From the sample build experience, copper oxidation was learnt not the major factor that caused cratering, but not optimum wirebonding parameters setting was the dominant contributor to minimize cratering defect. Even though oxidized copper wire was bondable without cratering, it is not recommended to use as it can't withstand wire-related stress test and revealed with lifted ballbonds after 300x temperature cycle test.
