# Impact of Reprocessing Technique on First Level Interconnects of Pb-Free to SnPb Reballled Area Array Flip Chip Devices

Joelle Arnold, Steph Gulbrandsen, Dr. Nathan Blattau  
DfR Solutions  
9000 Virginia Manor Road, Suite 290  
Beltsville, MD 20705, USA  
Ph: 301-474-0607  
Email: jarnold@dfrsolutions.com

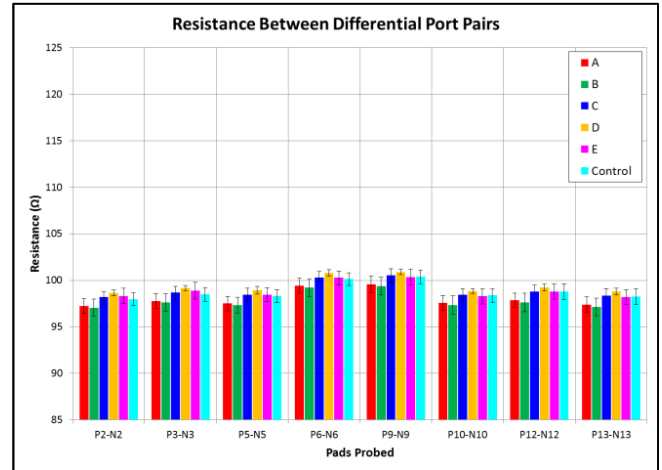
Five (5) reprocessed components were probed per population, all measurements for all components fell within the  $85\Omega$  and  $125\Omega$  range defined by the manufacturer specification. Average resistance for each pair by reballer is summarized in Figure 5. Minor deviations between particular bond pad pairs and reballers are evident, however, no statistically significant changes in measured resistance were observed as the result of reballing.

Figure 5: Average resistance between pads by differential port pair and reballer. Error bars indicate standard deviation.  $N=5$ .

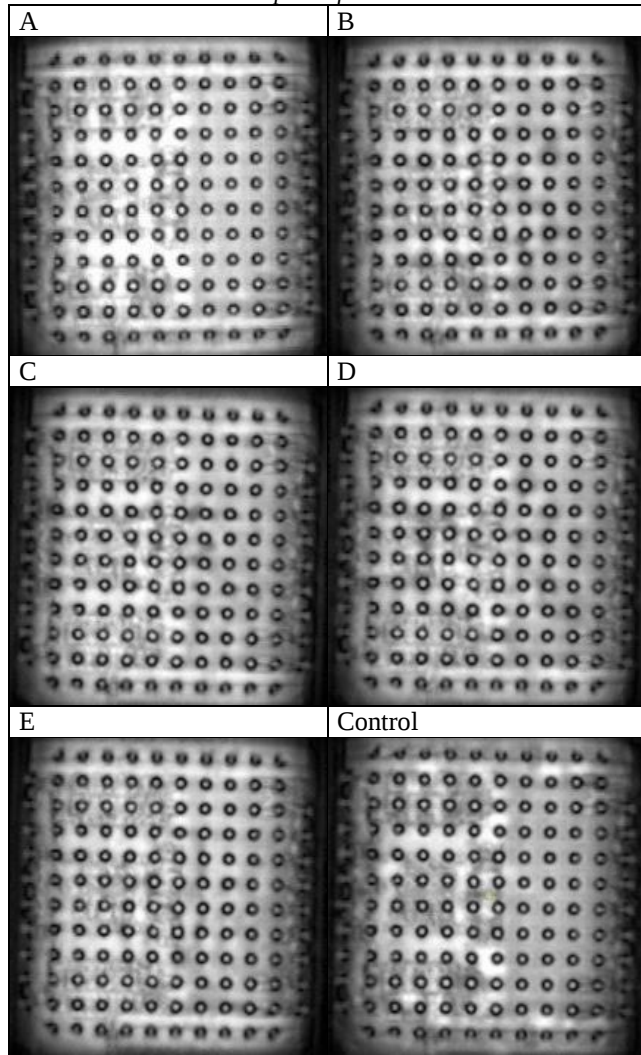
Table 1: SAM at die to bump interface reveals no delamination.

Tomographic acoustic micro-imaging (TAMI), a type of scanning acoustic microscopy (SAM), was performed on one flip chip processed by each reballer and a control. Imaging was focused at the interface where the solder bumps adhere to the pads on the die, visible in Table 1; and to the substrate, not shown. If observed, gaps, voids or delamination would be superimposed in red and yellow over black and white x-ray images; these defects were not observed on reballed or control components.

Acoustic microscopy indicated that no delamination occurred within the packages during the reballing process.

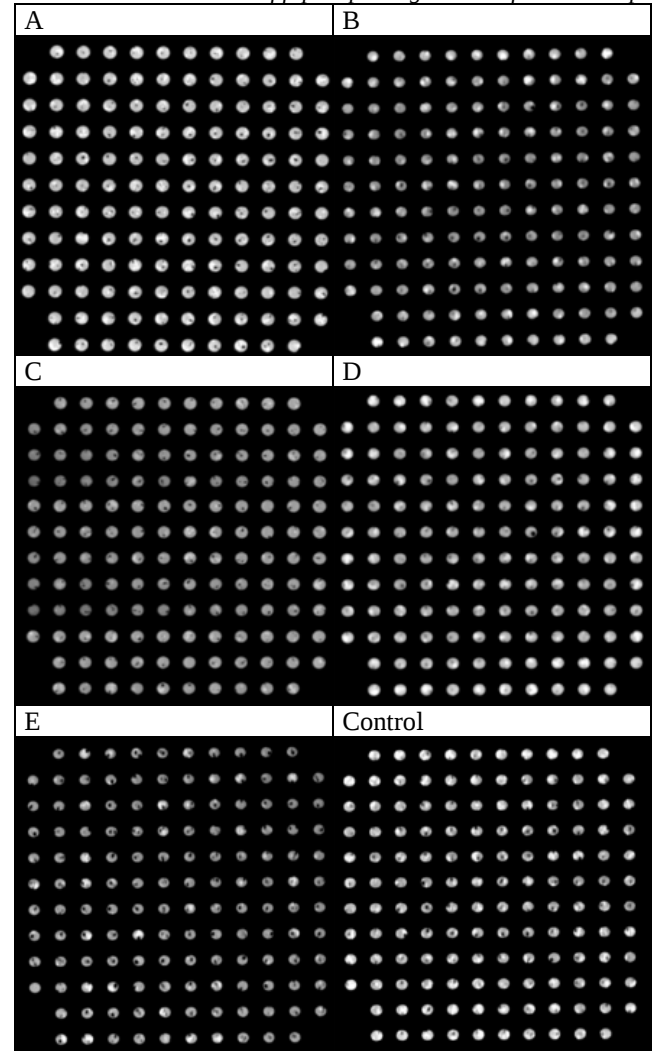
Table 2: Z-axis CT scans of flip chip along bottom of solder bumps.

solder joint, whereas a good joint would have no cracks [2]. The CT employed has a  $6\mu\text{m}$  spot size and can detect features as small as  $1.5\mu\text{m}$ . As each solder bump is  $\sim 0.65\text{mm}$  in diameter, fine cracks and defects would not be detected. No evidence of cracking of the solder bumps was seen in the X-Y scans, examples of which are shown Table 2, or the X-Z and Y-Z scans (not shown).

CT results indicated voiding in the solder bumps of the VSC3312 flip chips from all reballers, as seen by dark spots in the bottom slice images presented Table 2. There is more voiding in the bottom of the solder bumps than the top, as can be seen in the sample Y-Z plane cut, shown in Figure 6.

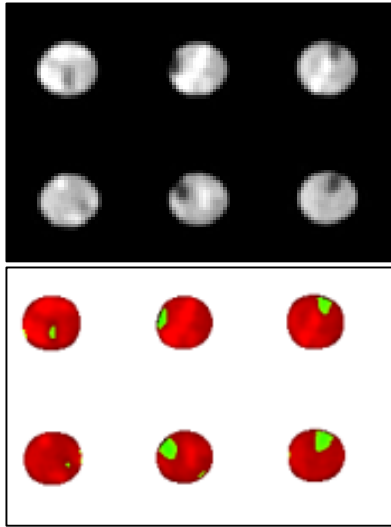
The bottom slice images were threshold corrected in ImageJ to allow for estimation of percent voiding. An example of a threshold and filter processed image used to calculate percent voiding can be seen in Figure 7.

Figure 7: Detail of Z-axis CT scan at bottom of solder bumps in control (top), and processed for void measurement (bottom).

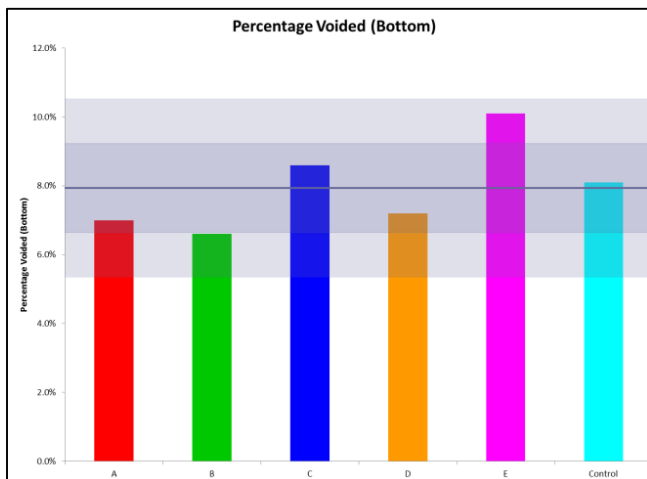
No specification exists for the amount of voiding deemed acceptable in first level interconnect solder bumps. IPC-A-610E states it is acceptable to have less than 25% voiding in a solder ball x-ray image. Despite the size and metallurgical differences between solder balls and bumps, the same mechanical principles should apply to both, and this metric is an acceptable guideline to indicate whether the voiding present in the solder bumps is a concern. After the simulated thermal events the VSC3312 flip chip experienced during reballing, the amount of voiding in the solder bumps was well below the 25% threshold and remained within two standard deviations of the mean, as displayed in Figure 8.

Figure 8: Percentage of cross sectional area voided, by reballer, with average voiding and two standard deviations indicated.

Bump voiding does not appear to correlate to reballing thermal stresses. Further study with thermal monitoring of the flip chips during reballing, and a larger sample size, would be necessary to confirm these findings.
