# Use of Wire Bonding to Study Bond Pad Damage from Wafer Probe

Stevan Hunter<sup>1,3</sup>, Jonathan L. Clark<sup>2</sup>, Darin Hornberger<sup>2</sup>, Lance Rubio<sup>2</sup>

<sup>1</sup>Idaho State University; <sup>2</sup>Brigham Young University Idaho; <sup>3</sup>ON Semiconductor, Pocatello, ID, USA

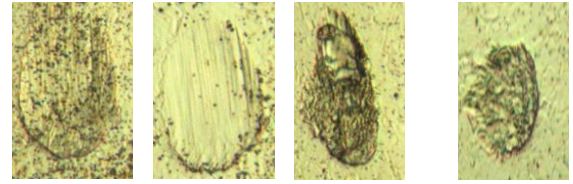
**Figure 3** Probe mark micrographs showing various characteristics. The two marks on the left are not very invasive and are less likely to cause cracking. The two on the right are deeper and more likely to result in cracks beneath.

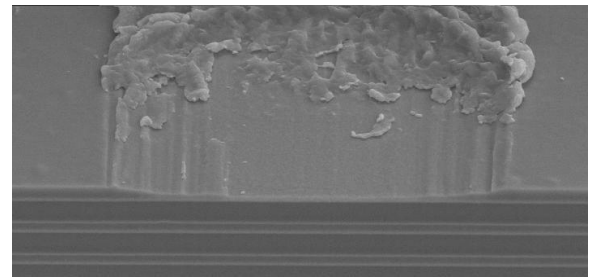
**Figure 4** A focused ion beam (FIB) cross section through a harsh probe mark shows that there is almost no pad Al thickness remaining in the deep scrub region.

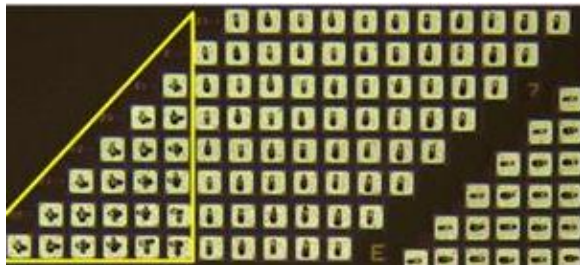
**Figure 5** A portion of the experimental test chip with large probe marks on the pads seen after harsh probing. All pads to the right are probed in a single test of 6 touchdowns at 4mils overdrive. Highlighted on the left are cross-probed pads, harshly probed twice, with one scrub direction perpendicular to the other.

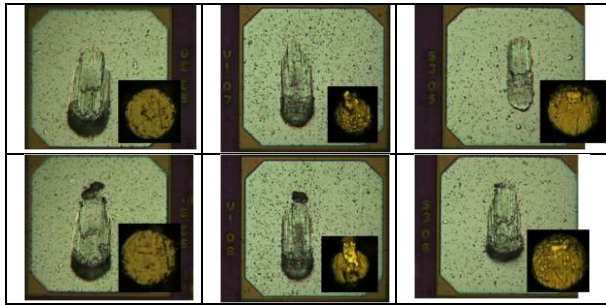
**Figure 11** Example probe marks and probe tip photos from a long and short tip length pair from each card. *High Force* (left); *Small-tip* (center); *Low Force* (right).

Note how the large tip marks are not as wide as the tip diameter, while the *small-tip* marks are as wide as the tips. Measurements on the probe cards revealed that the *small-tip* probes have about 5° lower bend angle, 100°, while the other two cards have tips at about 105°. Higher bend angle seems to make the tip “heel” do the scrubbing. Four mils of overdrive causes all of the tips to scrub about the same, regardless of the tip angle, though we see that probe marks from the *low force* tips are actually slightly shorter.

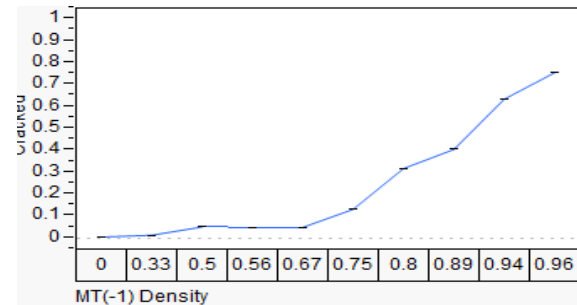
**Figure 12** Fraction of pads cracked in probing vs pattern density of the MT(-1) layer within the pad window for all 3 probe cards combined. Probing with 6 touchdowns at 4mils overdrive, not including cross probed pads

This probe cracking trend closely matches trends reported from our previous harsh probing experiments [1]. High MT(-1) pattern density pads are the weakest, showing the most ripple and cracking when harshly probed. But we notice unexpected cracking at 75% MT(-1) density and subtle cracking tendencies below 75% MT(-1) which invite further investigation. Figure 13 shows a breakdown of the cracking from each probe card within each MT(-1) pattern density value.

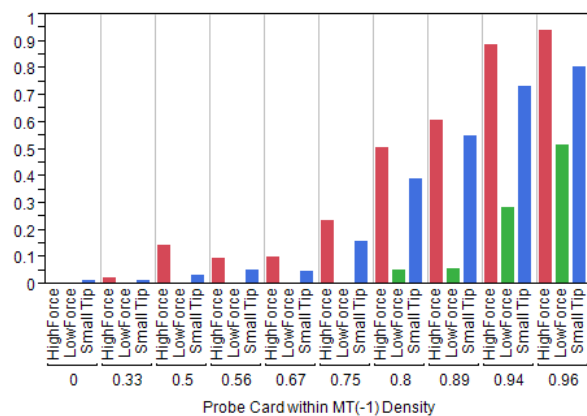
**Figure 13** Fraction of pads cracked after probing, comparing the 3 probe cards, with the x-axis being the

**MT(-1) pattern density, for 16 different pad structures in the experiment. Harsh probing conditions are: 6 repeated probe touchdowns at 4mils chuck overdrive.**

The *low force* card data are the green bars. Only the weakest of the structures were cracked by these probe tips in the harsh probing conditions. Cracking begins at 80% MT(-1) pattern density and increases from there. This probe card is most like a cantilever probe card that might be used in manufacturing for CUP pads having thin pad Al, and it appears that there is a good process window without cracking for MT(-1) pattern density at 75% or less.

The *high force* card data are in the red bars of figure 13, showing the most cracking in every case but one. Cracked pads increase dramatically from 67% MT(-1) density and higher on this card. Two of the pad designs at 75% MT(-1) density have top vias, contributing to increased cracking at that position on the chart. Cracking at lower than 75% MT(-1) in these harsh probing conditions is found to be due to interactions with relatively wide MT(-2) features. Using such strong cantilever probe tips and these harsh probing conditions should certainly be avoided if cracking is to be prevented in a manufacturing situation.

Cracking from the *small-tip* probe card is indicated by the blue bars, which closely follow the red bars of the *high force* cracks in figure 13. The *small-tip* tips exert only half the force per tip as compared to the *high force* card but still apply about the same stress in a smaller area, so the relatively high amount of cracking observed makes sense.

The *small-tip* card is the only card that cracked a pad designed with no MT(-1) at all beneath the pad window, at 0 on the x-axis. Cracking of this style pad is rare, based on our extensive previous experimentation. When MT(-1) is not present under the pad window, there is simply a stack of SiO<sub>2</sub> layers between MT(-2) and pad barrier film, with more than twice the usual SiO<sub>2</sub> thickness in total. This thicker sheet of SiO<sub>2</sub> does not tend to initiate cracks. It cannot bend as easily under the probe tip and cannot so easily stress the MT(-2) Al in a small spot to deform it into the local “valley” associated with probe crack initiation. We attribute this particular *small-tip* cracked pad having no MT(-1) to

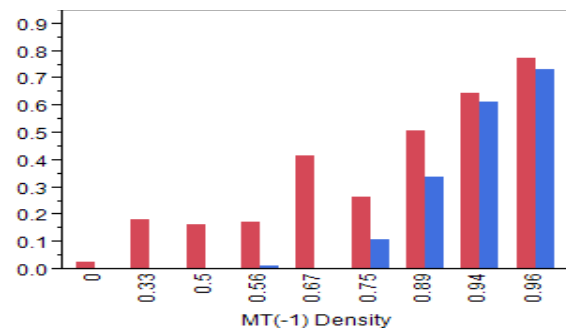
**Figure 14** Fraction of pads cracked in probing vs pattern density of the MT(-1) layer, from the cross-probed pads only: blue bars are cracked pads from the standard probe direction, red bars are cracked from probing in the cross-probe direction.

MT(-1) is designed with arrays of holes for the 75% through 96% designs in this case. So cross-probing on these “symmetric” designs simply adds more stress following the initial probing, and the additional cross-probed cracking we see in red is expected. Note how as the MT(-1) density increases (pad becoming more susceptible to ripple and cracking), the initial probing already had cracked nearly as many pads as did the cross-probing afterwards. Of course there are more total cracks found in the cross-probed pads.

The significant cross-probe cracking of pad designs having lesser MT(-1) density is due to the change from scrub parallel to perpendicular relating to the sub-layer metal lines and slots. The data confirms two different cracking mechanisms over patterned metal interconnects, which we have previously reported but not explained. Illustrations of probing in parallel and perpendicular to MT(-1) circuit lines are shown in figure 15.

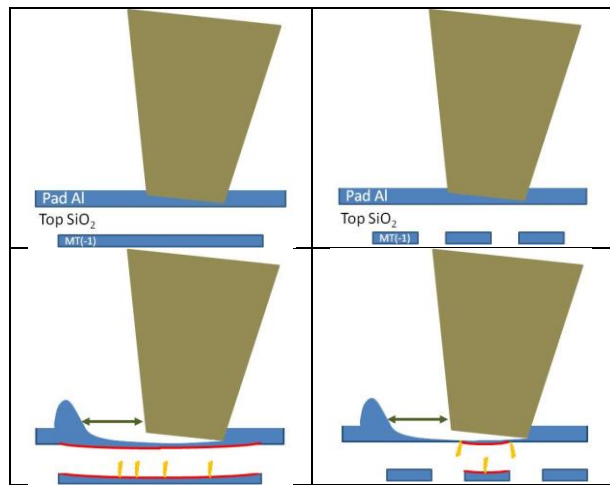
**Figure 15** Probe tip touchdown and scrub illustrations for 2 pad structures with MT(-1) lines and slots: (left) probe scrub parallel to MT(-1) line; (right) probe scrub perpendicular to MT(-1) lines. (Lower left) scrub in parallel may deform the Al into a valley and initiate cracks in the bottom of the SiO<sub>2</sub>; (lower right) scrub perpendicular to metal lines may cause cracks to initiate at both top and bottom.

The pad Al deformation is simplified in the cross section of cantilever tip probe marks shown in the bottom row of figure 15, with a “gouge” where initial touchdown and scrubbing occurs, and a “prow” where Al material has been “bull dozed” by the probe tip, building up at the farthest extent of the scrub.

As illustrated in figure 15, harsh probe scrubbing above a metal line, in the same direction as the metal line, can cause cracks to initiate above the Al “valley” formed. Harsh probe scrubbing *across* sub-layer metal lines tend to initiate cracks corresponding to the edges of the sub-layer metal features. The sub-layers involved may be MT(-2) features, not just MT(-1) in these harsh probing conditions. Even when the MT(-1) has arrays of holes for 75% or less pattern density, sufficient to prevent the majority of MT(-1) deformation and top SiO<sub>2</sub> cracking, MT(-2) features beneath can still interact with harsh probing, resulting in crack initiation of the top SiO<sub>2</sub>. Recall that the cantilever probe tip retracts along the same path that it forges, imparting stress again on the return trip. This reverse-direction scrub action may be important in the further initiation of cracks in the case of probing *across* metal lines and spaces.

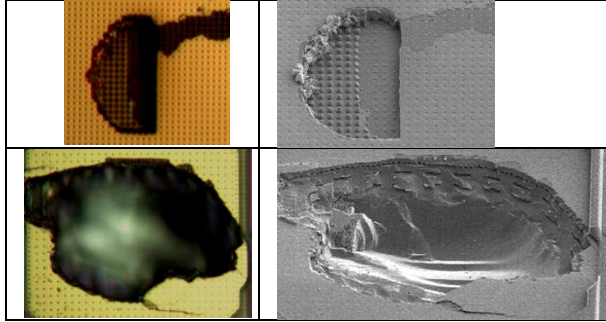
**Figure 17** Optical and SEM photos of craters associated with top vias and harsh probe cracking: (top) barrier lifting and severe probe cracks enhanced by bonding led to etching of sub-layer Al and breaking away of pad  $\text{SiO}_2$  layers; (bottom) crater after bonding, with the cracking going deep into the Si.

This severe pad damage of figure 17, observed after bonding, is rare in this experiment, occurring only on harshly probed pads having top vias.

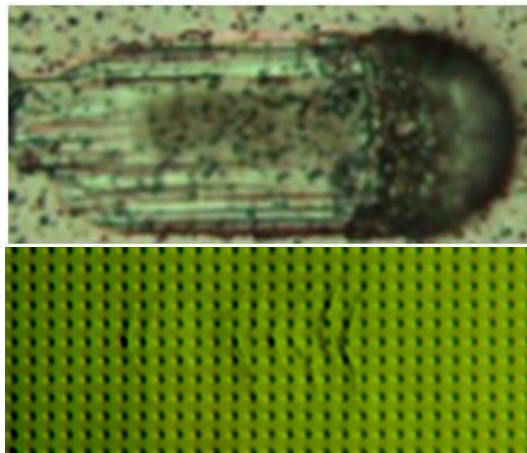
**Figure 18** Probe mark, and probe cracking from small-tip harsh probing on a pad with dense top vias, and MT(-1) having a pattern density of 75%

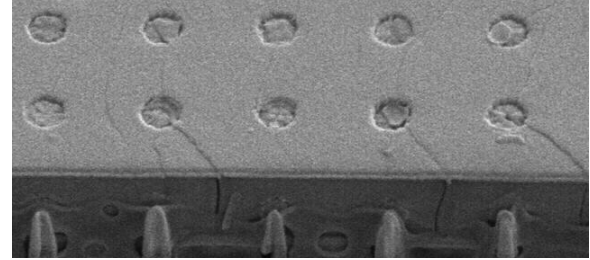
**Figure 19** SEM image of cracked pad barrier film and top vias in cratering test after harsh probing, with focused ion beam (FIB) cross section showing the expected vertical cracks in the top  $\text{SiO}_2$  film as well as unusual "wavy" lateral cracking of the  $\text{SiO}_2$ . The white cones along the bottom are portions of top vias.

The top surface cracking on this harshly probed pad is barely visible among the dense top vias, but the local hidden damage is severe, apparently enhanced by the smaller probe tip. In our extensive experimenting with bond pad structures, we find that such hidden damage is unique to pads having top vias, worse as vias are more closely spaced. The structure is mechanically weak in the probed region, and the damage will be enhanced by bonding, but remains localized in this case due to the patterned MT(-1) beneath. Previous data shows that for MT(-1) in a full sheet (100% density), local damage from cracking among top vias is likely to propagate cracks across the pad in bonding, as shown in figure 20.

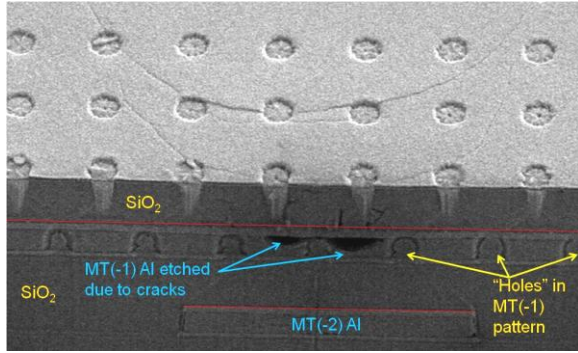
**Figure 21** FIB cross section after harsh probing and crater etch showing cracking among dense vias from the *small-tip* probe card (cut is perpendicular to the probe scrub)

The cracking occurs directly over the position of the MT(-2) wide line running parallel to the probe scrub. Red reference lines are to draw attention to the fact that the MT(-2) Al has dipped down in the center, causing a similar dip in the patterned MT(-1) layer above. Some of the cracks extend from the MT(-1) up to the to surface, allowing the crater etch to seep in and remove some Al from the MT(-1) in between the array of holes. Cracks among these vias are not simple vertical cracks. This hidden damage has a significant lateral cracking component in the SiO<sub>2</sub> film, and the mechanical strength of the structure has been destroyed in this region.

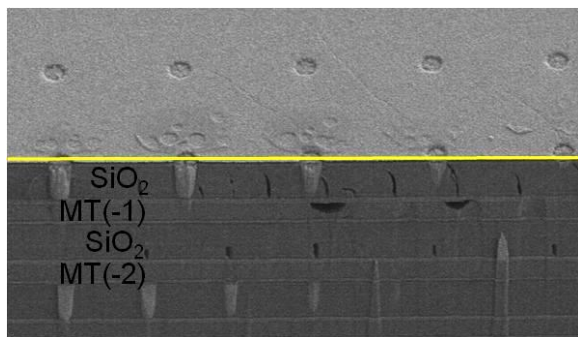
**Figure 22** FIB cross section after a cratering etch of the pad structure having 75% MT(-1) density (the MT(-1) holes are not seen in this view) and sparse top vias, probed by the *small-tip* card. Though there are some large cracks breaking the surface, most are hidden in the sub-surface portions of the top two SiO<sub>2</sub> layers. Probe scrub direction was right to left.

This hidden damage may be greater because of the reduced contact area of the tips, concentrating the stress in a smaller region as it scrubs. There are even cracks in the bottom of the top-SiO<sub>2</sub>-minus-1 film, which is unusual in our experience.
