Case Study: Radial Cracks in a Rigid-Flex Assembly

Christopher Matsuoka
Crane Aerospace & Electronics
Microelectronics Solution
10301 Willows Rd. NE
Redmond, WA, 98052
Phone: 425-895-5125
E-mail: chris.matsuoka@crane-eg.com

Key words: corrosion, ENIG, black pad, crack, medical device, PCB, failure analysis

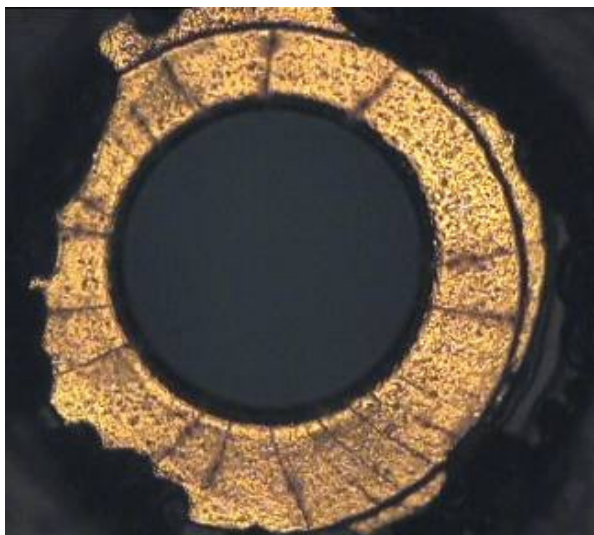
Figure 1 – Photo of severe cracking defect (176x magnification).

The cracks were found to vary in size, shape, quantity, and discoloration. Furthermore, the cracks were only observed on the top side of the board where a mechanical stiffener is adhered.

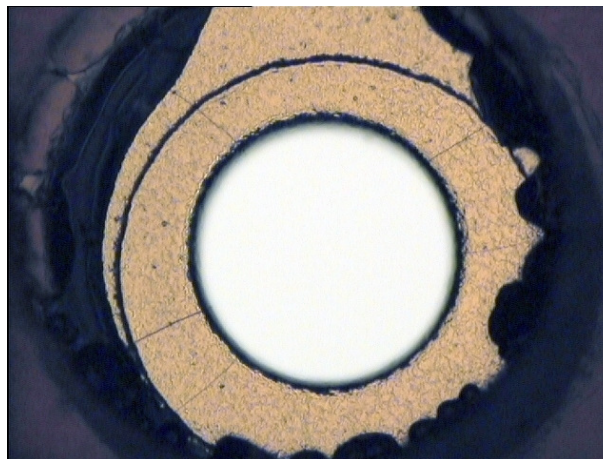
All incoming lots of PCBs were now visually screened 100%. Several boards were photographed and inspected at 176x using an OGP Smartscope. Figure 2 shows the as-received condition of the board at Crane, confirming the defect is occurring during the PCB fabrication process.

Figure 2 – As-received condition of the PCB, showing visible cracking on the annular rings (~120x magnification)

Given the difference in severity of the defects shown in Figure 2 and Figure 1, it was not clear whether the assembly process at Crane exacerbated this pre-existing defect. Our internal CBS (Crane Business Systems) tools identified several possible causes, and consequently the following actions were planned to learn more about this phenomena:

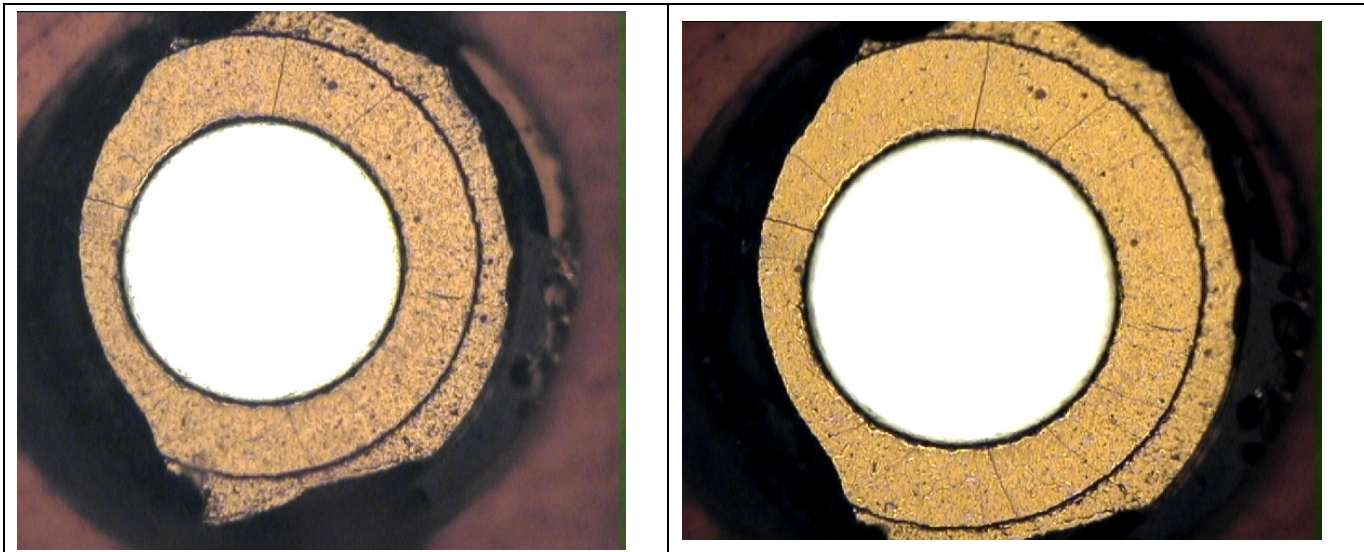
Results from the first simulation visually show all the thru-holes unchanged at ~176x magnification after all thermal exposures (Figures 4 and 5). Although Figure 4 may visually represent a majority of the sample population, there were still numerous instances where a dark residue was found surrounding each crack (Figure 1). Samples already exhibiting this condition appeared to worsen during the simulation (Figure 5).

Figure 4 – Condition of flex thru hole at location 2 before (left) and after (right) thermal processing.

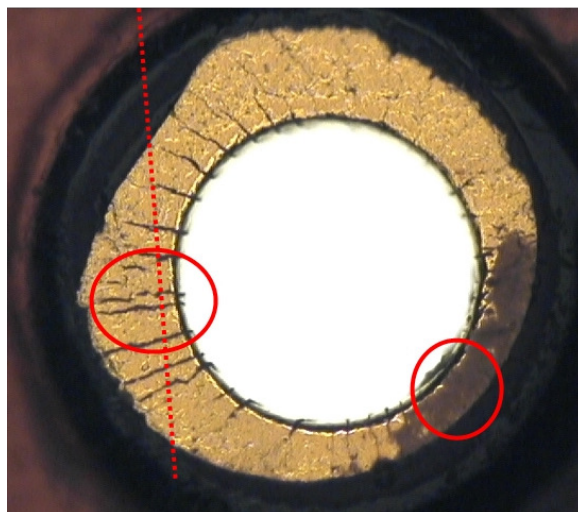
Figure 5- SN06-16-Y, SEM/EDS sample with the cross section plane defined by the dotted line and the desired EDS regions circled.

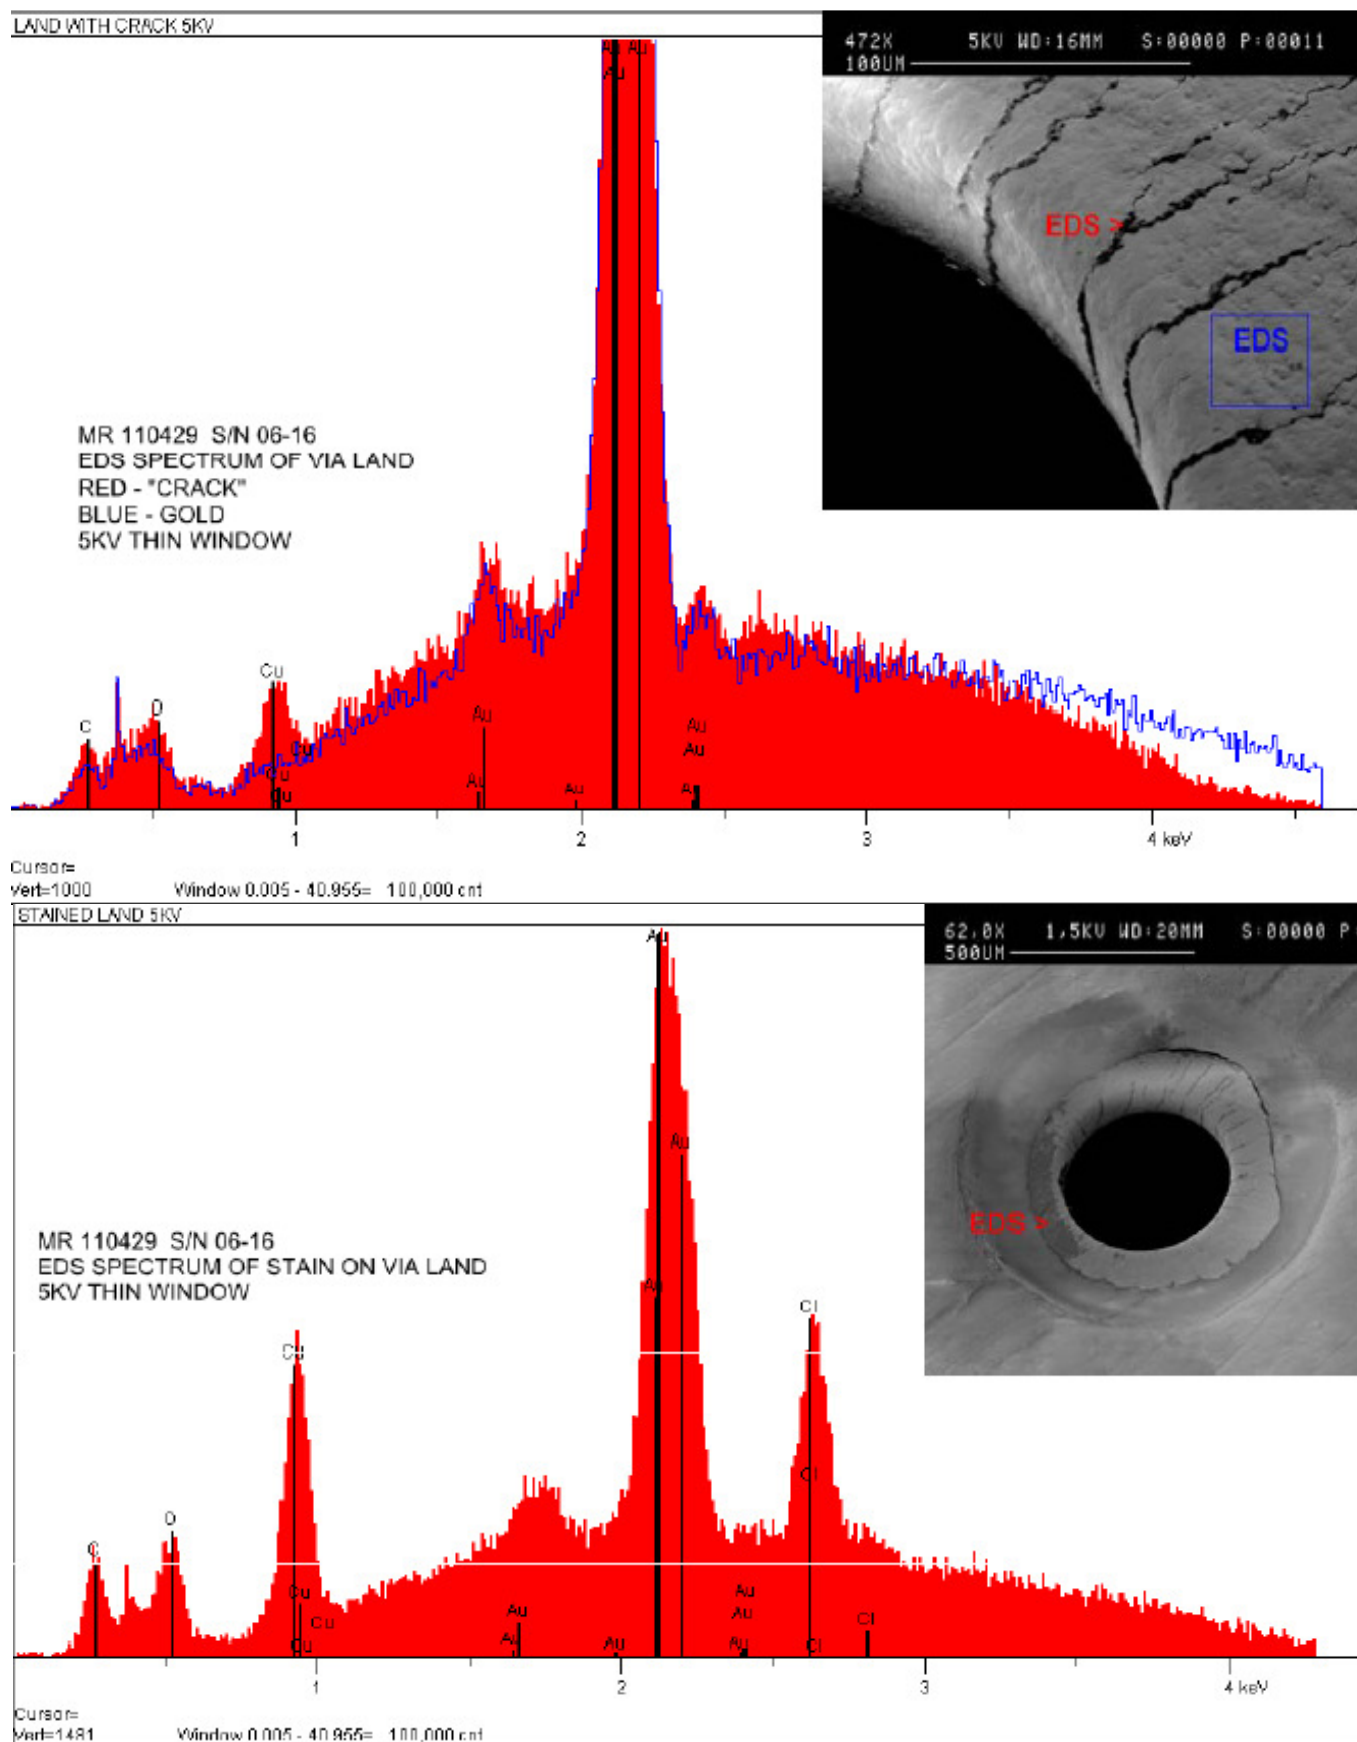
SEM images and EDS spectra of PCB sample 06-16, location Y, are shown by Figure 6. At the top of this figure two spectrums are superimposed. The blue line correlates to the region inside the blue box of the adjacent image where the gold was analyzed. The red line correlates to the center of the crack feature. At this magnification (472x) both areas were composed of Au, Cu, C, and O. SEM and EDS analysis of the stained region shown by the bottom half of the figure reports Au, Cu, C, O, and Cl. Chlorine is not used during Crane processing, but it may be a byproduct of the plating corrosion.

Figure 6 – SEM and EDS spectra of PCB 6-16, location Y.

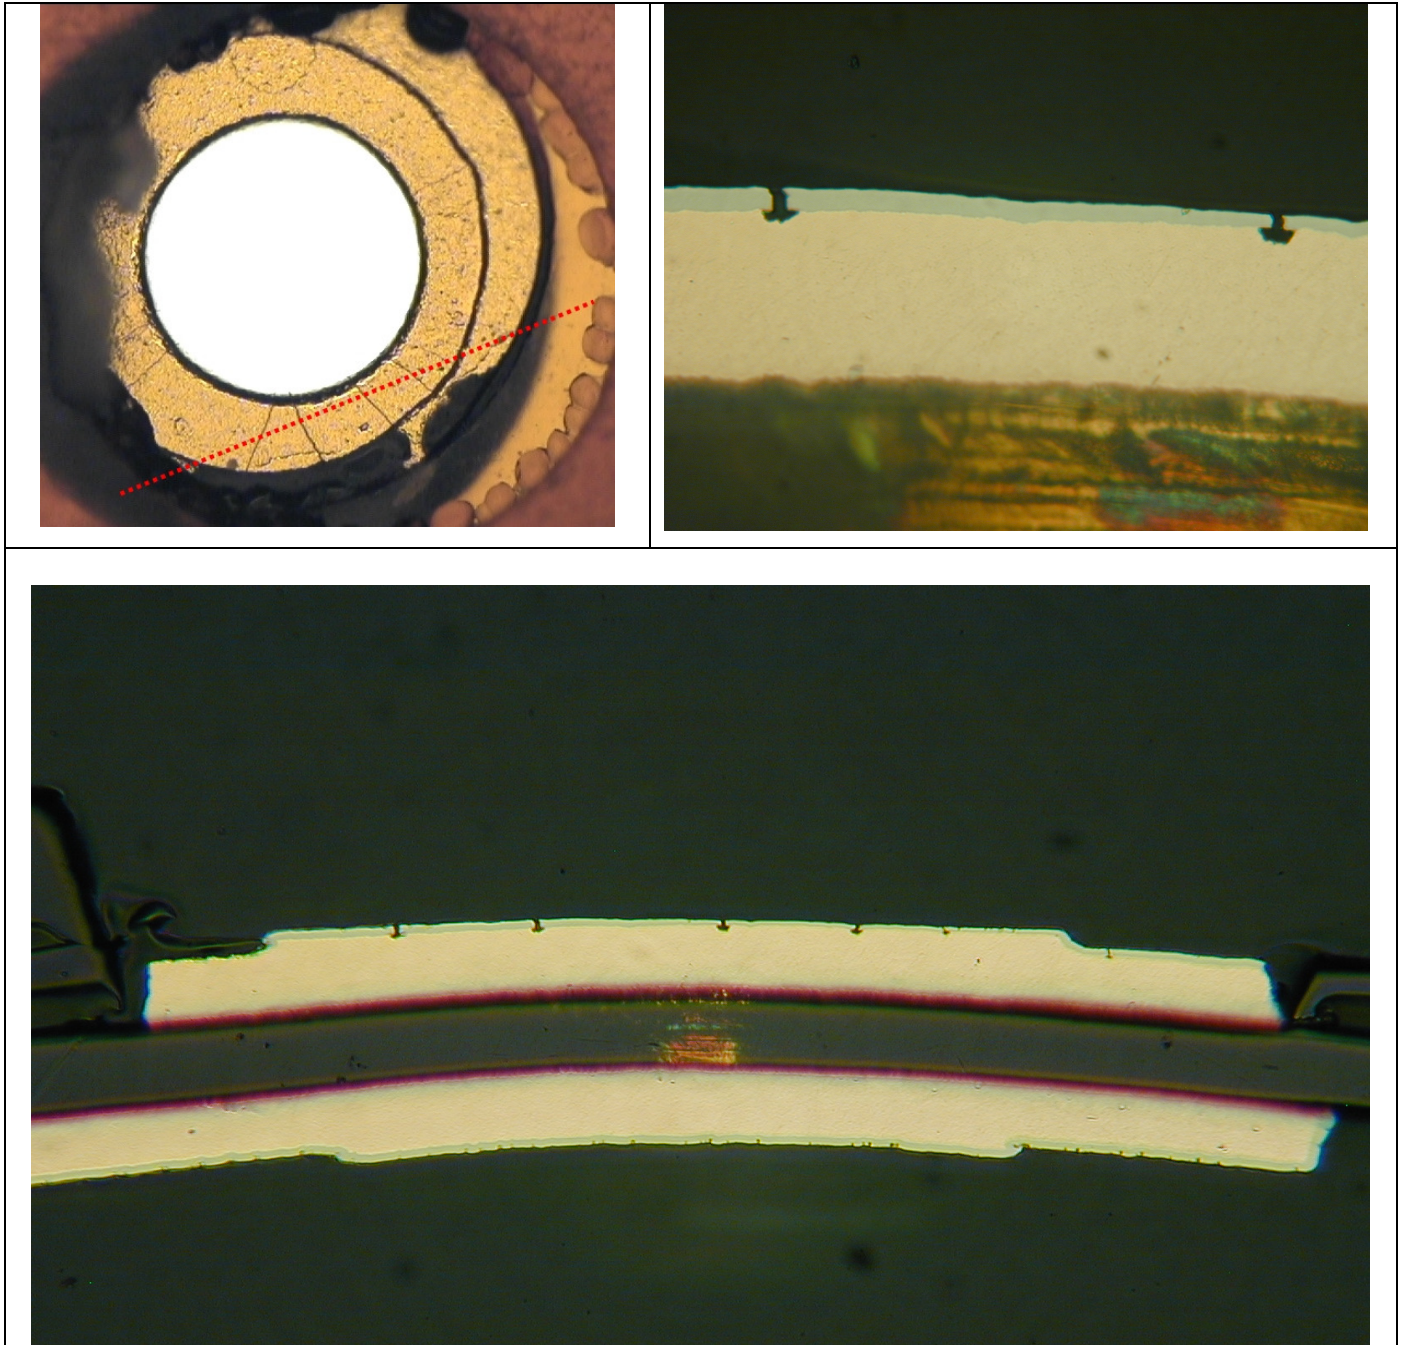
Next, the region of interest from each sample was removed from the rest of the board, vacuum encapsulated in epoxy and sectioned through the pre-defined planes. Optical examination of these samples revealed that the cracks on each annular ring were actually corroded fissures in the nickel-phosphorus [Ni(P)] plating. Pitting corrosion of the copper layer was also evident in most cases unless the entire Ni(P) layer had been consumed. Sample 1-8, location 7, is an example of this (Figure 7).

Figure 7- PCB Sample 1-8, location 7

Top Right: Sectioned view at 760x magnification highlighting evidence of pitting corrosion

Bottom: 150x view of section highlighting the difference between the opposing sides

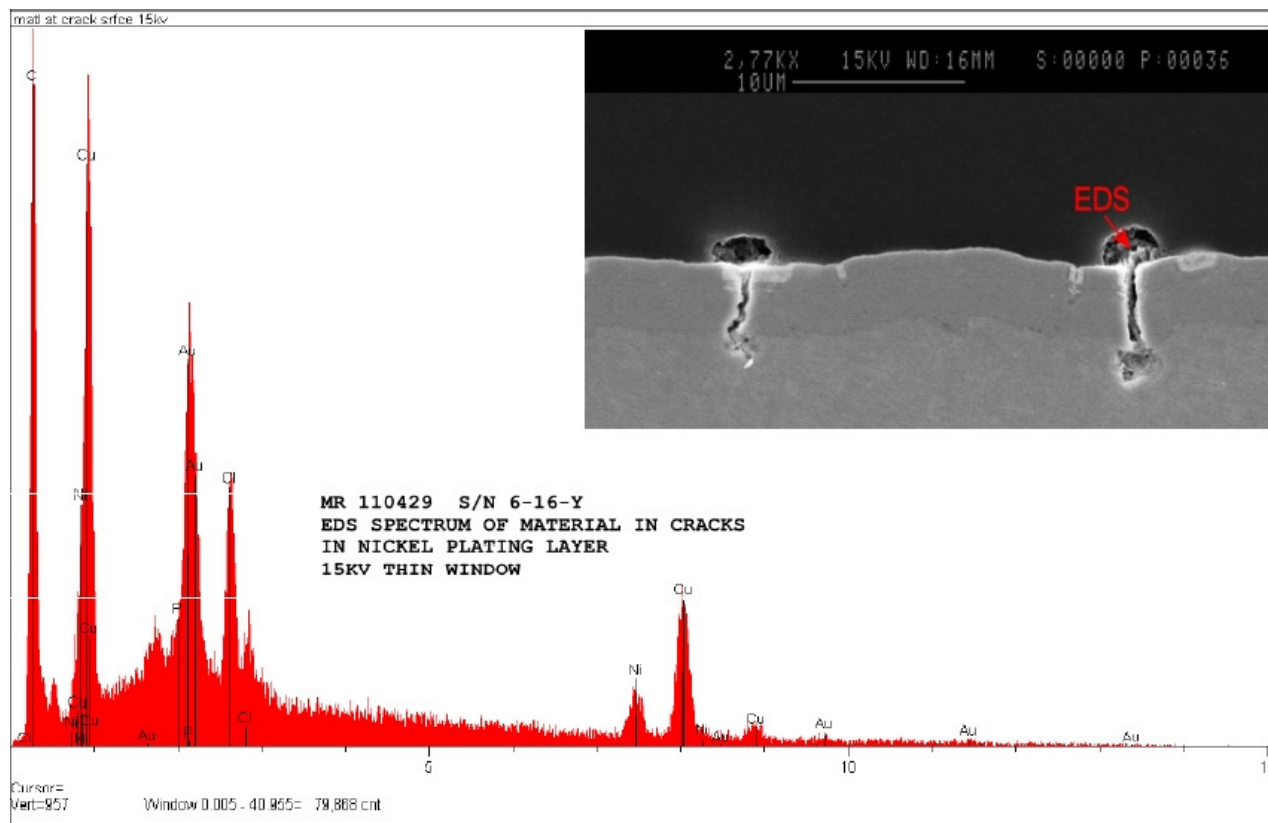
SEM and EDS analysis of PCB 06-16 after sectioning at location Y revealed the following composition: Au, Cu, Ni, Cl and P (Figure 8). This figure clearly shows the cracks are actually fissures with the corroded metals from the plating layers growing towards the surface.

Based on both visual and EDS spectra findings the problem appears to be related to the black

pad (excessive nickel-phosphorus corrosion) phenomenon. This was further confirmed by EDS analysis of the nickel-phosphorus layer and the black pad region. Ni and P compositions for both layers were 89% and 11% vs. 83% and 17% respectively.

Figure 8 – SEM and EDS spectra of a fissure in PCB 6-16, location Y.

The current supplier has changed the surface finish of the flex from ENIG to HASL after attempts to determine the root cause of the fissures proved unsuccessful. It is still unclear to the supplier how the cracks or fissure structures were initially created. Boards built recently with the HASL finish meet the visual requirements without the concern of black pad occurring.
