# Challenges for Achieving Automotive Grade 1/0 Reliability in FCBGA and fcCSP Packages

Knowlton Olmstead | Sr. Engineer  
Memory Product Development  
April 2021

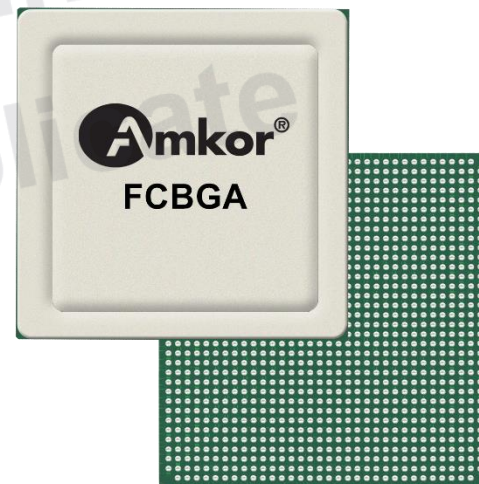
- ▶ Larger packages for greater integration
  - ▷ Sensors
  - ▷ ADAS
  - ▷ Infotainment
  - ▷ V2X
- ▶ TC challenges
  - ▷ Substrate crack
  - ▷ Bump crack
  - ▷ UF crack
- ▶ HTS challenges
  - ▷ Underfill oxidation → UF surface cracking
  - ▷ IMC growth → solder voiding

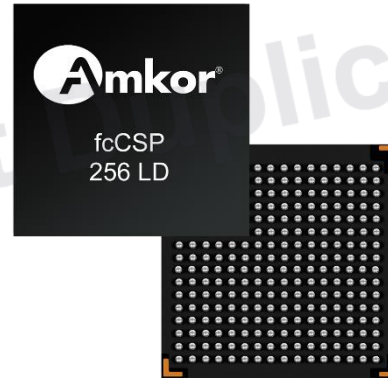
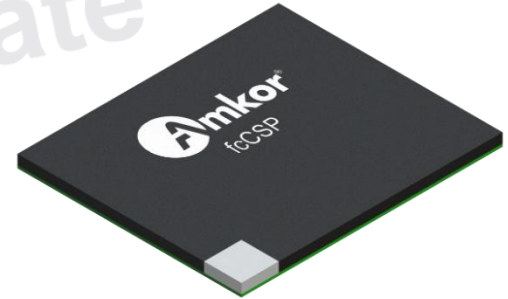
- ▶ Material degradation
  - ▷ HTS and TC
  - ▷ EMC embrittlement
- ▶ Long HTS time
  - ▷ 2xG0
