## Flipchip Reliability Improvements for an Automotive Sensor Application

### Abstract:

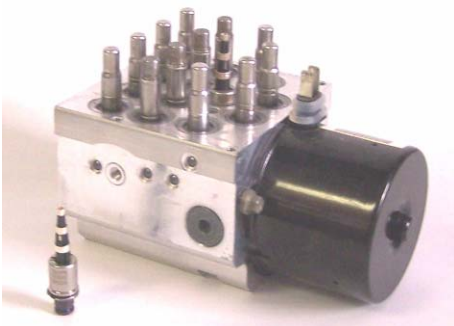
**Figure 2 – Typical Hydraulic Control Unit (HCU) for an ESC system**

The original approach chosen by Sensata for packaging sensors of this product family was to employ a flip-chip on flex. A typical sensor of this type utilizes a strain gauge sensing element wirebonded to a flex circuit. The flex circuit serves as the interface between the sensing element and customer driven I/O/connector as well as the substrate for the signal conditioning ASIC and supporting components. The flex is bonded to a polymer support structure (support ring) that allows it to be attached to the sensing element (pressure port) that interfaces the brake system Hydraulic Control Unit (HCU). Figure 2 shows an HCU, and Figure 3 shows the internals of a typical sensor.

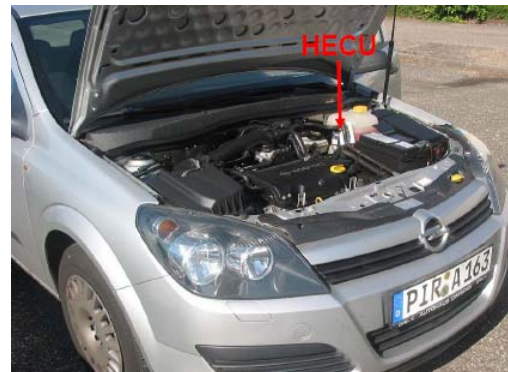
**Figure 4 & 5 – Typical location of ESC system HCU**

Drivers for this approach were smaller size and ease of manufacturing. The typical mounting location for the HCU is under the hood in the engine compartment. (See Figure 4 and 5)
