## Mechanism of Whisker Growth caused by Corrosion of Solder

### Abstract

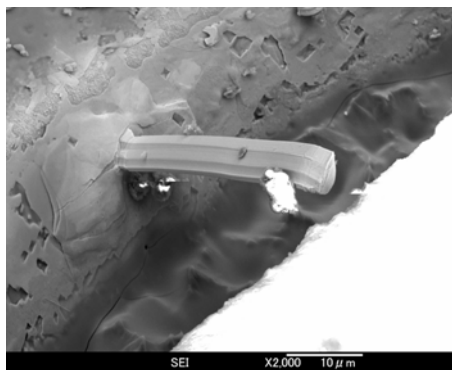
**Fig.3 SEM image of observed whisker**

This whisker is located at the side of Cu-wiring.

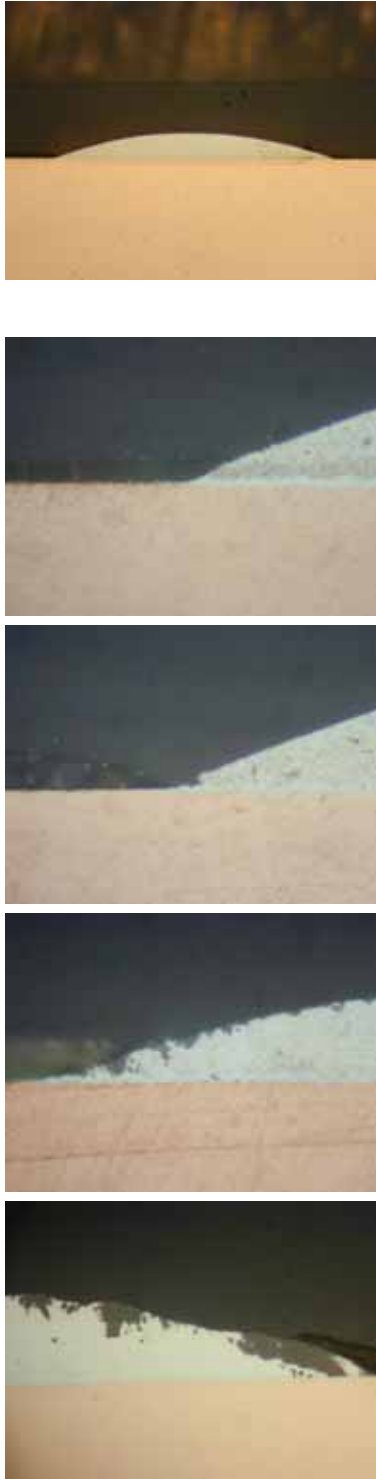
A solder ball (760 μm diameter) coated with flux was reflowed on Cu plate. Without rinse these plates were held in 85%-85C chamber for 0-1000h. After holding these, progressing conditions of corrosion were observed. Fig.18 shows these progressing conditions of corrosion. Tin solder began to corrode from 100h. As shown in these photographs the corrosion points are near Cu plate. From these figures corrosion make progress by local cell mechanism between solder and Cu metal. Active atom(Br) in flux will be considered to play a leading role of corrosion. In the case of the position far from Cu plate we could not observe any corrosion in spite of existence of flux. In case of Fig.17 we can observe two corrosion points- the shoulder and the lower part of wiring metal. So, wiring metal will expose at these points in air.

**Fig.18 Optical microscope images of corrosion (holding time; 0-1000h)**  
**(the upper is 0h ,the second is 30h, the third is 100h, the fourth is 300h, the bottom is 1000h)**

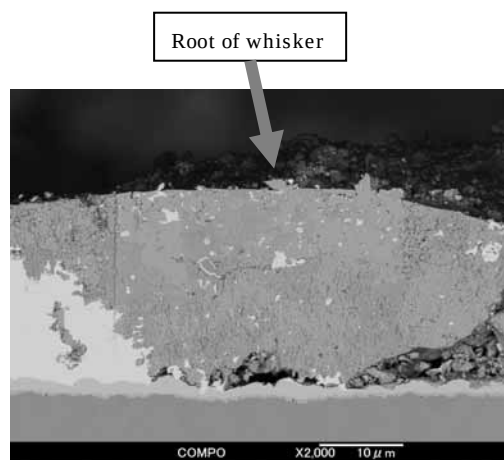
.We observed over 400  $\mu\text{m}$  length whisker caused by corrosion. To get the longer whiskers it will be important that thickness of solder is large. In the case of Fig.17 thickness of solder was about 5  $\mu\text{m}$ . Fig 19 shows the example of over 400  $\mu\text{m}$ . Fig.20 shows the cross section of the root of this whisker. In this case thickness of solder was about 30  $\mu\text{m}$ . The source volume of tin for whisker is larger than that in Fig.17.

**Fig.20 Cross section of the long whisker root(Fig.20)**
