Non-Destructive Top Layer Bond Pad Cross Section

Terence Q. Collier, Indira Gubeljc
CVInc
850 S. Greenville, Suite 108
Richardson, Texas 75081, USA
Ph: 972-664-1568; Fax: 972-664-1569
Email: tqcollier@covinc.com

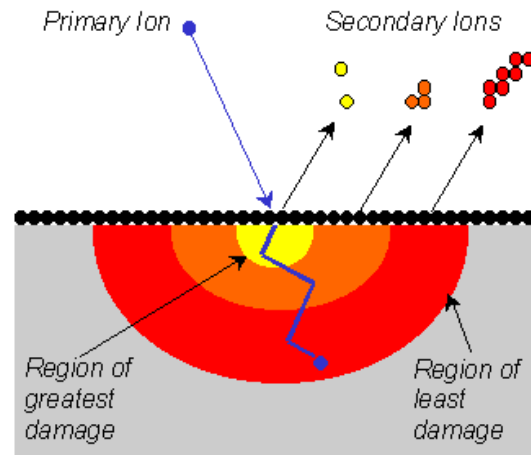
Figure 1. Damaged induced from ion milling. Image courtesy of Physical Electronics

In some cases this author has seen delamination beneath the ion milled pads as a direct result of the reduction in pad metal thickness. Similar thinning can occur during electrical test from the probe needle as it gouges the metal layer. When the metal is thinned the subsequent bonding can penetrate the barrier metal placing aluminum and/or gold directly in contact with silicon. Aluminum spikes and Au/Si intermetallics both contribute to electrical and mechanical failures in the device. Due to the beam width, milling can overlap adjacent areas to the pad. Milling active Si can also damage the die mechanically and electrically as discussed earlier and shown in figure 1.

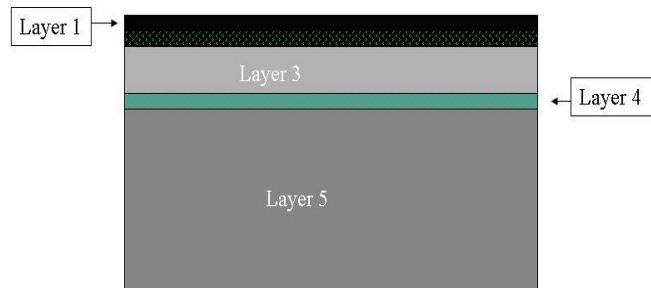
Figure 2. Bond pad and layers:

- Layer 1 – corrosion skin
- Layer 2 – AlF layer
- Layer 3 – Aluminum pad metal
- Layer 4 – Adhesion metal (Ti or TiW)
- Layer 5 – Substrate (Si)

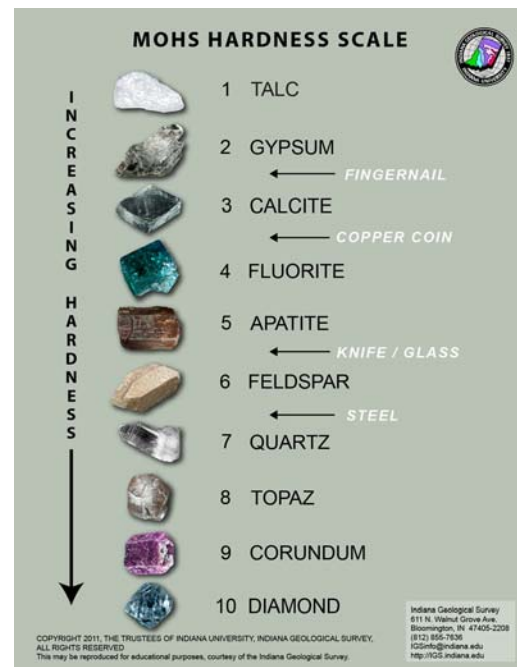
Figure 2. Hardness of various materials. Courtesy of Indiana Geological Society.

As stated earlier the sputter rate of analytical tools is based on aluminum oxide, a hard and durable material. The Mohs hardness is listed as 9 (corundum is a mineral of Al_2O_3), one of the hardest materials on earth. Yet the surface contaminants have been measured (using a nanohardness tester) revealing hardness ranges similar to gypsum (softer than a fingernail). Depending when and where the analysis is conducted in the wafer processing, the hardness will differ.

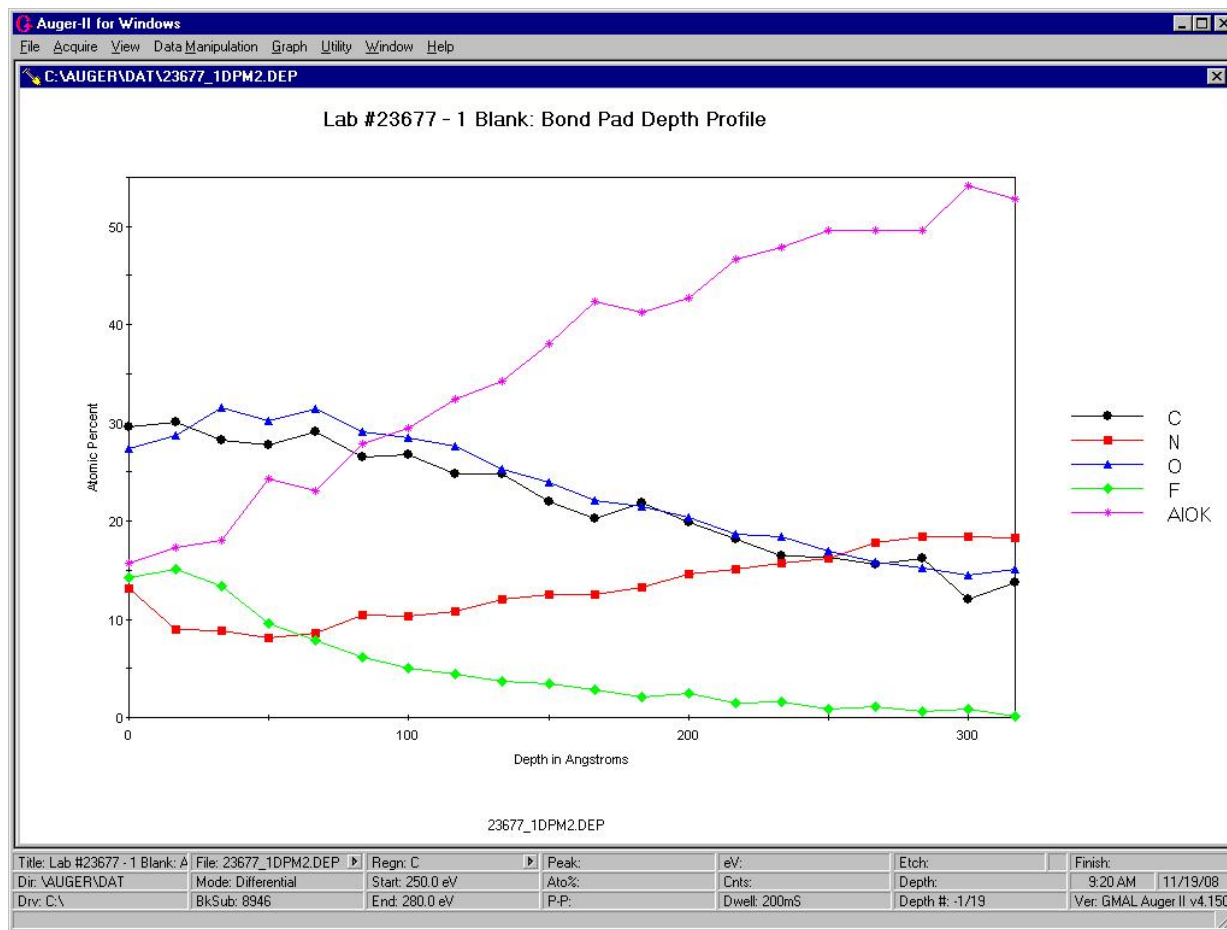
Figure 3. Ion milling elemental depth analysis. Bond pad sitting in N₂ purged dry box two weeks after wafer saw. Note that fluorine levels are detected at 300A depth in the pad. Corrosion makes up close to 50% of the material detected at that depth.

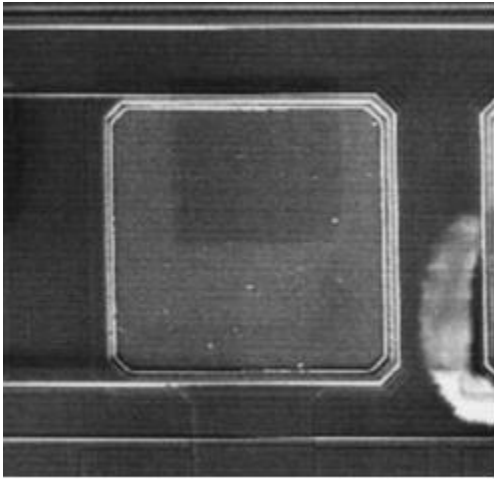
Figure 4. Aluminum pad with ion milling. Note milling extends into the active die area.

Ion milling is not the answer. Milling leaves a “hole” in the pad that can damage the die electrically and mechanically. The hole is the artifact that remains as the beam sputters layers to identify the chemical signatures of the pad. As each layer is sputtered away for analysis a hole is drilled deeper and deeper changing the thickness of the bond pad metal. A change of metal thickness would

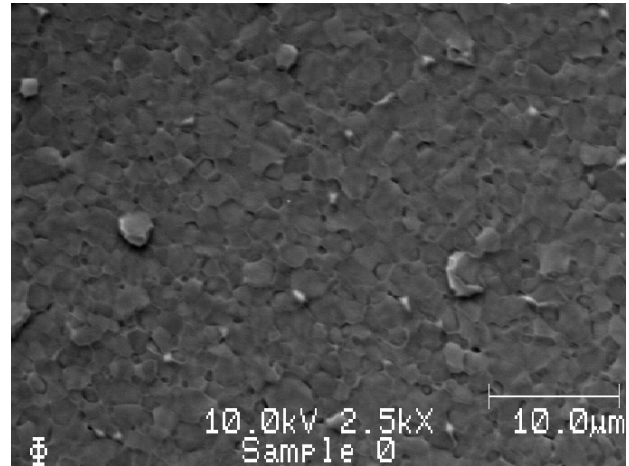
Figure 5. Aluminum pad bond pad (Auger) after two weeks in dry box. Note grains are not clearly defined due to the top corrosion layer.

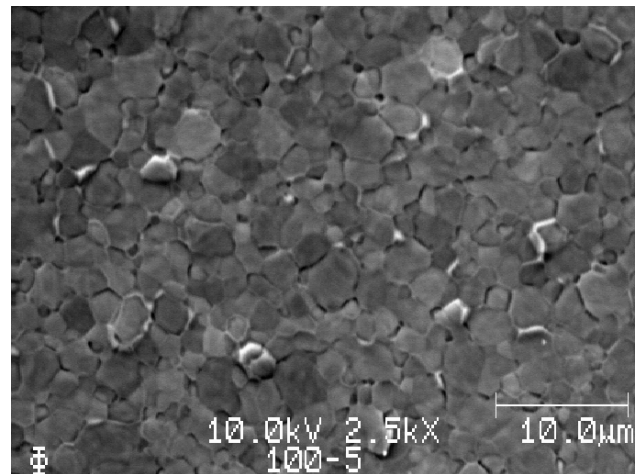
Figure 6. Aluminum pad bond pad (Auger) after two weeks in dry box plus cleaning. Note grains are clearly defined indicating the corrosion layer has been removed.

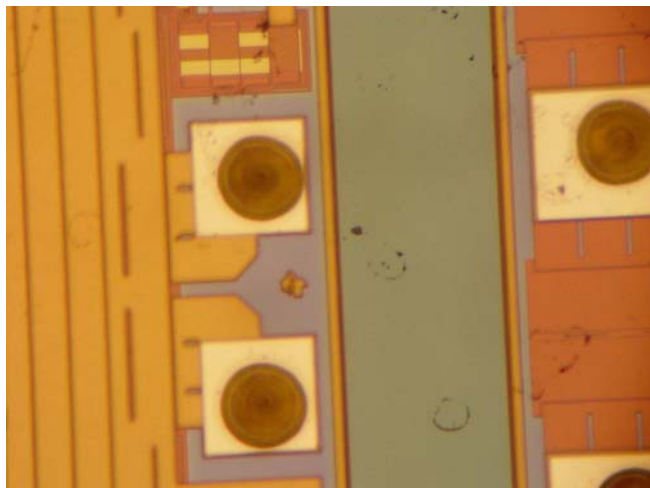
Figure 7. Gold ball bumps on 2 week old aluminum bond pads.

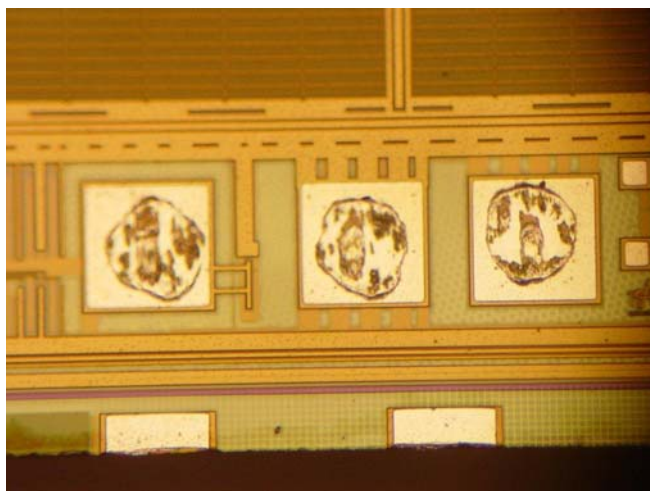
Figure 8. Gold ball removed from aluminum pads. Note the absence of IMC formation under the original pad. Also note the impression remaining after the bump has been removed.

The die plus gold ball bonds are immersed into a selective etch that removes gold and leaves the aluminum metal intact. The selectivity of the etchant has one additional benefit, the Au-Al intermetallic is not etched with the gold. An artifact of the bond imprint remains behind after the gold ball is removed since the etch does not attack the

base aluminum base metal. A clean “footprint” of the original bond pad image is clearly imageable and the ball bond area relative to the complete area of the pad can be compared.

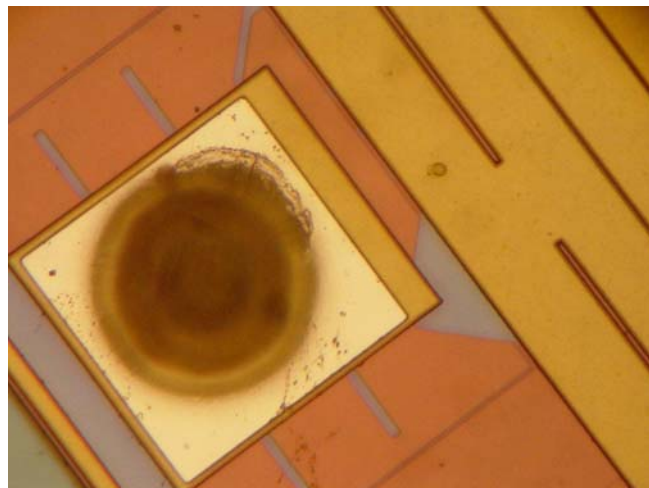
Figure 9. 2nd gold ball on etched aluminum pad. Note the area where the original bump has been etched in the upper center of the pad.

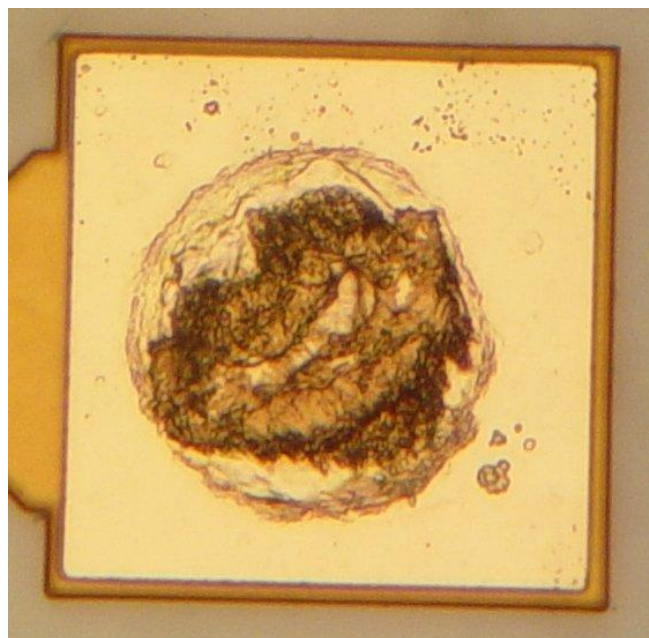
Figure 10. 2nd gold ball etched. Not increased amount of IMC formation compared to original pads.

The image also can be compared to show another important feature of this process. Not only is the area of

the bond impression obvious, the degree of intermetallic (IMC) formation is readily discernible as well. The percentage of IMC formed can be measured and compared to the total area under the impression, the area of the ball bond impression and then the area of the IMC not formed under the impression. This ratio serves to demonstrate the degree of bonding between the gold ball bond and aluminum pad.

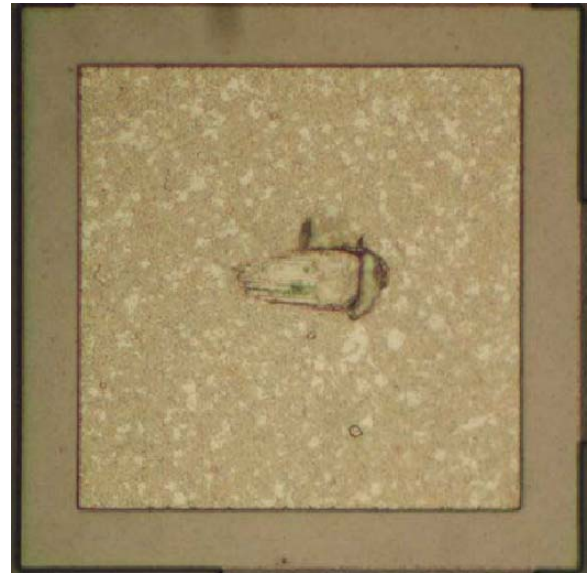
Figure 11. Probe mark on aluminum bond pad showing metal pit and pileup

The “pitting” of the pad leads to surface voiding but the largest defect is by far the probe mark. When the gold ball bond is attached to the die bond pad the goal is a compressed coplanar interface between aluminum and gold. Since the Al pad is not flat -and- the gold is trying to displace corrosion, contamination and “pile-up” layers from the probe mark to form a good bond its not difficult to understand how poor bonding can occur. When the post impact can be directly measured in the x, y and z etch pad

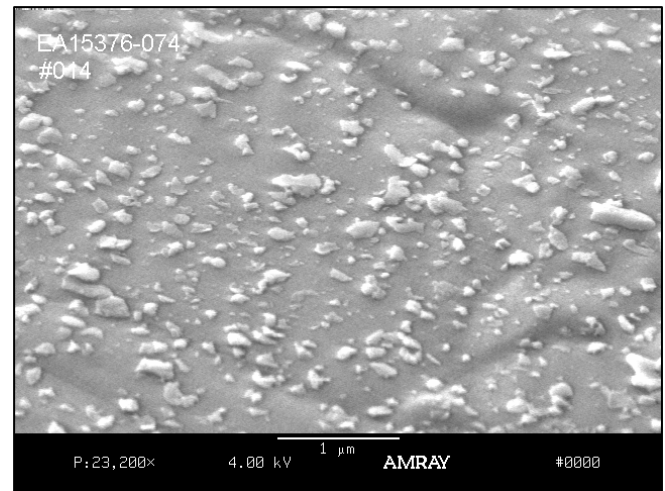
Figure 12. Aluminum pad with corrosion materials on the surface. These materials might falsely show pitting after sectioning and some can lead to Horsting voiding.

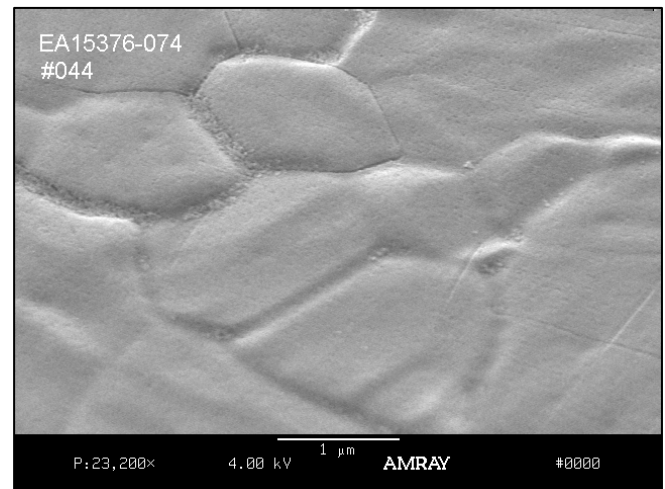
Figure 13. Cleaned pad. Note that there are still small amounts of corrosion within the grain boundaries.

Pads can be cleaned in both wet and dry processes to reduce the corrosion thickness. In this case a wet process developed by CVI was used to remove the corrosion layers. The parts were then bonded to compare to die that were not cleaned. It's clear from the imaging that cleaning the pads can demonstrate a significant increase in IMC formation and a reduction in voiding. A good experiment would be to clean a group of pads and run an uncleaned controlled group though temp cycling to determine if Horsting and Kirkendahl voids can be eliminated or reduced.
