## Impact of Process Improvements on Reliability of RCP Technology During Scale-up

**IMAPS Device Packaging Conference**

### Freescale's Redistributed Chip Package IMAPS Device Packaging - 2011

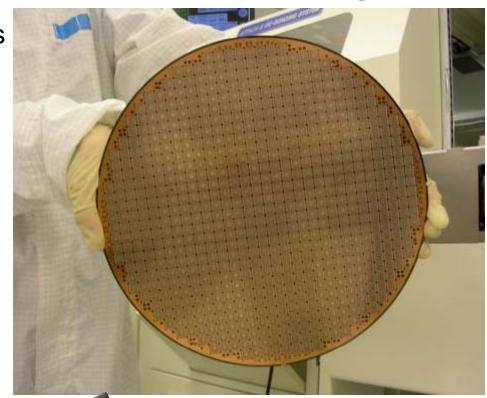
#### 300 mm round panel

9 x 9 mm packages 258 IO, 0.5 mm pitch 716 packages/panel 2 layer build-up

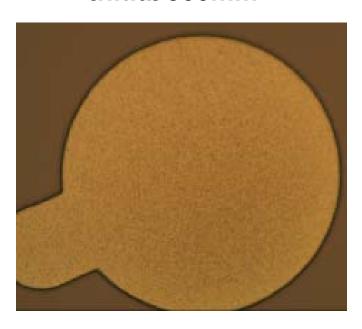
#### **Initial 300mm**

- Spray based process
- Appearance and uniformity dependant on plate rate and environmental factors

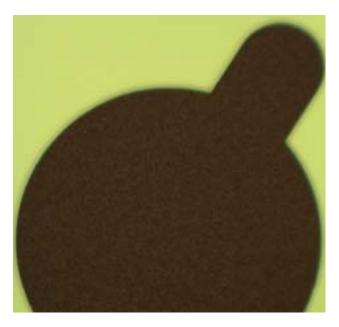
#### 200mm Lab

- Immersion process
- Appearance independent on plate rate and environmental factors

Goal: Optimize 300mm to achieve 200mm Cu surface roughness

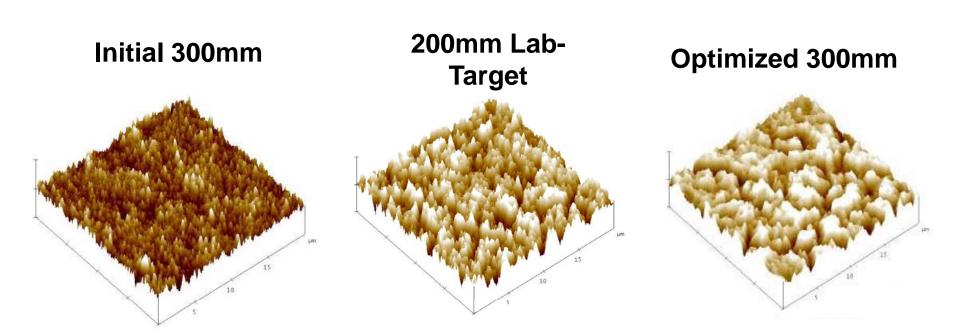
#### Initial 300mm vs. 200mm Lab Cu Surface Structure

Targeted roughness was achieved through Cu finishing process optimization

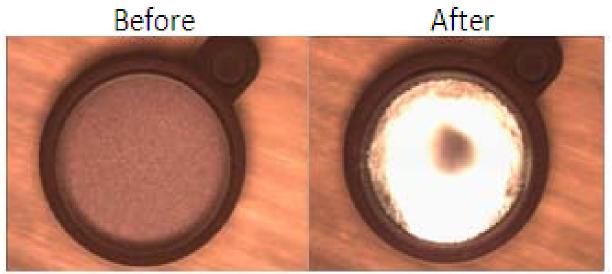
Cell P11 200mm Lab/Flux D

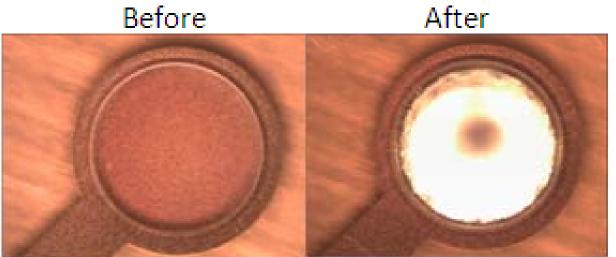
Cell P15
Std 300mm/Flux D

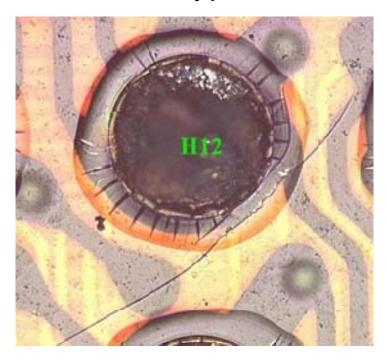
#### Typical Dielectric Cracking After AATC

Cell P19/21, 1500 cycles -40/125C

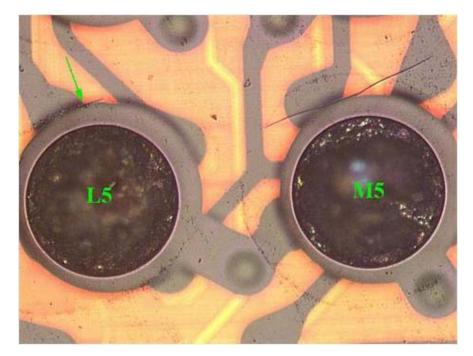
Cell P15, 1500 cycles -40/125C

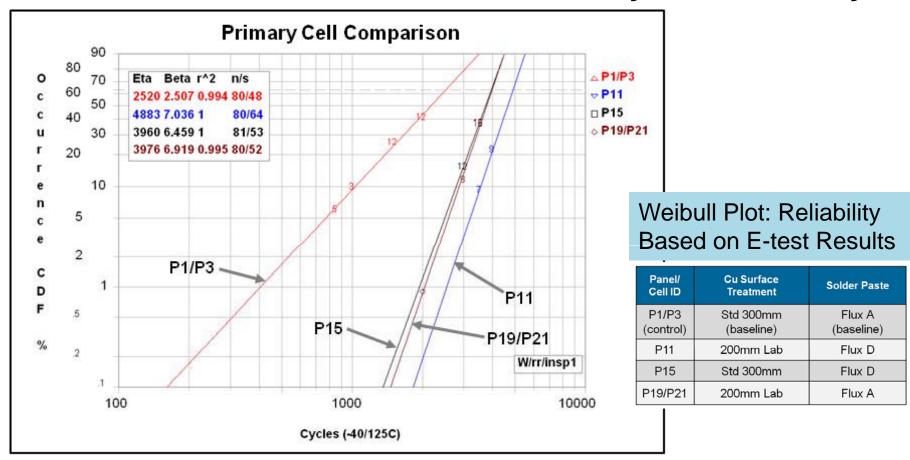
- Weibull plot shows clear life improvement of experimental cells vs the control
- Characteristic life of cell P11 is approximately 4800 cycles
- 200mm treatment and Flux D provide similar level of improvement

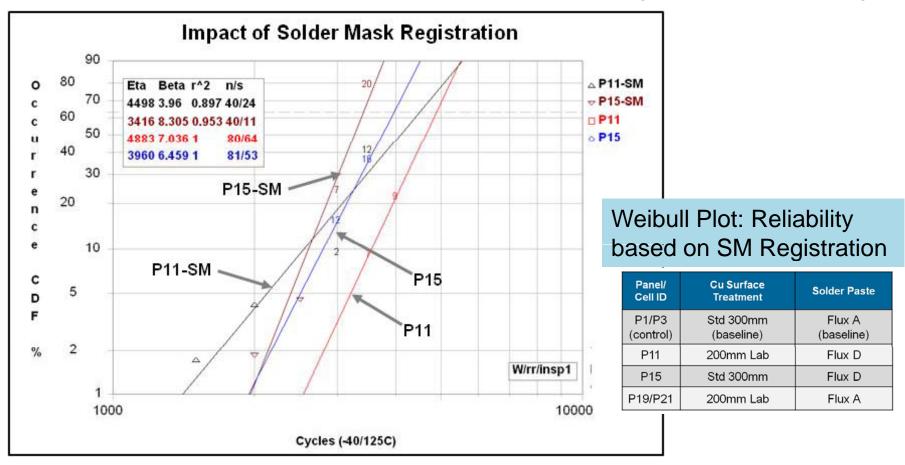
- Weibull plot shows misregistered SM has small impact on reliability
- The SM misregistration would be a concern only for high reliability applications
