# Temperature Induced Voltage Offset Drifts in Silicon Carbide Pressure Sensors

R.S. Okojie<sup>a</sup>, D. Lukco<sup>b</sup>, V. Nguyen<sup>c</sup>, and E. Savrun<sup>c</sup>

<sup>a</sup>NASA Glenn Research Center, Cleveland, OH, USA

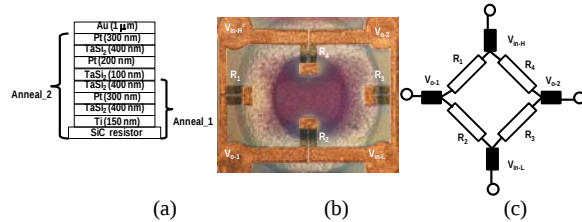
Fig. 1: a) Contact metallization used consisted of alternating layers of TaSi<sub>2</sub> and Pt; b) The pressure sensor top structure shows the location of the contact metallization on the terminals; c) The equivalent Wheatstone bridge circuit of the sensor and the corresponding contact terminals and piezoresistors.

Another deposition of TaSi<sub>2</sub> (100 nm)/Pt (200 nm)/TaSi<sub>2</sub> (400 nm)/Pt (300 nm) was performed, which was followed by a 2  $\mu$ m aluminum (Al) deposition. Contact pattern was defined in Al and etched in H<sub>3</sub>PO<sub>4</sub> at 50 °C for 4 minutes. The Al was used as etch mask to etch the TaSi<sub>2</sub> (100 nm)/Pt (200 nm)/TaSi<sub>2</sub> (400 nm)/Pt (300 nm) stack by reactive ion etching under the following set of conditions: Ar=140 sccm, SF<sub>6</sub>=5 sccm, Pressure=25 mT, and Power=300 Wrf. The residual Al etch mask was stripped in H<sub>3</sub>PO<sub>4</sub> and the wafer underwent a second furnace anneal as described above. Finally, Au deposition was performed, followed by bond pad definition and etching in H<sub>2</sub>O:HCl:HNO<sub>3</sub> at 40 °C for 2 minutes. The Au was used to prevent the diffusion of oxygen from the top surface. The wafer was diced into individual chips, as shown in Fig. 1(b), and some known good ones were selected and packaged. The maximum temperature during the packaging processes was 750 °C for a total of 30 minutes. The circuit schematic of the SiC pressure sensor depicting the closed Wheatstone bridge configuration used in the evaluation is shown in Fig. 1(c).

The circuit schematic of the SiC pressure sensor depicting the closed Wheatstone bridge configuration used in the evaluation is depicted in Fig. 1(c). The  $V_{oz}$  plots of sensors 195-196, 197-199, and 200-202 as functions of time at elevated temperatures are shown in Figs. 2(a), (b), and (c), respectively. Sensors 195-196 were initially soaked at between 700 and 735 °C for the first 24 hours, after which the temperature was dropped to 635 °C for the remaining duration of the test. These two sensors, as indicated by the large changes of  $V_{oz}$  shown in Fig. 2(a), failed within the first few hours. Sensors 197 and 199 that were treated between 680 and 700 °C also failed, but a little later {see Fig. 2(b)}. While the  $V_{oz}$  of sensor 199 did not run away, it, however, went through large swings and stability was never achieved. Failure was manifested by the gradual non-linearity observed in the I-V characteristics in all the five sensors in the course of time. In contrast, the recorded  $V_{oz}$  drift of sensor 200 (615 °C) after 450 hours was 25 mV before rolling

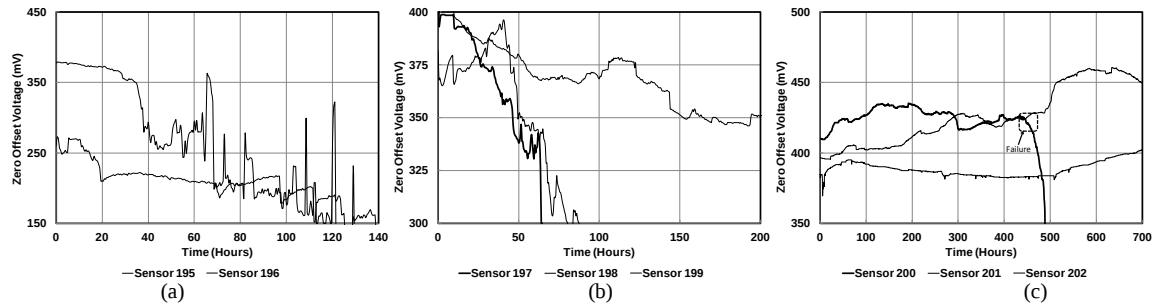
Fig. 2: Offset voltage drift characteristics of a) sensors 195 and 196 between 700 °C and 735 °C for 24 hours before dropping to 635 °C, b) sensors 197-199 between 680 and 700 °C, c) sensors 200-202 between 605 °C and 625 °C.

off to failure {see Fig 2(c)}. The time of failure of this sensor coincided with the rapid increase of the bridge resistance, as seen in Fig. 3(a). Ideally, a flat  $V_{oz}$  response is achieved if the four resistors,  $R_1$  to  $R_4$ , remain relatively unchanged at temperature. The smallest deviation from previous values is reflected as drift in the  $V_{oz}$ . In the case of sensor 201 (612 °C), the maximum  $V_{oz}$  drift was 30 mV after 450 hours, beyond which it gradually increased. The resistor-time characteristics shown in Fig. 3(b) indicated small changes up to 450 hours, after which a higher rate of increase was observed. This transition point, for all practical purposes, coincided with the upward

$V_{oz}$  drift seen in Fig. 2(c). Sensor 202 (605 °C) offered the most promising result in that the maximum  $V_{oz}$  drift after 450 hours was about 10 mV, and slightly above 15 mV after 700 hours. The result is also reflected in the characteristics of the bridge resistance elements seen in Fig. 3(c), which showed smaller relative changes from previous values compared to sensors 200 and 201. Based on prior reported results [4-6], it is believed that the improved performance of sensor 202 was due to the fact that it experienced the lowest temperature (605 °C).

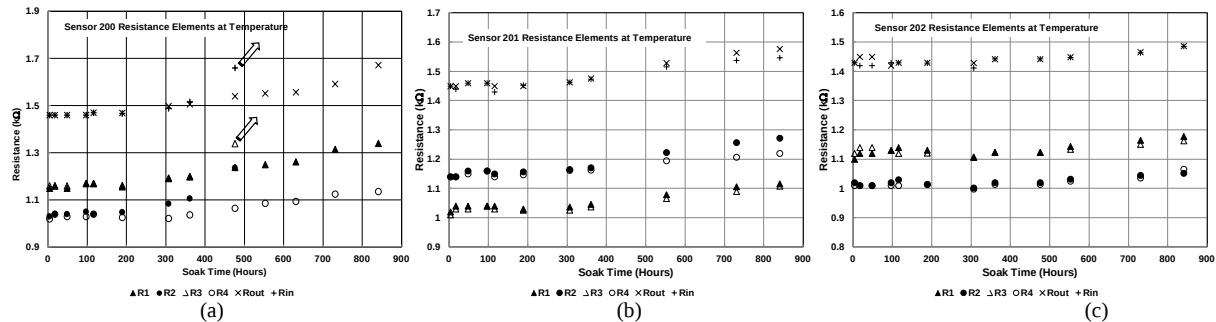
Fig. 3: Wheatstone bridge resistance values measured at between 605 °C and 615 °C of a) sensor 200, b) sensor 201, and c) sensor 202. Degradation of resistance occurred earlier as temperature increased.

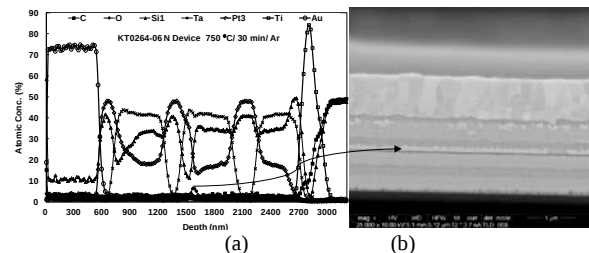
Fig. 4: a) The AES analysis of the tracking sensor initially annealed at 750 °C and b) corresponding FE-SEM image. The arrow indicates potential oxygen path created due to process error.

The Auger electron spectroscopy (AES) depth profile analysis of the unpackaged tracking sensor initially annealed at 750 °C is shown in Fig. 4(a), and the corresponding field emission scanning electron microscopy (FE-SEM) image of the contact cross section in Fig. 4(b). From the AES analysis, the PtSi zone reactions are well defined. No significant Au migration through the first PtSi layer is observed, thus further confirming the diffusion barrier property of PtSi against Au reported earlier [4, 5]. The observed oxygen peak at about 1600 nm was due to a thin oxide layer that formed after the first furnace anneal. The oxygen peak coincides with the dark line seen in the cross section FE-SEM image of Fig. 4(b). After 400 hrs at 605 °C, another tracking

topmost PtSi barrier layer. The oxygen peak in the film previously observed in Fig. 4(a) has broadened due to tailing caused by sample roughness. The migration of Pt toward the SiC interface is observed. After 500 hours, however, the analyses of another tracking sensor revealed dramatic changes in the elemental concentration and film microstructure, as can be seen in Figs. 6(a) and (b) of the AES and FE-SEM, respectively. A high concentration of oxygen is observed to grow at the interface between the first deposited TaSi<sub>2</sub> and Pt layers. A review of fabrication process steps revealed that an over etching error at that interface resulted in the infiltration of oxygen between the layers, after which subsequent oxidation during thermal treatment induced stresses in the films that resulted in the

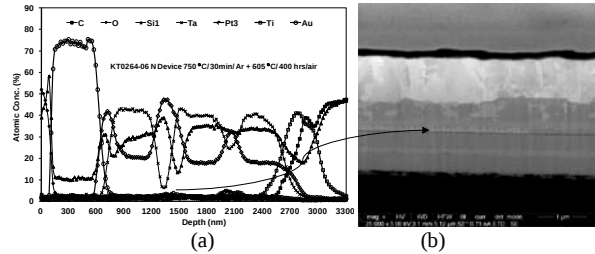
Fig. 5: a) The AES analysis of the tracking sensor initially annealed at 750 °C and after 400 hrs at 605 °C, and b) corresponding FE-SEM image.

sensor was extracted from the oven and analyzed, the AES and FE-SEM results of which are shown in Fig. 5(a) and (b), respectively. As expected, the diffusion of oxygen from the top surface was blocked by Au while the diffusion of Au was prevented by the

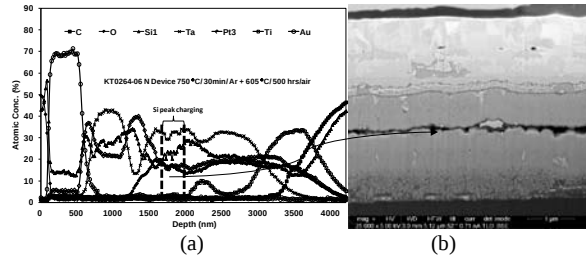
Fig. 6: a) The AES analysis of the tracking sensor initially annealed at 750 °C and after 500 hrs at 605 °C. Oxygen and Pt migration to the SiC interface are observed; b) corresponding FE-SEM image shows delamination induced stress by oxidation between TaSi<sub>2</sub> layers. High density of grain boundaries are observed in the bottom metal stack. No significant microstructural changes are seen in the top set of metallization stack.

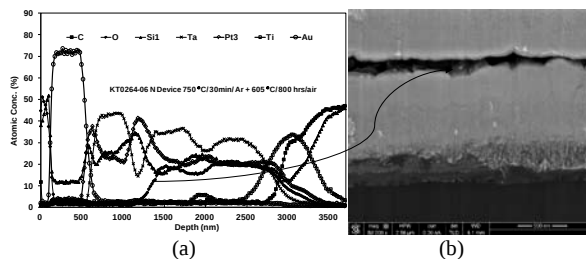
Fig. 7: a) The AES analysis of the tracking sensor initially annealed at 750 °C and after 800 hrs at 605 °C, and b) corresponding FE-SEM image. Further oxidation induced stress reveals film warpage and interlayer delamination. Also present is the high density of grain boundaries in the bottom metal stack.

It is evident that the presence of oxygen and Pt at or near the SiC interface between 400 and 500 hours coincided with the accelerated changes in the bridge resistance and the  $V_{oz}$  that were observed. After 800 hours, little change was observed in the AES and FE-SEM profiles, as seen in Figs. 7(a) and (b), respectively. Remarkably, the diffusion of Au was prevented during the entire test duration by the topmost layer of PtSi. Also of significance was the prevention of oxygen diffusion into the contact from the top by Au.
