# Sustainment of Printed Hybrid Electronics: Reliability and Repairability Studies

March 7-10, 2022

Beihan Zhao, Christopher Riso, David Leslie, Dr. Abhijit Dasgupta, Dr. Siddhartha Das,  
Center for Advanced Life Cycle Engineering (CALCE), University of Maryland, College Park, MD 20742.

To understand the reliability and repairability of electronics printed using the AJP process, through experimental and computational modeling, to take full advantage of this technology and realize its industrial potential

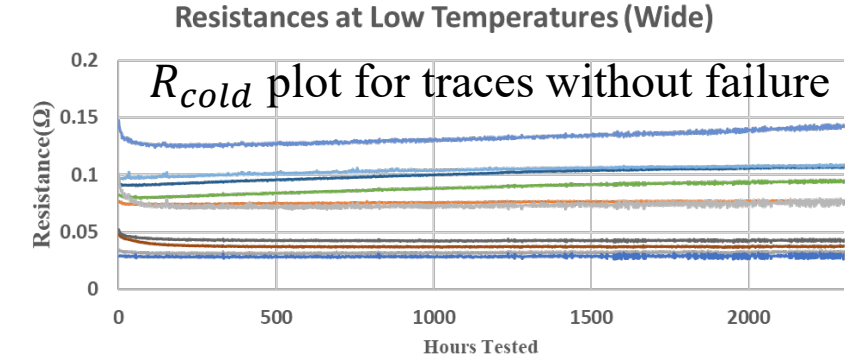
'trench' feature

- Resistance at temperature extremes ( $R_{hot}$  and  $R_{cold}$ ) plotted for each sample
- Failure sites: interconnect for 4-point resistance measurement (due to local geometric defects ('trench' feature) near copper pad)
- Failure mechanism: localized fatigue cracking due to local stress concentration at geometric defect site

- Cracks induced by CTE mismatch were found in the area covering the ‘trench’ between the NEA121 layer and copper pad, and it is found that equivalent plastic strain was an order of magnitude higher in that area, compared to the rest of the specimen.

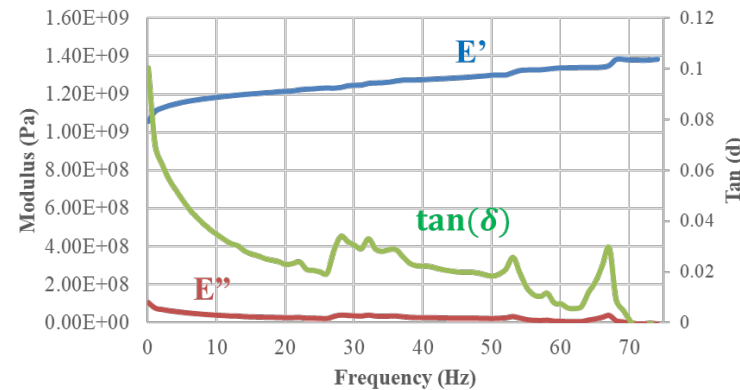
Storage Modulus, Loss Modulus, Phase Change

Dynamic Mechanical Analysis (DMA) for printable dielectric materials

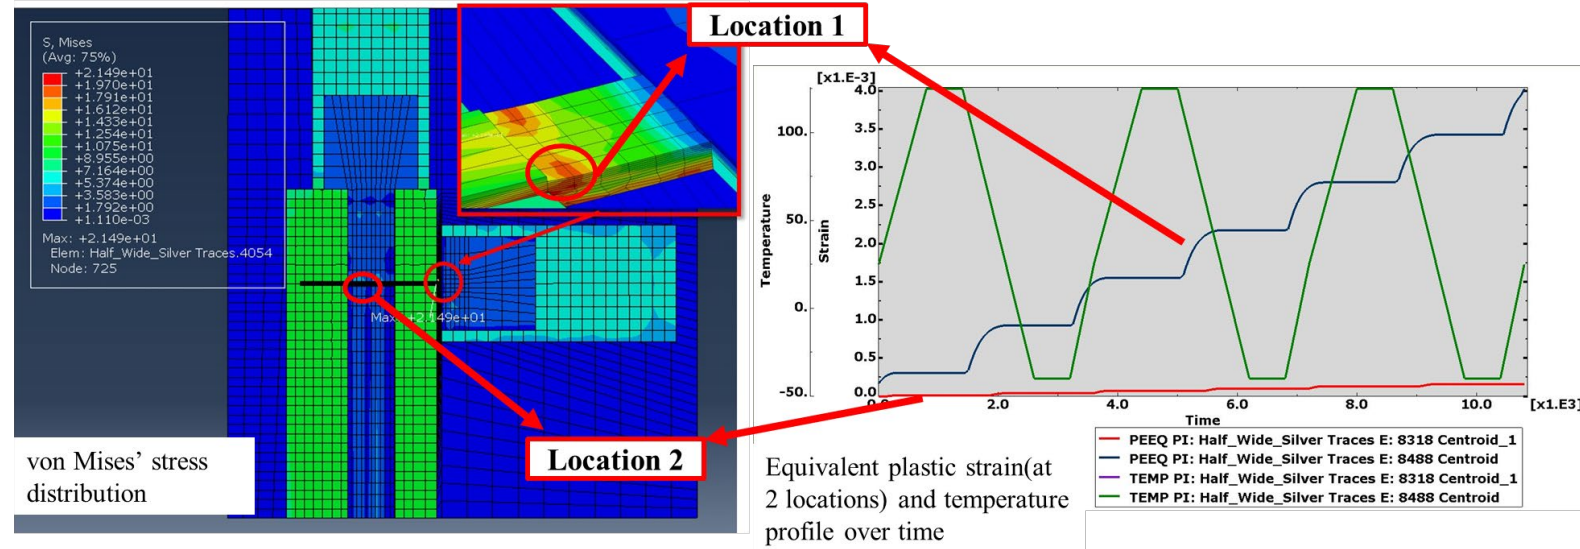
von Mises' stress distribution

- The 'trench' feature(as introduced previously) has been included in the geometry, a hexahedral mesh was applied after multiple cell partitions
- As expected, the maximum equivalent stress was located near the trench area.
- Significant plastic strain concentration observed near the 'trench', which can be considered to be a qualitative indicator of failure risk

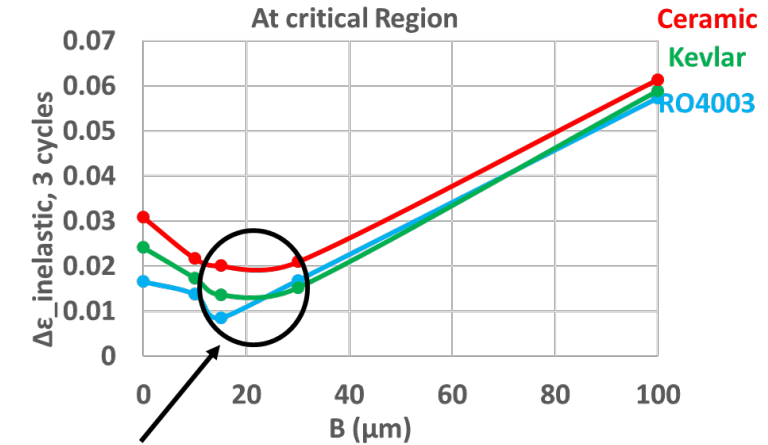
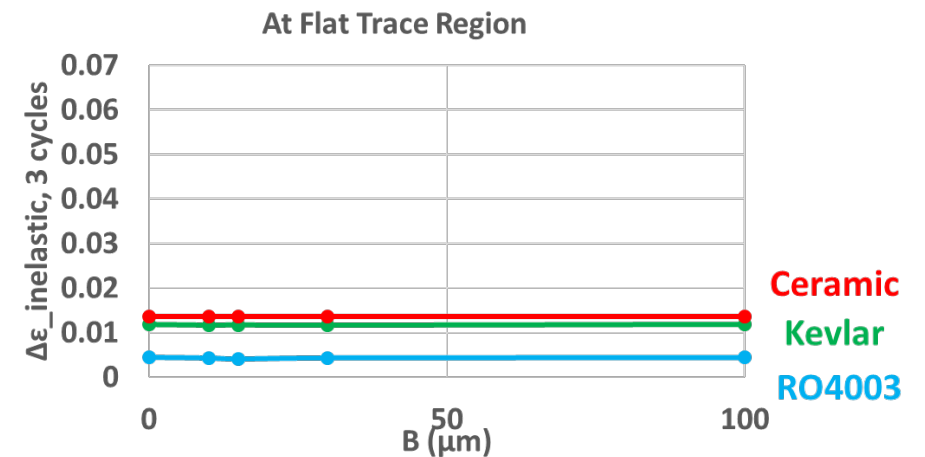
Deformed geometry with CEEQ contour, deformation factor  $\sim 300$

Volumetric averaged plastic strain over 3 cycles vs of transition height B

**Critical Region**

**Recommendation:**  
Approximately  
 $15\mu\text{m} < B < 30\mu\text{m}$

**Recommendation:**  
Approximately  
 $15\mu m < B < 30\mu m$

- When  $B > 30\mu m$ , the geometric change at the transition critical region became dominate, and the inelastic strain between the cases with different substrates became less significant
- The plot for flat region here are for comparison as well as a sanity check
- Needs to update the model with the newest layout and N7000 for FR4 substrate for sanity checks

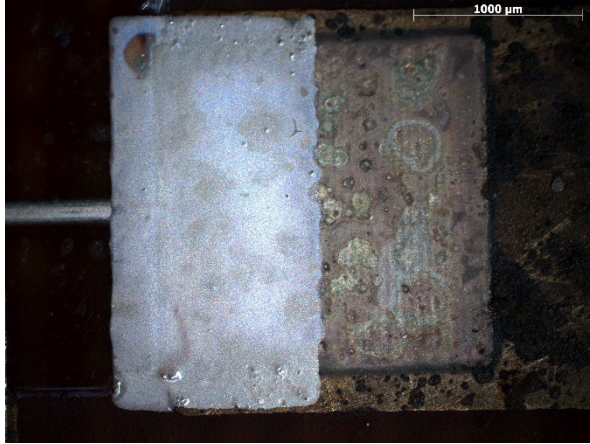
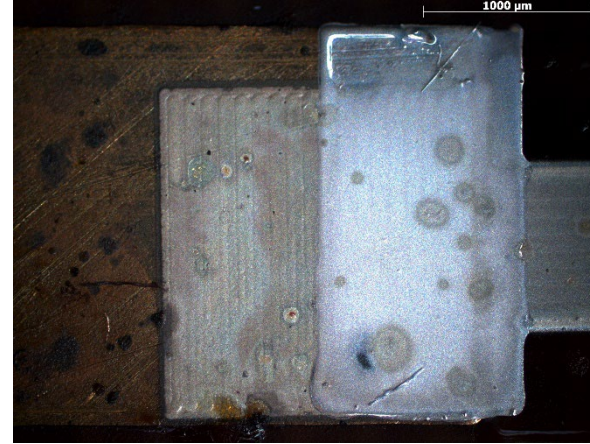
## Repaired pads without cracks

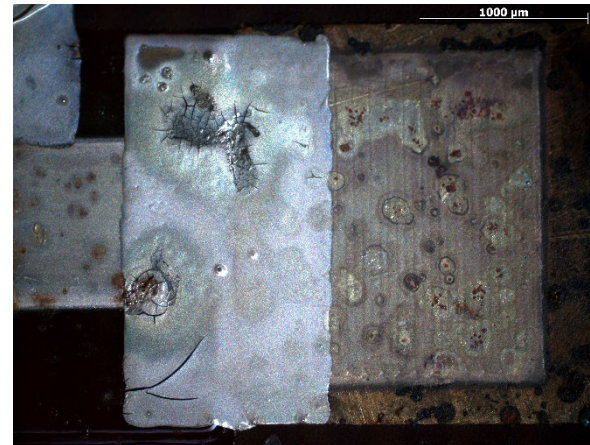
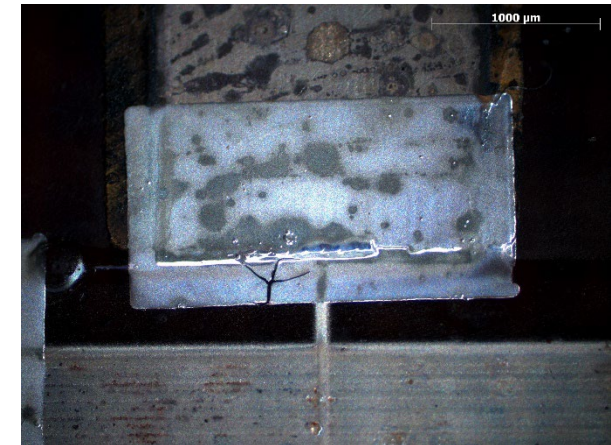
## Repaired pads with cracks
