A Comprehensive Study of Surface Finishes for High Frequency/High Speed Applications

Frank Xu, Ph.D., Martin Bunce, Jim Watkowski, Anna Lifton, Raghu Raj Rangaraju, and Rommel Bumagat

Abstract

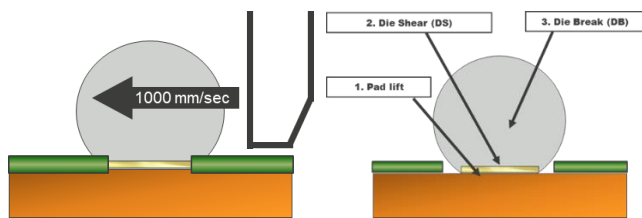
Figure 1a: Schematic of a ball shear setup.

Figure 1b: Schematic of ball shear failure mechanism.

Ball shear tests are performed to evaluate the solder joint reliability. Testing was done on ball grid array (BGA) test coupons with solder mask defined pads with solder resistor openings at 250 μm . The ball shear test at low-speed shear conditions (0.3 – 0.5 mm/sec) have been reported in the previous paper [5]. In this paper, only high-speed ball shear data is presented. Figure 1a is the schematics of a ball shear setup. It was tested at 1000 mm/sec and the spacing between the shear head and board surface is 20 μm . Three failure mechanisms are described in Figure 1b. Pad lifting, where the pad is lifted off the substrate due to the high shear force and weak pad / substrate adhesion, is rare. Die shear (DS) failure mechanism indicates a weak bond strength between the solder and pad finishes. Lastly, die break (DB) is the preferred failure mechanism where the failure happens within the solder.

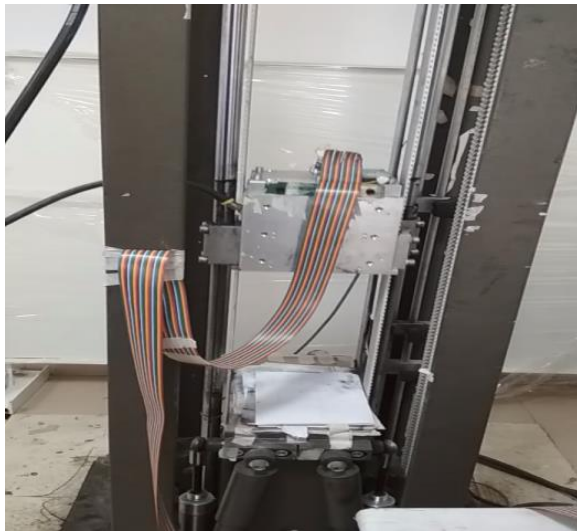
Figure 2: Drop shock test setup.

The dummy CTBGA84 components are used for the drop shock test. The drop shock table height and striking surface are adjusted to obtain a half-sine shock pulse with 1500 Gs and 0.5 msec peak, following the JESD22-B111 standard. Failures are defined as a drop of 1V or more in the applied potential for at least 0.5 msec, based on the IPC/JEDEC-9706 standard, being detected and recorded using a high-speed data acquisition system. The interval plot of the drop shock performance is presented.

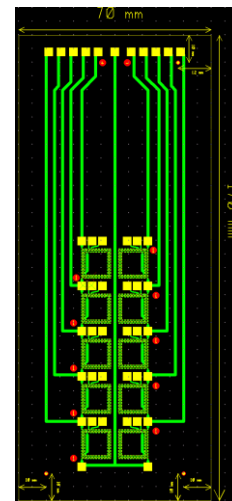
Figure 3: A drawing of the electromigration test vehicle.

the composition of the solder alloy, as well as the microstructure of the joint. Higher current densities, higher temperatures, and the presence of defects or impurities in the solder can accelerate electromigration. In order to study the effects of the various surface finishes on the electromigration, the current and temperature are fixed at 5A and 100 °C. SAC 305 solders are used for the test. The drawing of in-house designed PCB board is shown in Figure 3. There are ten ball grid array (BGA) patterns at the bottom of the test vehicle, plated with the finish of interest. The BGA228 components (corresponding current density: $1.0\text{E}+04 \text{ A/cm}^2$) are used for the test up to 400 hours. The failure is defined as 20% increase of initial resistance.

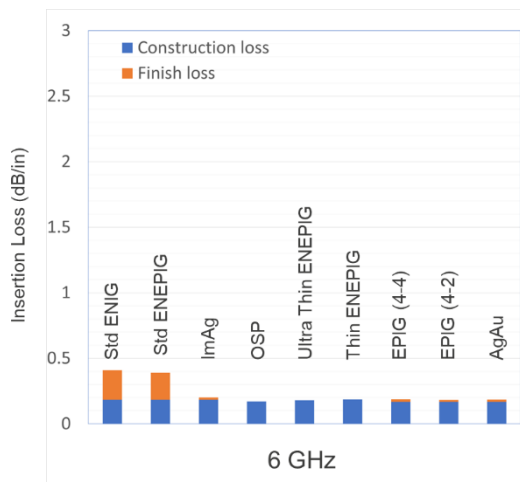
Figure 4a: Signal loss of various finishes considering the loss from both construction and surface finishes at 6 GHz.

Figure 4 displays signal loss of each finish at three representative frequencies (6, 40 and 77 GHz). The signal loss value consists of two parts, the loss due to surface finish (finish loss) and the loss due to everything else – laminate, copper trace and its roughness, etc. (construction loss). As described previously, the signal loss test panel was cut in half before processing the surface finishes. Both half strips, with and without surface finishes, would be subjected to the signal loss testing. Signal loss, from both the substrate only (construction loss) and the plated panel (consisted of both construction loss and finish loss), would be obtained. The difference between the two would be the signal loss from surface finish. The purpose of this is to eliminate substrate lot-to-lot variation, although it can't eliminate the within-substrate strip variation.

At 6 GHz, it already shown that both standard ENIG and ENEPIG plated strip has greater signal loss (~ 0.4 dB/in) than other finish's plated strips (~ 0.2 dB/in). The signal loss from the ENIG and ENEPIG finish itself is around 0.2 dB/in, half of the total loss. When frequency goes up, so does the signal loss. The signal loss from the construction becomes more prominent than the surface finishes in higher frequencies. At both 40 GHz and 77 GHz, ENIG and ENEPIG again showed the greatest loss, while ImAg and OSP showed the least loss. Thin Nickel ($0.2 \mu\text{m}$) ENEPIG, Ultra-thin Nickel ($0.1 \mu\text{m}$) ENEPIG, EPIG and AgAu finishes showed comparable signal loss. It's interesting to note that the construction losses from both EPIG and AgAu are smaller than that of both thin and ultra-thin Nickel ENEPIG-plated strips. The difference in the construction loss is comparable to their corresponding surface finish losses.

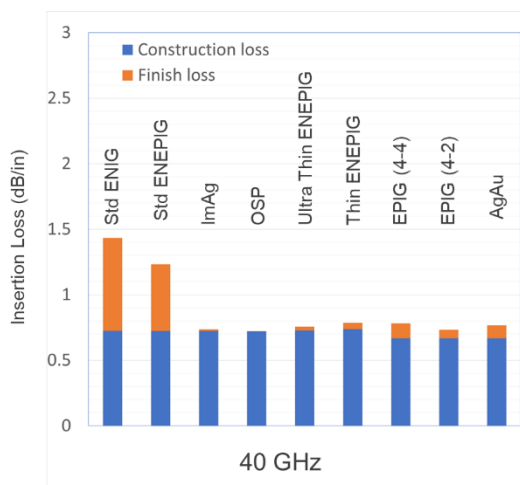
Figure 4b: Signal loss of various finishes considering the loss from both construction and surface finishes at 40 GHz.

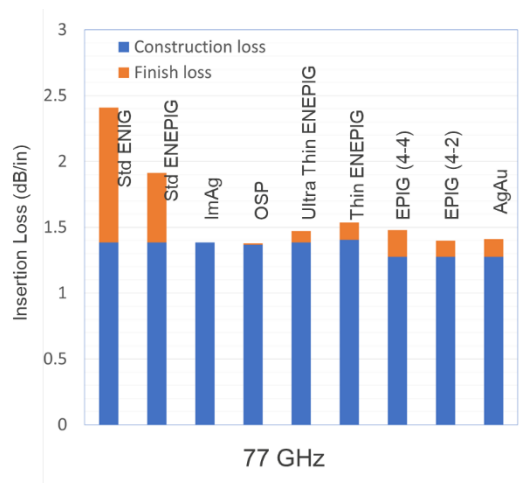
Figure 4c: Signal loss of various finishes considering the loss from both construction and surface finishes at 77 GHz.

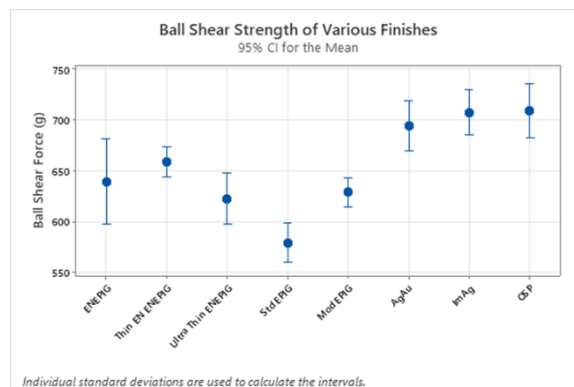
Figure 5a: Interval plot of high-speed ball shear strength of various surface finishes.

As mentioned previously, the low-speed ball shear results have been reported. Here we only present the high-speed ball shear results which was done at 1000 mm/sec using DAGE 4000HS instrument. The ball grid array (BGA) with $250 \mu\text{m}$ solder resist open (SRO) is used as the testing substrate. 250 mm SAC 305 solderball and Alpha WS-608 paste flux are used to form the solder bumps. Each test condition is repeated twenty times to ensure good statistical significance. Figure 5a shows the interval plot of high-speed ball shear strength of various surface finishes. It can be clearly seen that the standard EPIG finish has the lowest ball shear strength.

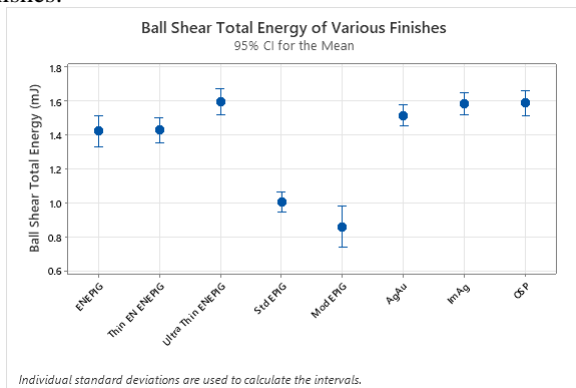
Figure 5b: Interval plot of high-speed ball shear total energy of various surface finishes.

Figure 5b is the interval plot of high-speed ball shear total energy of various surface finishes. Here the total energy needed to shear the solderjoint is recorded and reported. It's clearly seen that both standard and modified EPIG finish require the least amount of energy to shear the solderjoint,

while it takes similar amount of energy to shear all other finishes.

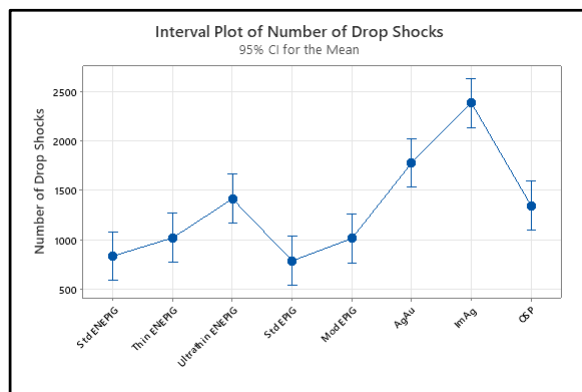
Figure 6: Interval plot of drop shock performance of various surface finishes.

As pad sizes continue to shrink, the significance of the drop shock test has increased, particularly in mobile phone applications. In Figure 6, the number of drop shocks for each finish is displayed. The first three finishes shown are standard ENEPIG, thin nickel ENEPIG, and ultra-thin nickel ENEPIG. Interestingly, it can be observed that as the nickel interlayer thickness decreases, the drop shock performance improves, primarily because of an increasingly higher proportion of Cu-Sn solder joint.

Initially, it was believed that the complete elimination of nickel, as seen in EPIG or modified EPIG finishes, would further enhance the drop shock performance. However, this is not the case. The reason lies in another deposition mechanism utilized during the plating process for EPIG finishes, which results in microvoids formation [5].

AgAu, ImAg and OSP finishes all provide robust drop shock performance which is linked to preferred Cu-Sn solderjoint formation in those finishes compared to more brittle Ni-Sn solderjoint.

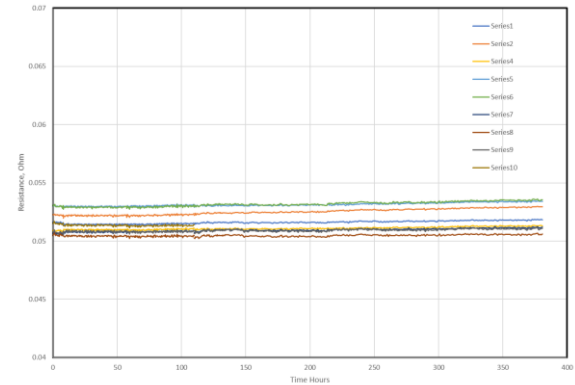
Figure 7a: Resistance vs time in electromigration test in OSP surface finish plated testing vehicle.

Figures 7a to 7h present the electromigration results for the solder joints, displaying the resistance plotted against the testing time for up to 400 hours. Among all the finishes tested, with the exception of standard EPIG and modified EPIG, consistent resistance is observed throughout the entire test duration. However, both standard EPIG and modified EPIG exhibit a sharp increase in resistance after approximately 50 to 100 hours of testing, indicating that the solder joints have been compromised during the high current/high temperature test.

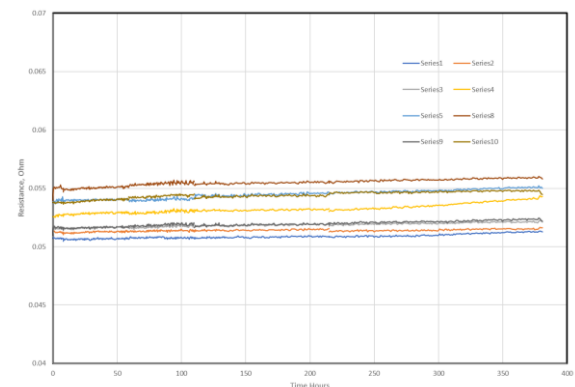
Figure 7b: Resistance vs time in electromigration test in Standard ENEPIG surface finish plated testing vehicle.

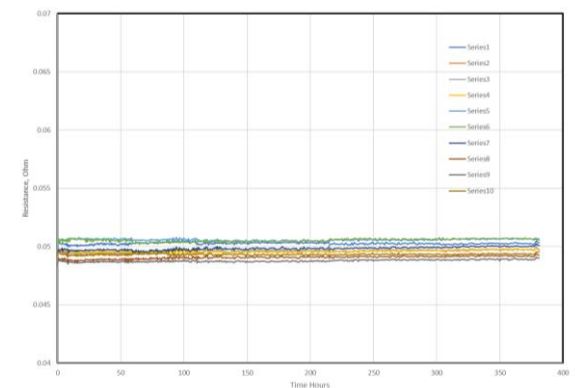
Figure 7c: Resistance vs time in electromigration test in thin nickel ENEPIG surface finish plated testing vehicle.

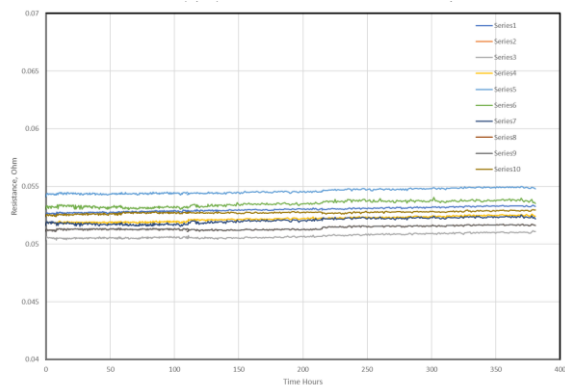
Figure 7d: Resistance vs time in electromigration test in ultra-thin Ni ENEPIG surface finish plated testing vehicle.

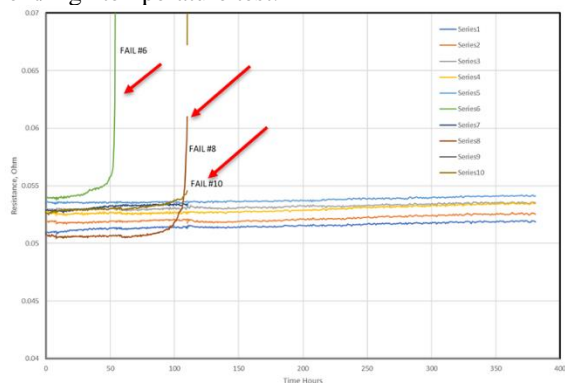
Figure 7e: Resistance vs time in electromigration test in standard EPIG surface finish plated testing vehicle.

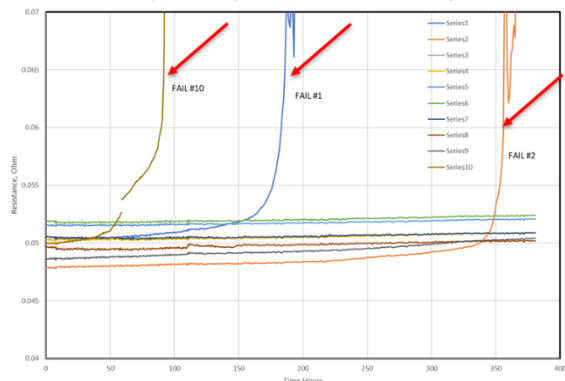
Figure 7f: Resistance vs time in electromigration test in modified EPIG surface finish plated testing vehicle.

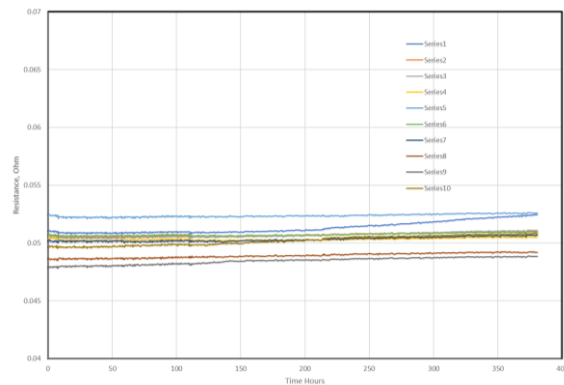
Figure 7g: Resistance vs time in electromigration test in AgAu surface finish plated testing vehicle.

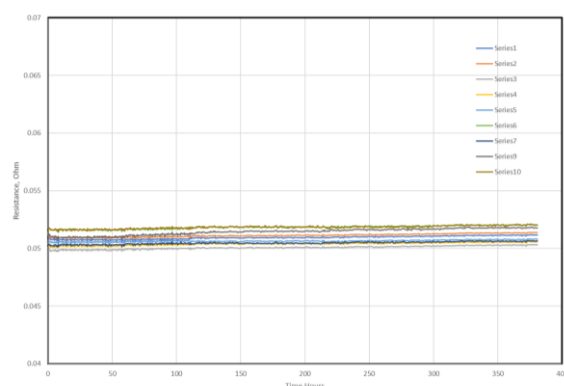
Figure 7h: Resistance vs time in electromigration test in ImAg surface finish plated testing vehicle.

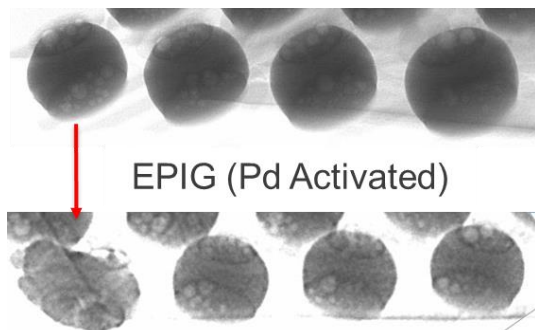
Figure 8a: X-ray imaging of standard EPIG solder joints before and after electromigration test.

X-ray imaging is employed to examine the alterations in solder joints before and after undergoing the solder joint electromigration test, indicated by the red arrow in Figure 8. As the X-ray images clearly display, it is evident that the solder joints in both standard EPIG (Figure 8a) and modified EPIG (Figure 8b) have collapsed following the test. In contrast, all the other surface finishes demonstrate intact solder joints after completing the electromigration test.

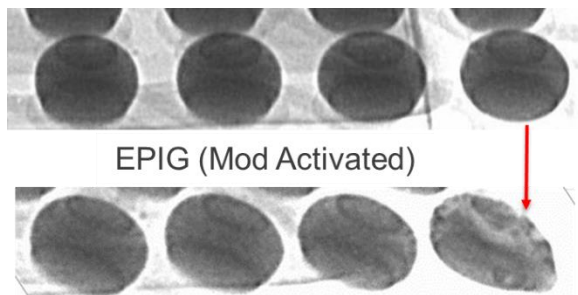
Figure 8b: X-ray imaging of modified EPIG solder joints before and after electromigration test.

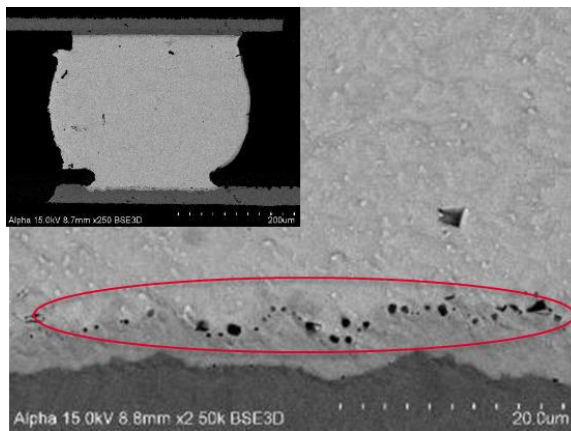
Figure 9: SEM cross section view of standard EPIG solder joint after the electromigration test.

To conduct a detailed examination of the solder joints, a cross-section sample is made based on the X-ray imaging results. Figure 9 displays a scanning electron microscope (SEM) image of a standard EPIG solder joint (cathodic side) after undergoing the electromigration test. The inset provides an overview of the cross-section. The red circles indicate voids that appear in the solder joint when subjected to high current density, leading to collisions between electrons and metal atoms. These collisions cause the metal atoms to move in the direction of electron flow. Over the course of the electromigration testing, this movement of metal atoms results in the formation of voids, primarily on the cathodic side of the solder joint.

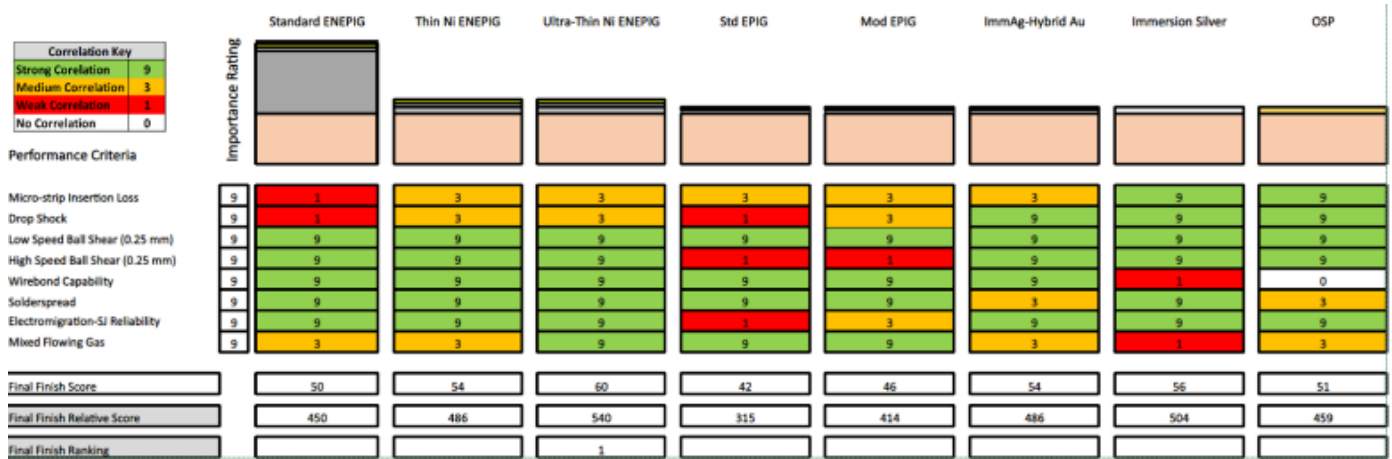
Figure 10 Quality function deployment matrix of various surface finishes

All surface finishes were compared across the performance requirement matrix and a quality function deployment (Figure 10) [8] was constructed to produce a data driven tool to align surface finish performance against design needs. As it shows, there is no one perfect surface finish that fits every application. Fabricators would pick the performance criteria with corresponding importance rating and evaluate the surface finishes according to their specific needs.
