A Study of Solder Joint Failure Criteria

Jianbiao Pan, Ph.D.
Cal Poly State University
1 Grand Ave.
San Luis Obispo, CA 93407
Phone: (805) 756-2540
Email: pan@calpoly.edu

Julie Silk
Agilent Technologies
1400 Fountaingrove Parkway
Santa Rosa, CA 95403
Phone: (707) 577-4296
Email: Julie_silk@agilent.com

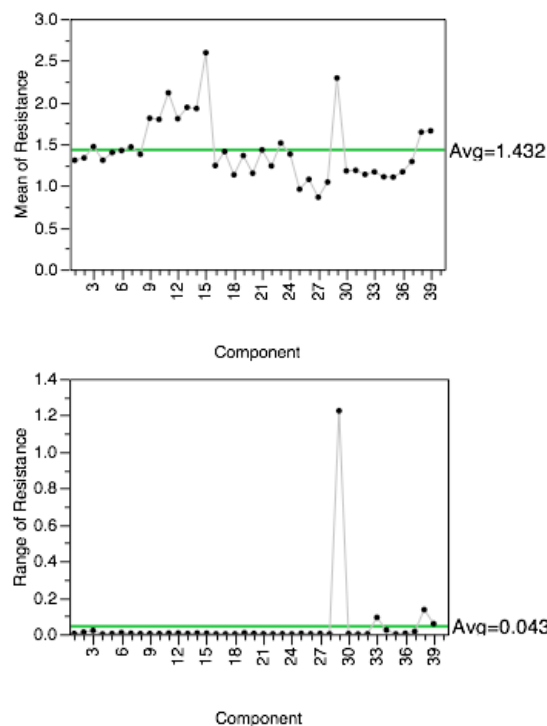
Then we plotted the mean and the range of resistance of solder joints in each component on each board. Figure 1 shows the mean and the range of resistances on board F01. It is clear that the range of 8 measurements for component 28 is over 1.0 Ω which seems high though the mean of the resistance looks normal. We found out that the resistance of this component on other boards had similar large variations as well. This may indicate that there are cracks in the solder joints for this component.

Figure 1. Mean and Range charts for resistances of 39 components in Board F01 measured 8 times.

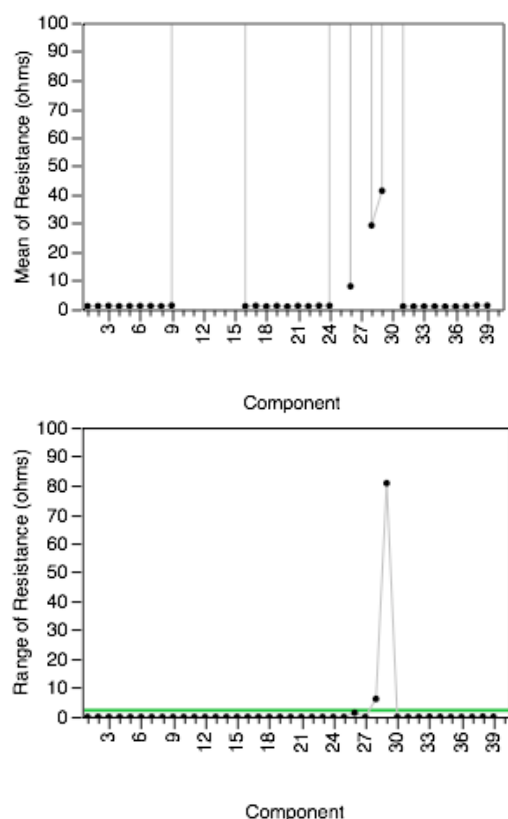
Figure 2 shows the mean and the range of resistance of solder joints on board T01. It is clear that two groups of components (components 10 ~ 15, and components 25 ~ 30) have unusual high resistance. SEM images of these two groups show all of them have cracks in solder joints of these components as documented in reference [19]. After excluding these data, the revised mean and range charts are shown in Figure 3. From examination of the mean and range of all solder joints on 5 randomly selected boards, we concluded that maximum natural variation of good solder joints with the Agilent measurement system is below 0.2 Ω. We propose to use 10 times the maximum variation, or 2 Ω as the failure criteria. Our principles for selecting the failure criteria are 1) to detect solder joint failure as early as possible, and 2) minimum fault detection due to measurement error/variation.

Figure 2. Mean and Range of Resistance for 39 solder joints on Board T01 measured 8 times.

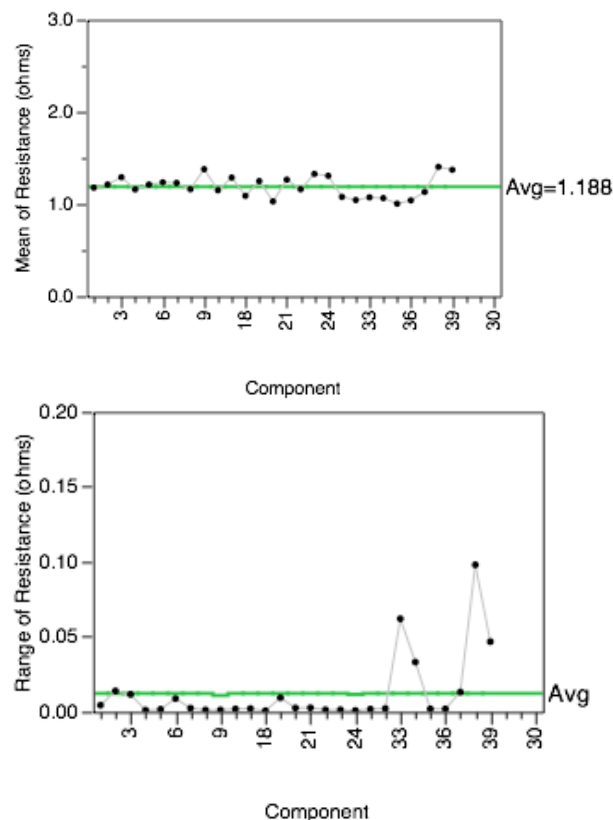
Figure 3. Revised Mean and Range charts of Resistance for 39 daisy-chained solder joints on Board T01 measured 8 times after data of components 10~15 and 25~30 are removed.

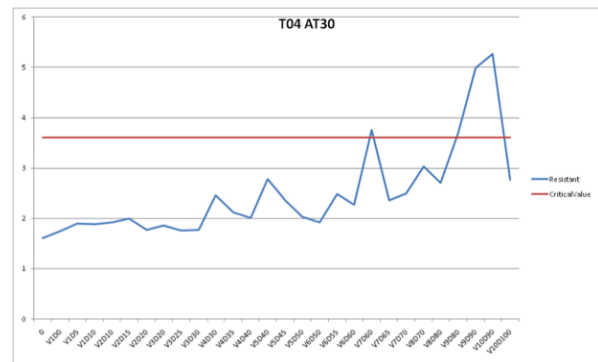
Figures 6 and 8 show that the resistance increase was slightly over 2 Ω during the reliability testing and below 2 Ω at the end of the reliability testing.

Figure 6. Resistance value of each reliability test for Component AT 30 on Board T04

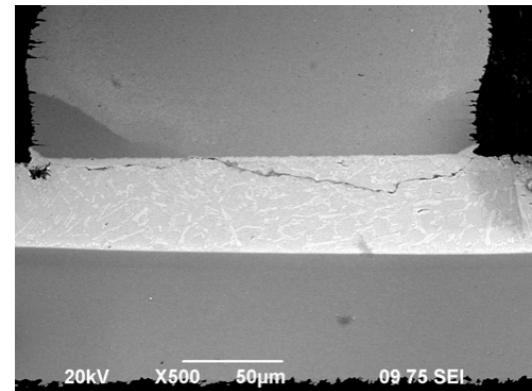
Figures 7 and 9 show that a full crack occurred on at least one of the solder joints at the end of the reliability testing. Thus, our definition of failure criterion of 2 Ω increase in resistance proved to be able to detect solder joint failure, or a full crack. More examples on the relationship between the resistance change and the crack in solder joints are shown in Figures 10 to 18.

Figure 7. SEM image of solder joint Pin32 in the daisy-chain of Component AT30 on Board T04

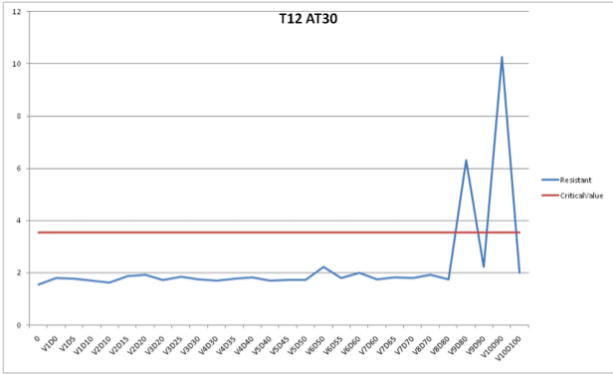
Figure 8. Resistance value of each reliability test for Component AT 30 on Board T12

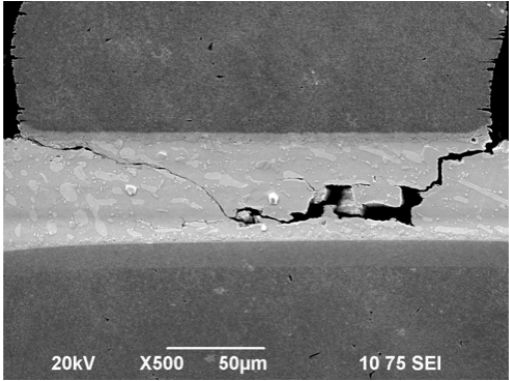
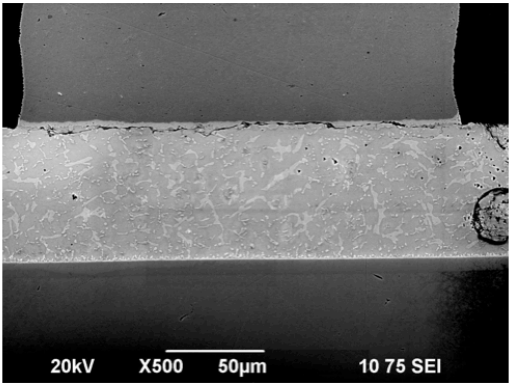
Figure 9. SEM image of solder joint Pin1 in the daisy-chain of Component AT30 on Board T12 AT30

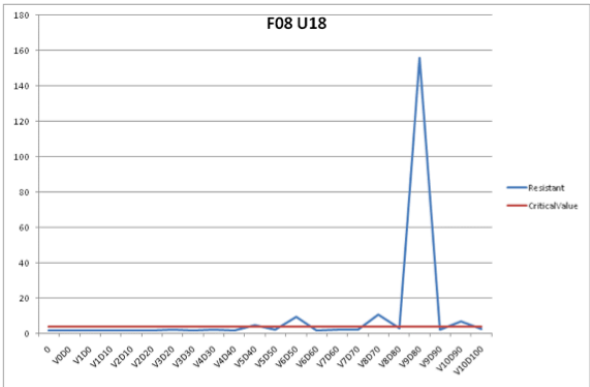
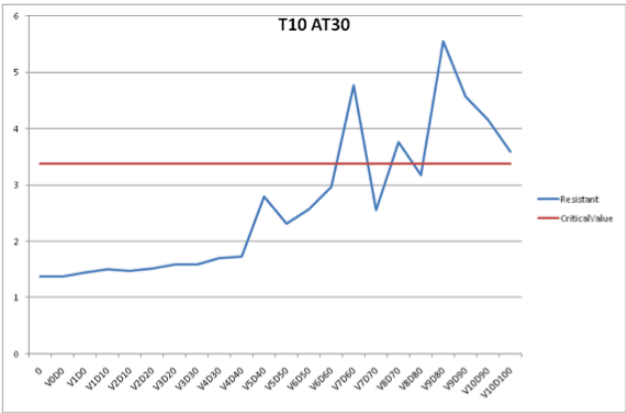
Figure 10. Resistance value of each reliability test for Component AT 30 on Board T10

Figure 11. SEM image of solder joint Pin32 in Component AT30 on Board T10

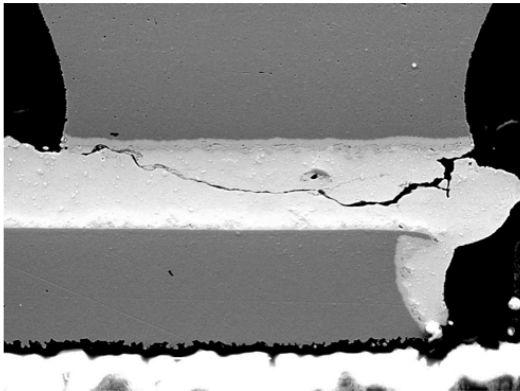
Figure 13. SEM image of solder joint Pin30 in Component U18 on Board F08

Figure 14. SEM image of solder joint Pin29 in Component U18 on Board F08

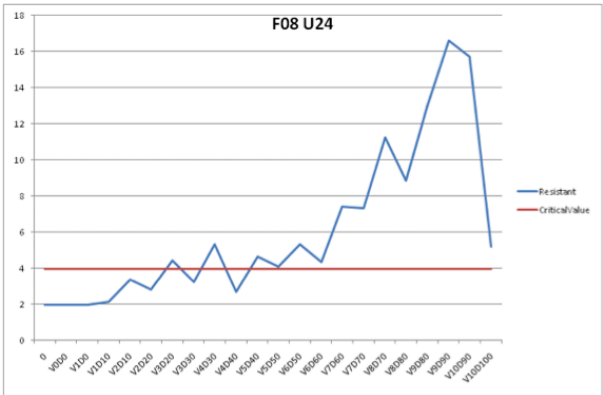
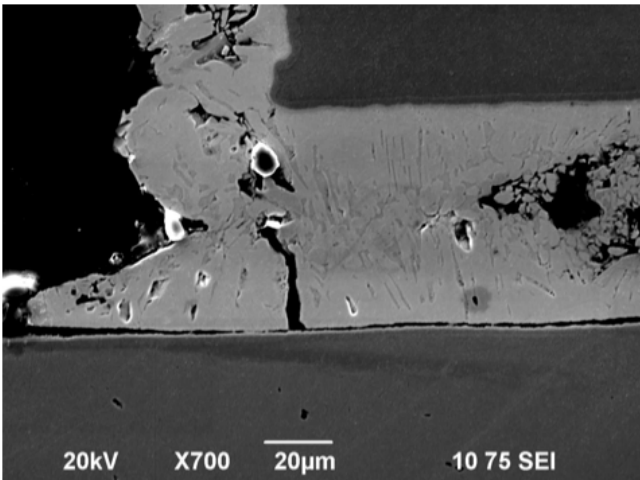
Figure 16. SEM image of solder joint Pin2 in Component AT3 on Board T06 (full cracks were founded in 7 solder joints in this component)

Figure 18. SEM image of solder joint Pin1 in Component U24 on Board F08, IMC Cracks

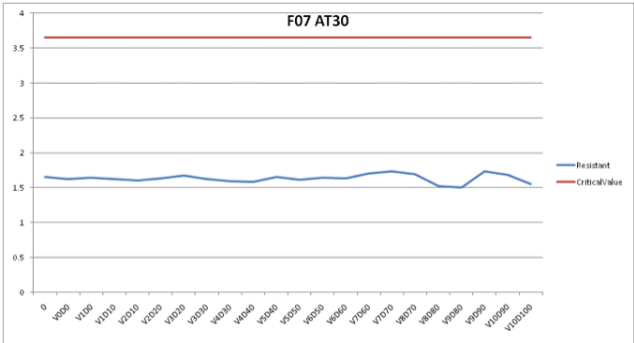
The next question is whether the failure criteria of 2 Ω increase in resistance can detect partial cracks in solder joints. Figure 19 shows the resistance value after each reliability test for Component AT30 on Board F07. It indicates that no resistance values exceed the critical value. However, a SEM image of one of the solder joints in the daisy-chain shown in Figure 20 indicates that partial cracks occurred in the solder joint. Thus, partial cracks cannot be detected using the method described in this paper. We believe that none of the failure criteria defined in five industry guidelines summarized in Table 1 are able to detect partial cracks in solder joints because they all rely on an electrical discontinuity while there is electrical continuity in partially cracked solder joints. Time-domain reflectometry (TDR) or a new approach based on acoustic emission [20] may be the solutions to detect partial cracks. Note that the method using acoustic emission was developed for early detection of pad cratering [20]. It is unclear yet whether the method could be used for detecting partial cracks in solder joints.

Figure 19. Resistance value of each reliability test for Component AT30 on Board F07

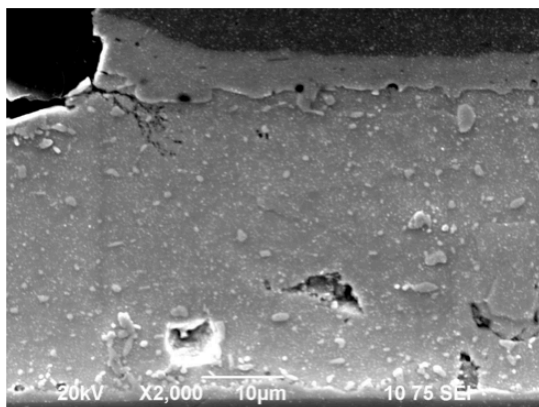
Figure 20. SEM image of one of the solder joints in Component AT30 on Board F07
