## FAILURE ANALYSIS OF DISCOLORED ENIG PADS IN THE MANUFACTURING ENVIRONMENT

<sup>1</sup>Crane Aerospace & Electronics

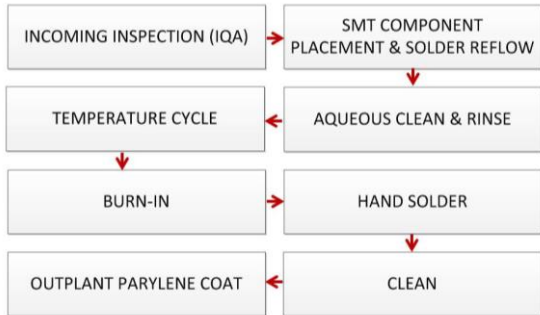
Figure 2: Electronic assembly (EA) process map for some operations.

A general process map is shown Fig 2. After 100% of visual PCB inspection upon receipt, components go through the surface mount technology (SMT) line using an SnPb water soluble solder paste. After cleaning and two thermal processes, EAs are moved through 3 hand soldering operations, again, using SbPb solder and water soluble liquid flux. An aqueous cleaning follows each soldering step. The parts are then sent outplant to be parylene coated on the top side of the assembly.
