A Case Study of the Reliability of Copper Bond Wires In Plastic Encapsulated Integrated Circuits

Ken Turner
Hi-Rel Laboratories
6116 N Freya
Spokane, WA 99217
Ph: 509-325-5800
Email: Ken.Turner@hrlabs.com

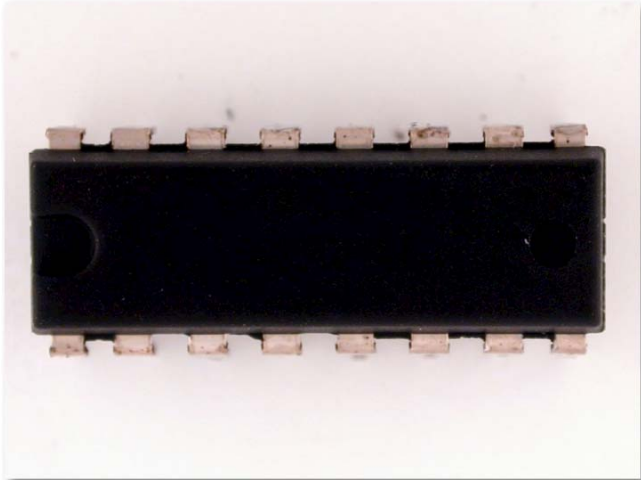
Figure 1. Optical macrograph of a typical sample.

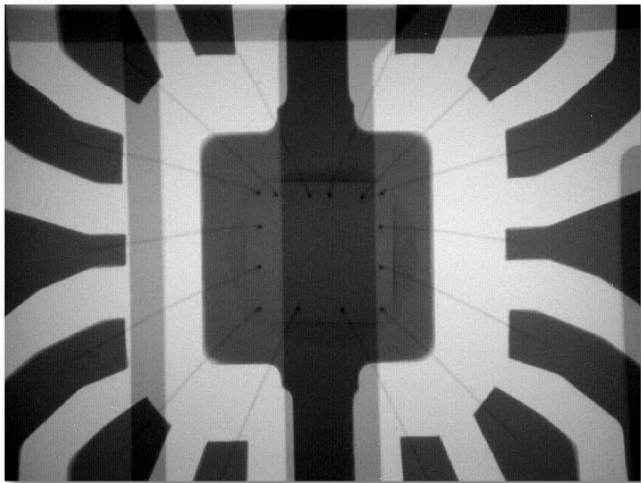
Figure 2. Radiographic image of an integrated circuit with copper wire bonds. Copper bond wires can be identified by their lower density when compared to gold.

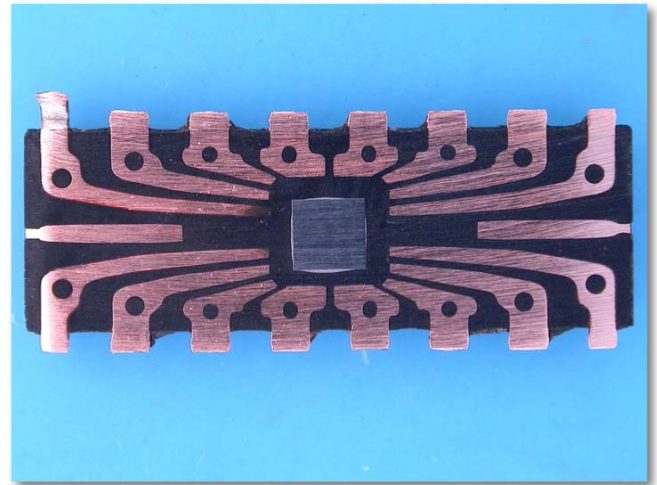
Figure 7. Optical macrograph of a DIP after dry grinding the backside of the encapsulant away, exposing the lead frame and the underside of the die.

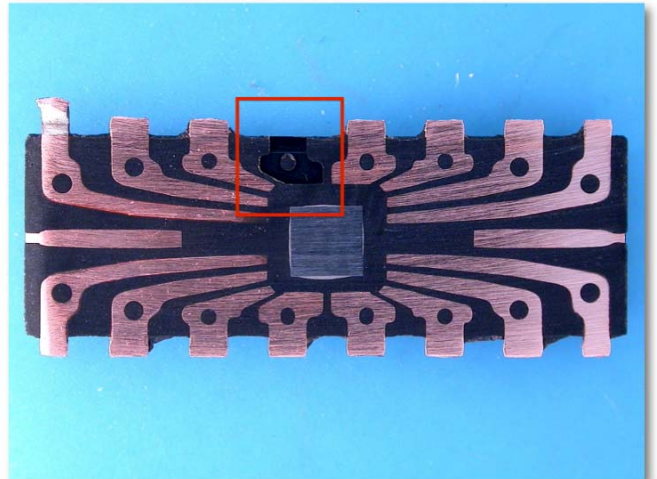
Figure 8. Optical macrograph of the device in figure 7 after removal of the pin 4 lead.

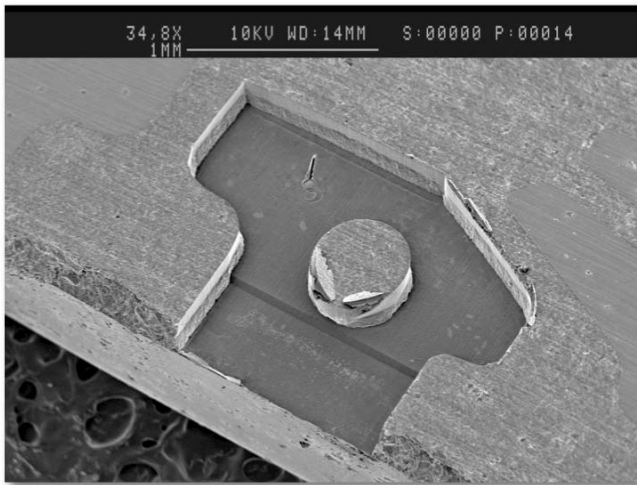
The images in figures 9 and 10 document the condition of the removed lead and the impression in the encapsulant. The only induced damage is due to the tensile overload of an intact bond wire, which is easily distinguishable from a corroded stitch bond.

Figure 9. SEM image of the device after removal of pin 4 showing the impression of the lead.

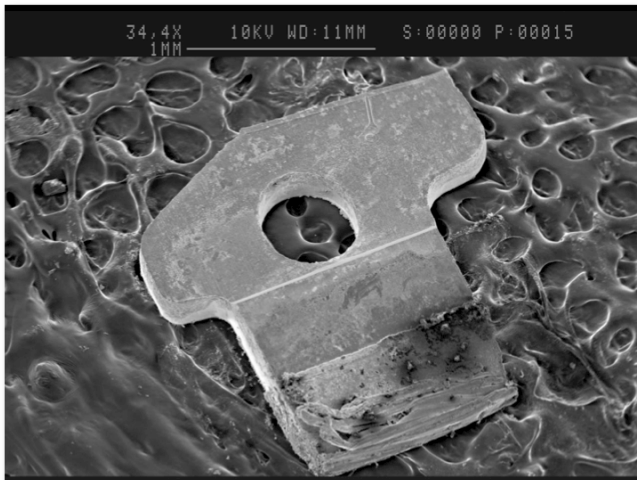
Figure 10. SEM image of the pin 4 lead after removal from the package.
