# Copper Crystal Structures in Plated Microvias. Their Recrystallisation and a Means to Identify Joints at Risk of Premature Failure

T. Bernhard, R. Massey, K. Klaeden, S. Zarwell, S. Kempa, E. Steinhäuser, S. Dieter, F. Brüning  
Atotech GmbH  
Erasmusstrasse 20  
10553 Berlin, Germany  
Email: [roger.massey@atotech.com](mailto:roger.massey@atotech.com)

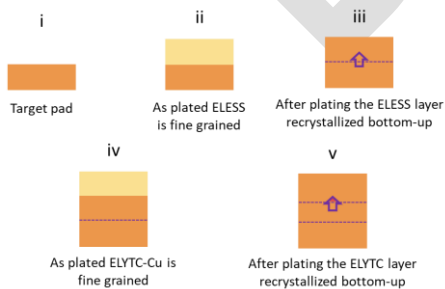
The dramatic increase in the Ni content is expected, and should be associated with its use as a refining element common to ELESS Cu deposits. As such, the Ni can be used to determine the location of the ELESS Cu layer within the overall structure. The other elements (C, N, S, Cl), which are typical to either additives in plating electrolytes, or would indicate an organic surface contamination, all remain low and could be considered to be at an acceptable background level, as they clearly have no detrimental effect on the proposed “bottom-up” recrystallisation. The general process of this “bottom-up” recrystallisation is described schematically in Figure 8

Schematic sequence for “bottom-up” recrystallisation

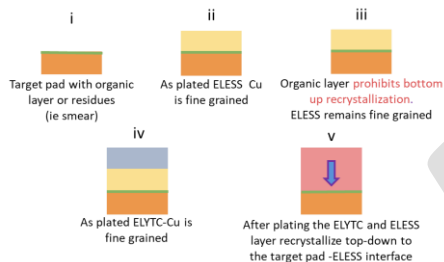
Here we can conclude that an appreciable level of surface contamination, from desmear and rinse water residues were present on the target pad, and were of sufficient concentration to hinder grain boundary diffusion from the Cu foil into the ELESS Cu layer and the diffusion front was suspended at this interface. Subsequently the recrystallisation of the ELESS and ELYTC Cu occurred independently of the target pad, and so can be described as “top-down” in manner.

Figure 10 again shows the schematic of the sequence for the contaminates at the target pad surface impacting the diffusion and subsequent recrystallisation

Schematic sequence for “bottom-up” recrystallisation
