# Soldering defects on immersion tin and the impact of the tin-oxide layer

# Introduction

## Immersion Sn

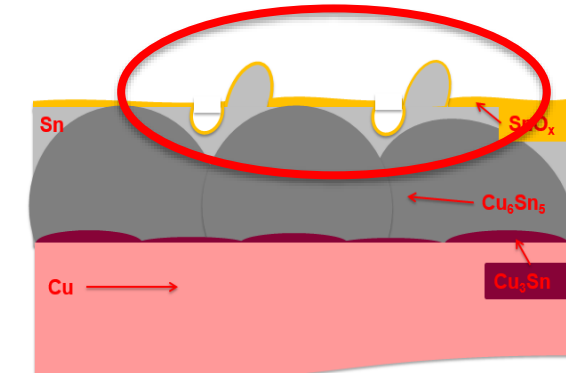
Potential defect:  
Sn-Oxide layer breaks and liquid tin penetrates to the surface

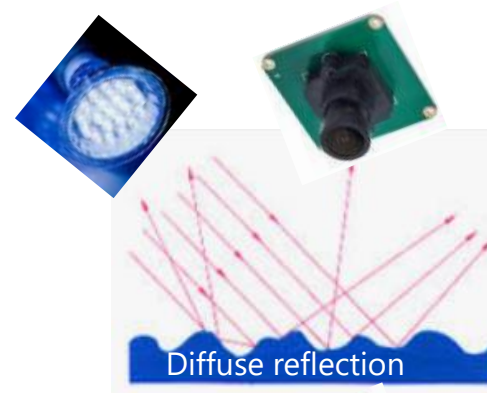
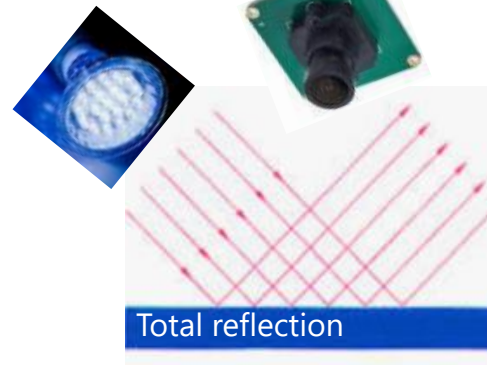
Cross section of normal tin surface as received  
Surface roughness  $S_Q > 250\text{nm}$

Cross section of shiny tin surface 1xRF (LF,  $O_2 < 1000\text{ppm}$ )  
Very flat surface  $S_Q < 100\text{nm}$

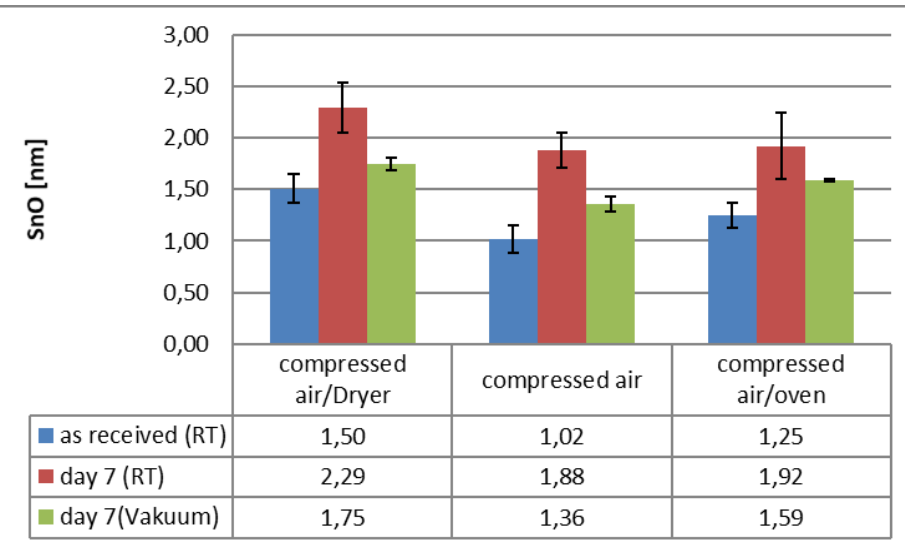
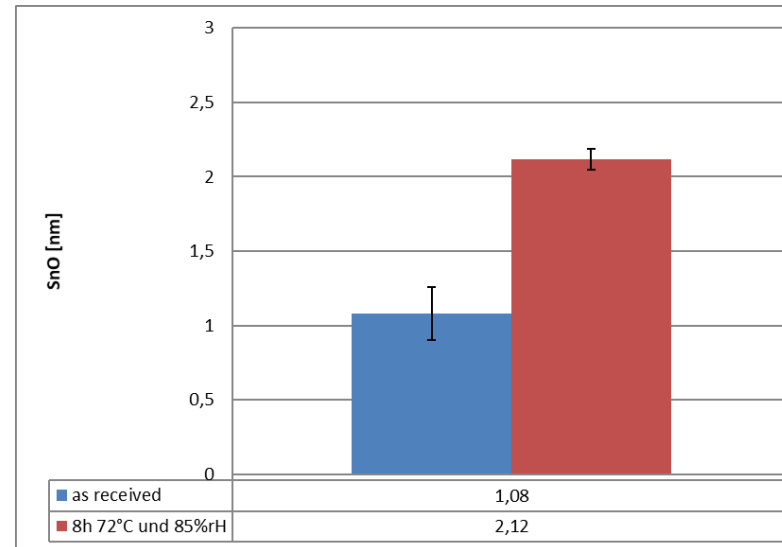
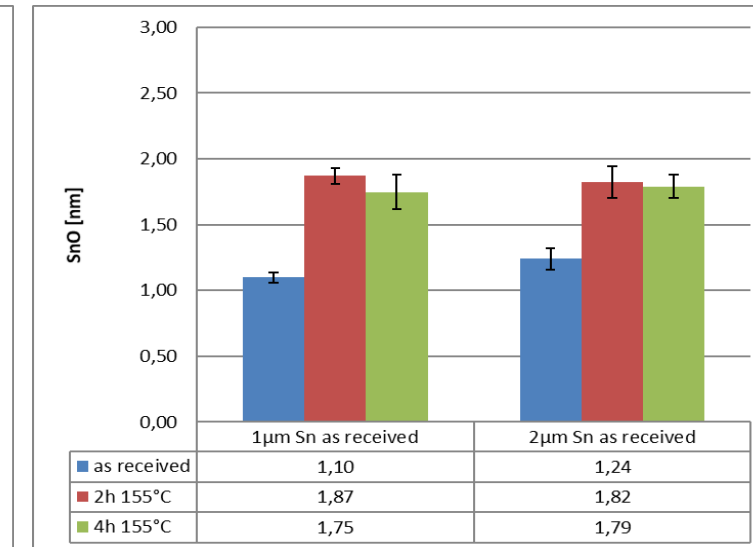
- Impacting factors on oxide formation – measured by SERA and confirmed by TEM

- Vacuum packing inhibits oxide formation
- Low impact of drying temperature
