## Silver Epoxy Filled Via Analysis for High Reliability RF MCM Microelectronics

Joe Kreuzpaintner, Karen Wooldridge, Donna Gerrity, Bill Clark, & Hector Deju  
HARRIS GCSD  
2400 Palm Bay Rd  
Palm Bay, FL 32905  
321-729-2588, jkreuz01@harris.com

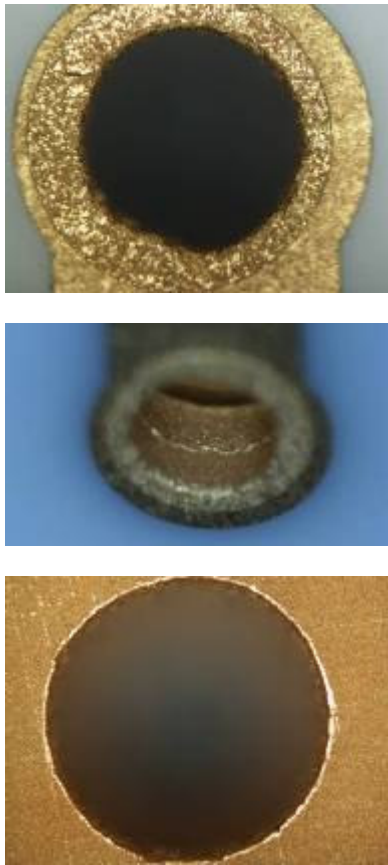
Figure 6. Filled via cross-sections

The BPF filter is mounted to the RF Hybrid base using silver epoxy per MIL-STD-883, method 5011. Prior to placing the filter into the hybrid, the via holes are filled with the same silver epoxy used for substrate attach and then cured. This prevents the wet silver epoxy attachment material from squeezing up through the via holes during attachment (scrubbing motion) to the hybrid base. The resulting bond line is approximately 0.003" with the vias partially filled, Figure 6.

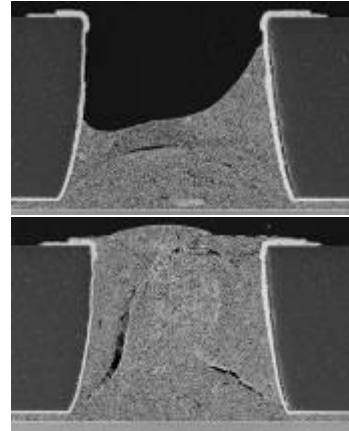
Figure 7. Failed BPF filter vias top side view

The BPF filter showing the "out of family" RF power loss was removed from the RF module and cross sectioned, Figures 7 and 8. The via fill exhibited hair line cracks near the top of the epoxy fill. After completing the cross-section, it was evident that the metallization separated from the via wall, Figure 8.
