# Use of Wire Bonding to Study Bond Pad Damage from Wafer Probe

Stevan Hunter<sup>1,3</sup>, Jonathan L. Clark<sup>2</sup>, Darin Hornberger<sup>2</sup>, Lance Rubio<sup>2</sup>

<sup>1</sup>Idaho State University; <sup>2</sup>Brigham Young University Idaho; <sup>3</sup>ON Semiconductor, Pocatello, ID, USA

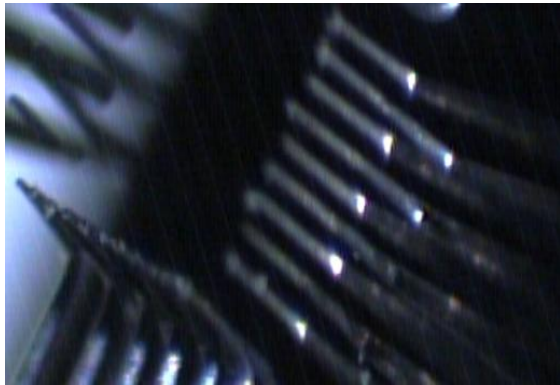
**Figure 2** Cantilever probes micrograph. Tips are still dirty with Al nodules from a harsh probing run. This probe card has two tiers of 1mil diameter probe tips, for 40 pads in a rectangular pattern.

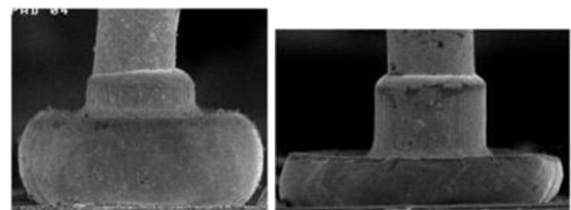
**Figure 7** Scanning electron micrographs (SEM) of 1mil Au wire ball bonds used in this experiment: (left) standard bonding recipe; (right) harsh bonding recipe, with higher ultrasonic power and lower substrate temperature. In past experiments, more cracking was caused on weak pad structures by the “harsh” bonding recipe.
