Case Study: Radial Cracks in a Rigid-Flex Assembly

Christopher Matsuoka
Crane Aerospace & Electronics
Microelectronics Solution
10301 Willows Rd. NE
Redmond, WA, 98052
Phone: 425-895-5125
E-mail: chris.matsuoka@crane-eg.com

Key words: corrosion, ENIG, black pad, crack, medical device, PCB, failure analysis

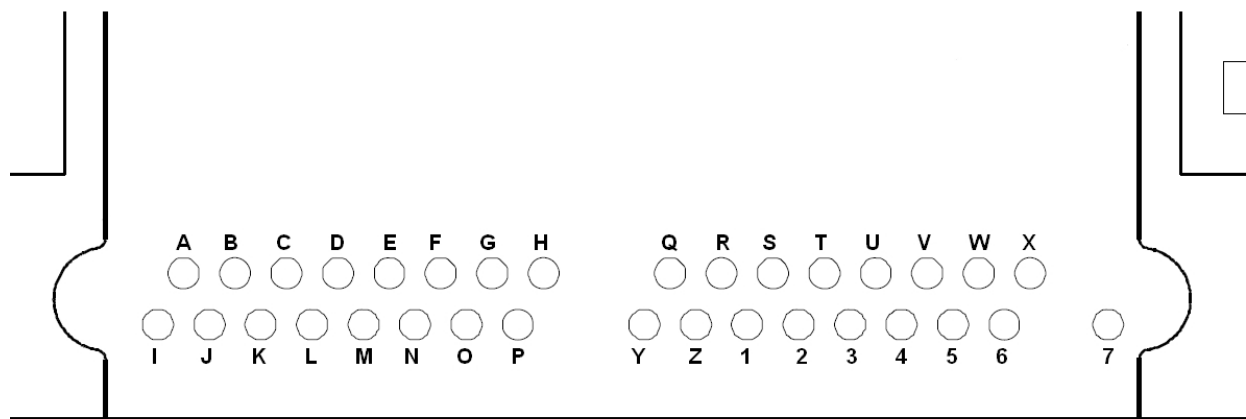
Figure 3 – Alphanumeric visual key used to provide traceability of every flex thru-hole throughout the assembly process.

During the first simulation nine sample bare boards from three different supplier lots were randomly selected. To establish a baseline, each flex thru hole was photo documented prior to any thermal exposure; pictures were then taken after each solder reflow, temperature cycle, and burn in test. A visual key was created to alphanumerically define the location of each thru-hole per board as shown by Figure 3.
