# DIE CRACK PREVENTION AND DETECTION IN ADVANCED PACKAGING

**March 03, 2020**

**Woo Young Han**

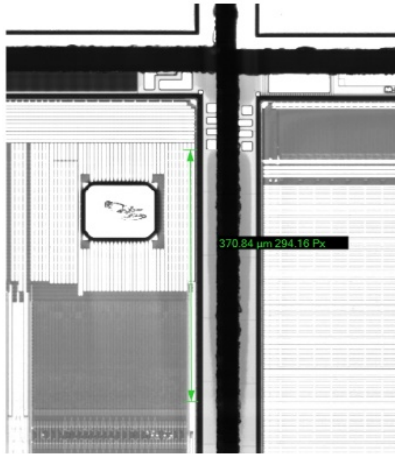
Brightfield Image

Sidewall cracks can be seen on both the bright field image on the left and the new height topography image on the right.

However, the contrast of the cracks are much greater on the topography-based image than the contrast on the brightfield image.
