# Defluxing of Copper Pillar Bumped Flip Chips

Ravi Parthasarathy, M.S.Ch.E., ZESTRON Corporation, Manassas, VA

Umut Tosun, M.S.Ch.E., ZESTRON Corporation, Manassas, VA

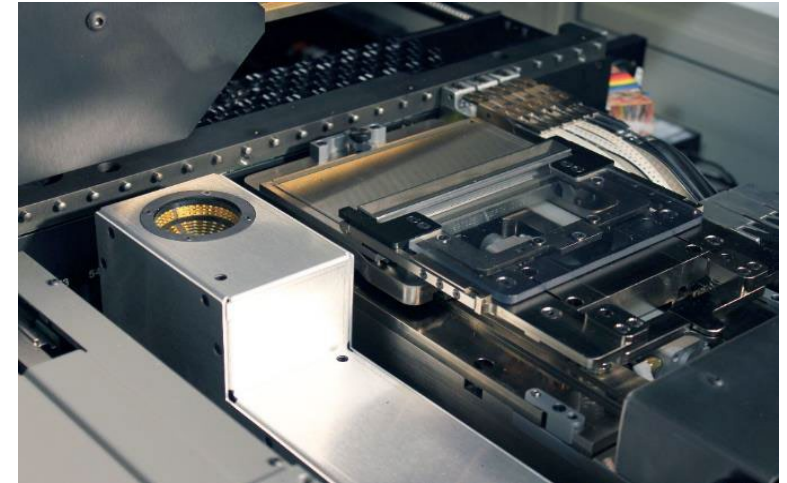
- Flux Application
  - Flux Dip Package
  - Using LTFA Technology, on-board dipping process
  - Uses a plate ~ 38 microns thick to create a film
- X-Ray Inspection
  - Post-placement, inspection done to ensure bump is aligned properly to the pad
  - First Article Inspection (FAI) performed on remaining lot and necessary adjustments were carried out

Linear Thin Film Applicator (LTFA)

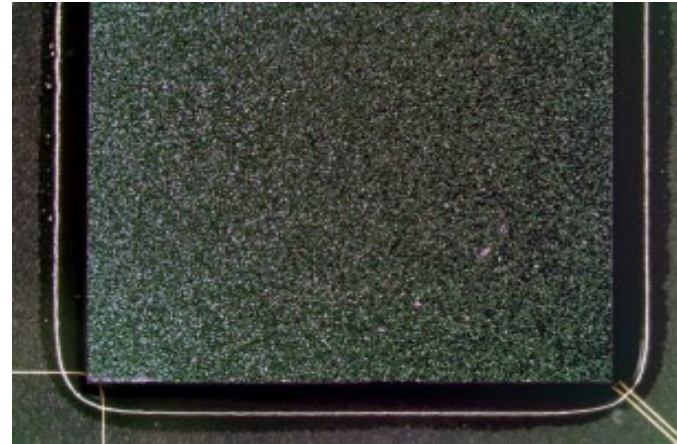
Flip chip 10mm x 10mm in size on substrate (with underfill)

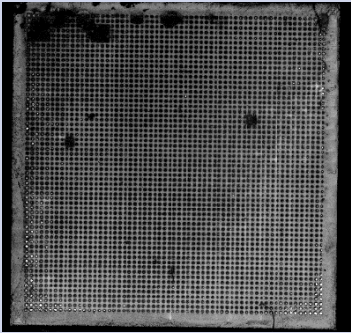
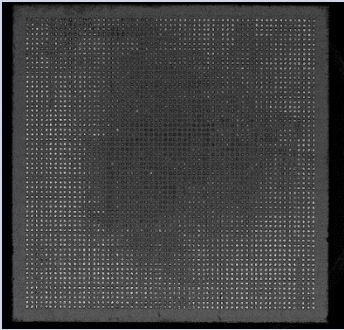
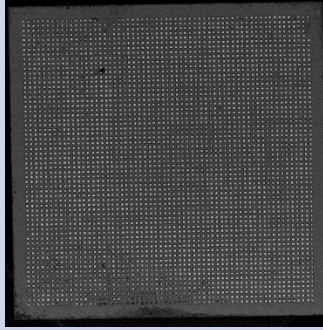
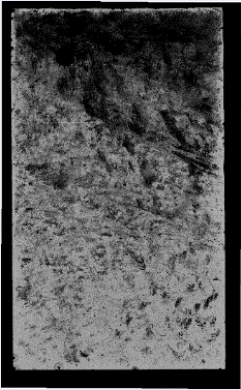
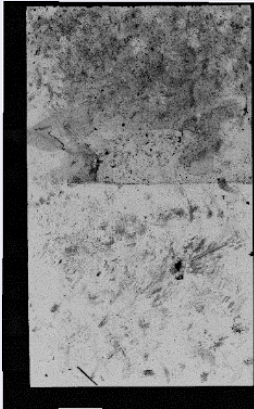
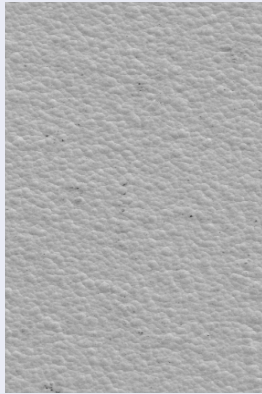
Un-clean	De-ionized water at 2.0 fpm	Cleaning Agent @ 2.0 fpm
Chip backside (BSE detector)

Au-pad (BSE detector)

Results	High amount of organic residues visible on chip backside and all over the Au-pad (black)	Organic residues visible especially in middle area of chip and slight residues visible over the Au-pad (black/dark grey)	No residues visible on the chip and Au-pad

- SEM/EDS Results
  - **Substrates cleaned with DI-water:**
    - Showed presence of organic residues on both chip and Au-pad at 2.0 fpm
    - Significant amount of organic residues seen on both chip and Au-pad at 3.0 fpm
  - **Substrates cleaned with Cleaning Agent:**
    - Did not exhibit any organic residues at 2.0 fpm
    - Very minor amount of residues observed on Au-pad at 3.0 fpm
- FTIR Results
  - **Substrates cleaned with DI-water:**
    - Significant amount of residues observed on both bumps and Au-pad at 2.0 fpm
  - **Substrates cleaned with Cleaning Agent at 3.0 fpm**
    - Did not exhibit any carbon/flux signals on the bumps
    - Very minor residues observed on the Au-pad

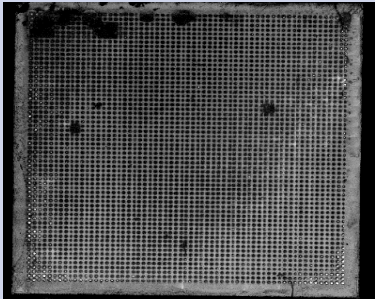
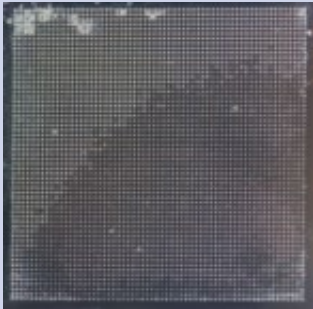
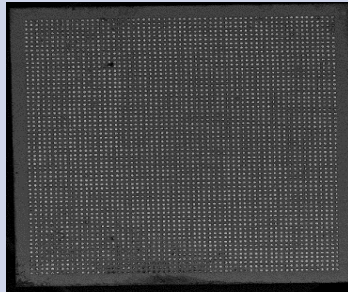
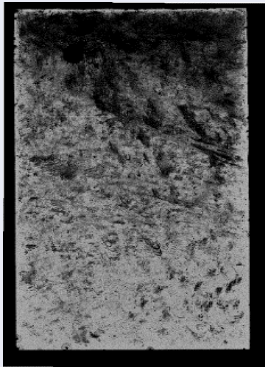
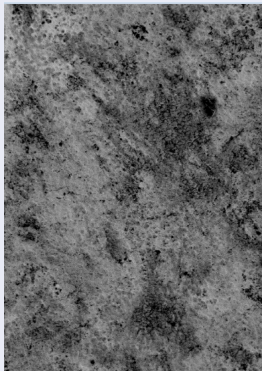
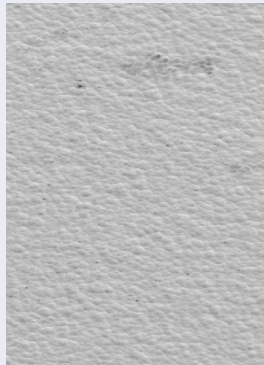
Un-clean	De-ionized water at 3.0 fpm	Cleaning Agent @ 3.0 fpm
Chip backside (BSE detector)

Au-pad (BSE detector)

Results	High amount of organic residues visible on chip backside and all over the Au-pad (black)	Significant amount of residues visible on chip and Au-pad (black/dark grey)	No residues visible on the chip, very minor amount observed in few small areas upper corner on Au-pad (black / dark grey)

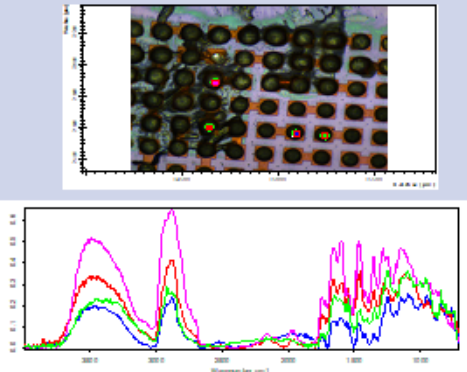
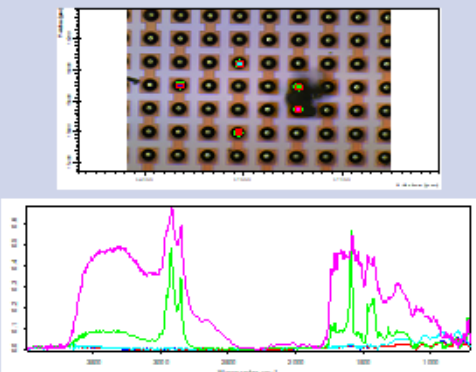
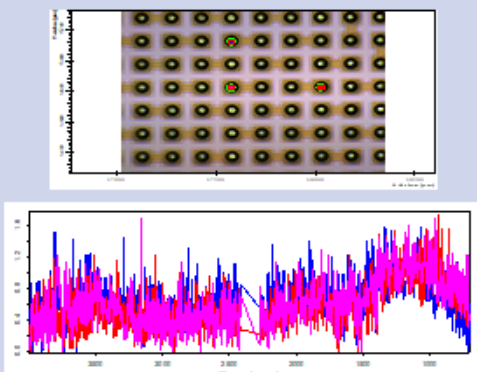
Un-clean	De-ionized water at 2.0 fpm	Cleaning Agent at 3.0 fpm
Chip backside (bumps)

Results	Significant amount of carbon/flux signals visible on bumps and Au-pad.	Carbon/flux signals visible around bumps and Au-pad	No detectable carbon/flux signals visible on bumps and very minor residues visible in upper right corner on Au-pad

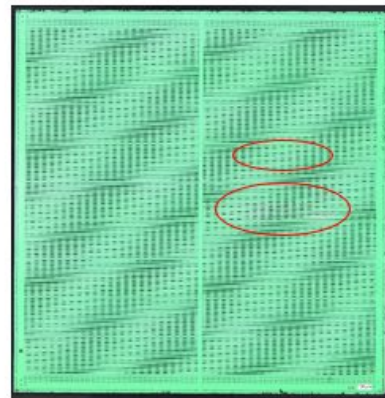
Visual Inspection

# Results – Trial 2 (Low Conc., High Temp., Faster belt speed, 1X wash pass)
