# Study of Suitable Palladium and Gold Thickness in ENEPIG Deposits for Lead Free Soldering and Gold Wire Bonding

Yukinori Oda, Masayuki Kiso, Seigo Kurosaka, Akira Okada, Kota Kitajima, Shigeo Hashimoto\*

C. Uyemura and Corporation Ltd, Central Research Laboratory, Osaka, Japan, and

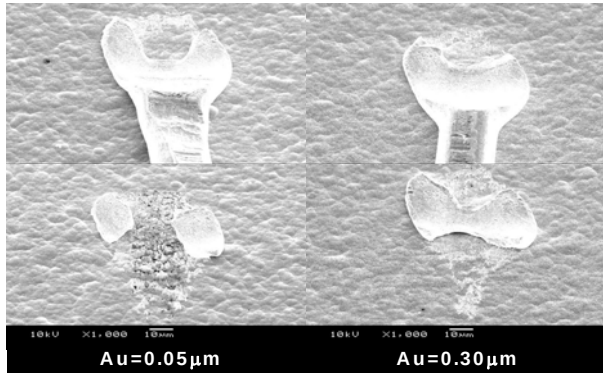
**Fig.-3 Difference in shape between secondary wire bond when making change to gold deposit thickness**

between the 2 gold thicknesses tested. Exposed underlying metal was evident in the case of the 0.05 $\mu$ m gold thickness. In contrast with the 0.3 $\mu$ m gold thickness no exposed underlying metal was evident.

Points with 6.5g wire pull strength in the gold deposit thickness of 0.05 $\mu$ m and those with 11.5g strength in the gold deposit thickness of 0.3 $\mu$ m were chosen, to conduct SEM observations on the secondary bond surface after the wire was pulled. Fig.-3 shows the results of these observations. Observation on the fracture surface indicated a wide difference

Since gold is a soft metal, it can be theorized that unless the gold deposit has a certain level of thickness for wire bonding, the underlying metal is scraped off to degrade the pull strength. The thicker gold deposit has a cushioning effect on the bond and produces a bond of superior strength. Insufficient gold and the possibility of nickel diffusion are the main contributors to the loss of wire bond strength.

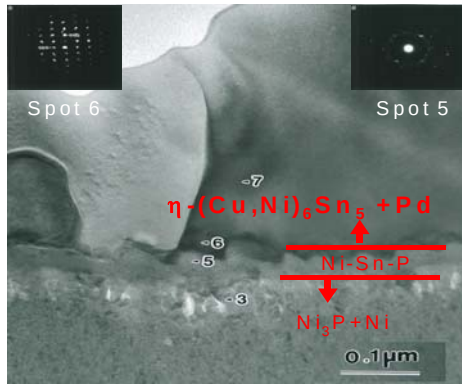
**Fig.-6 TEM observation on IMC with Sn-3.0Ag-0.5Cu soldered to ENEPIG deposit after heat treatment applied at a temperature of 150 degree C for a period of 1,000 hours**

The details of the IMC layers for Sn-3.0Ag-0.5Cu and Sn-3.5Ag were analyzed by TEM. Fig.-6 shows TEM image in the vicinity of IMC layers with Sn-3.0Ag-0.5Cu soldered to the ENEPIG deposit after applying heat treatment at a temperature of 150°C for a period of 1,000 hours, and Fig. 7 shows the result of EDS analysis of the spots shown in the micrograph. According to the results of EDS measurement and diffraction measurement, Spot 3 is a layer referred to as the “phosphorous-rich layer” and assigned  $\text{Ni}_3\text{P}+\text{Ni}$ . Spot 5 was assigned Ni-Sn-P since Ni, Sn and P were detected and no crystals were defined by diffraction<sup>(3)</sup>. The Spots 6 and 7 had the same hexagonal crystal as that of  $\text{Cu}_6\text{Sn}_5$  from the results of TEM diffraction measurement. In addition, since the EDS measurement result showed the detection of Ni, these spots were identified as  $(\text{Cu}, \text{Ni})_6\text{Sn}_5$ . Furthermore, since this layer had uniform palladium distribution, the Spots were assigned as  $(\text{Cu}, \text{Ni})_6\text{Sn}_5+\text{Pd}$ . Subsequently, Sn-3.5Ag was soldered to the ENEPIG deposit, and we then conducted TEM and FE-SEM measurement of the IMC layers formed after aging at a temperature of 150°C for a period of 1000 hours. The results are shown in Fig.-8.

Applying long-term heat treatment under these conditions, two layers were found one was columnar and the other was of uniform crystal structure. The results of EPMA mapping (Fig. 5) show that the palladium aggregates were found only in the columnar alloy layer.

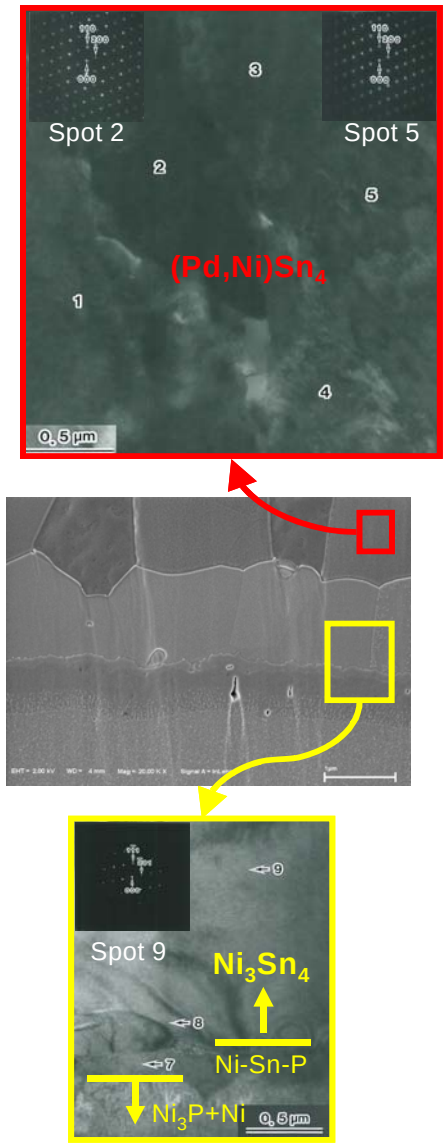
**Fig.-8 TEM and FE-SEM observations on IMC with Sn-3.5Ag soldered to ENEPIG deposit after heat treatment applied at a temperature of 150°C for a period of 1,000 hours**

Further analyses were conducted on IMC Layer Spots 7 to 9 in the lower main part, the results of the EDS analysis shown in Fig. 9. Furthermore, from the diffraction results, we determined that the Spot 7 was Ni-Sn-P layer, and the Spots 8 and 9 were Ni<sub>3</sub>Sn<sub>4</sub> layers.

Subsequently, the diffraction result indicates that columnar parts (Spots 1 to 5) of the upper layer are of structure close to Ni<sub>3</sub>Sn<sub>4</sub>, while the EDS result indicates a ratio obviously different from that of Ni<sub>3</sub>Sn<sub>4</sub>. These ratio differences were observed with thick<sup>(3)</sup> gold deposits where an alloy (Au, Ni)Sn<sub>4</sub> was identified. Since AuSn<sub>4</sub> and PdSn<sub>4</sub> produce the same orthorhombic crystal and due to the element ratio of EDS, we determined this alloy as (Pd, Ni)Sn<sub>4</sub>. This (Pd,Ni)Sn<sub>4</sub> alloy has portions that vary in palladium content.

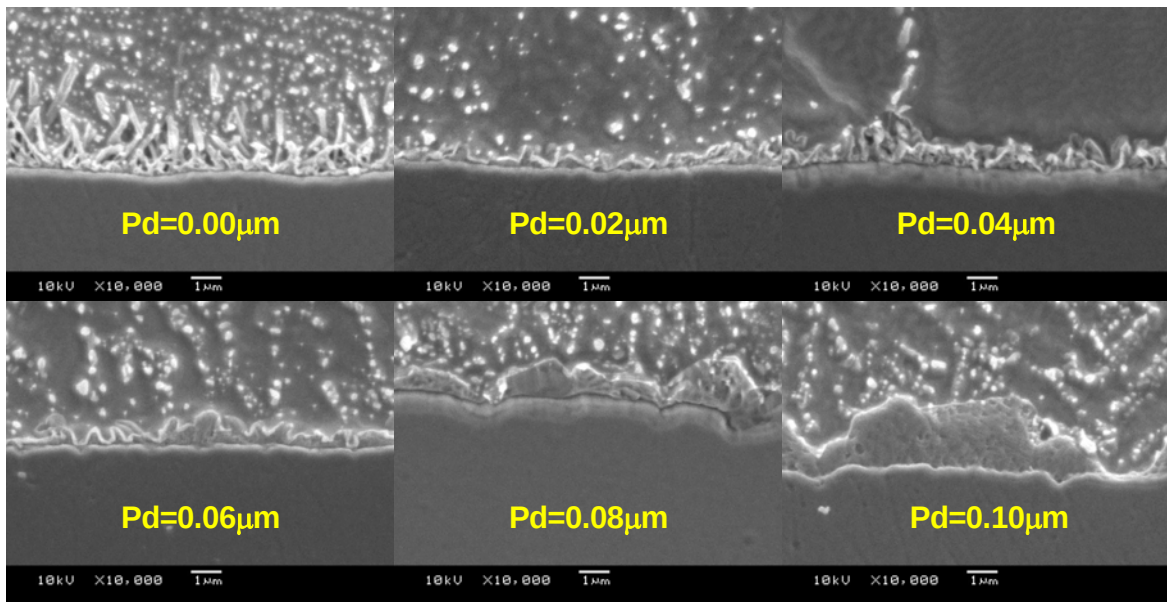
**Fig.-10 Photograph of alloy layer after conducted the reflow process once at a temperature of 240°C on Ni-P/Pd/Au deposit with changed palladium deposit thickness**

Additional observations on the cross section of alloy layers with varying palladium thicknesses were conducted. The reflow process was conducted once at a temperature of 240°C and gave the results showed in Fig. 10. The results indicate that ENIG (Pd=0.00um) has formed needle-like alloy layers and ENEPIG has formed uniform alloy layers. However, if the palladium deposit thickness is increased to 0.08um or higher, the alloy layers become markedly thicker. The increased thickness has an adverse effect on the reliability of the solder joint.
