11th International Conference and Exhibition on *Device Packaging*

# Suitability of Copper Wire Bond ICs in Automotive and Other Harsh Environment Applications

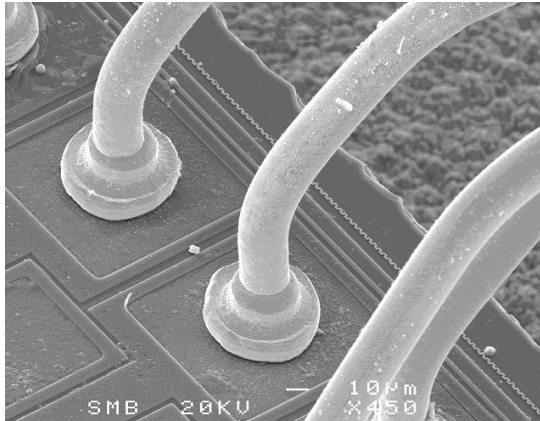
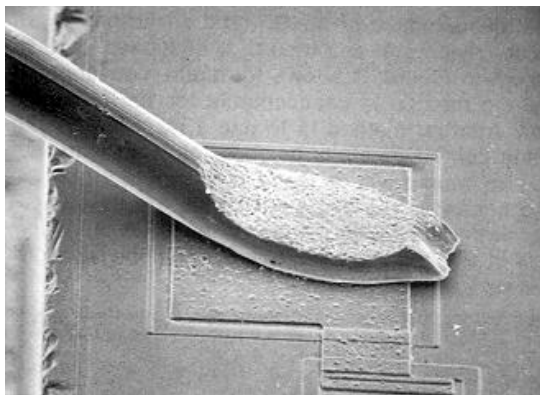
1. The bonding process begins with a threaded capillary.

4. Force and Ultrasonic Energy are applied over Time and the Ball Bond is made.

7. The capillary rises with the Wire Clamps off for a specific distance.

10. The EFO forms the next Free Air Ball and the cycle begins again.

2. Electrical Flame Off (EFO) forms the free air ball.

5. The Looping Sequence

8. The Wire Clamps are applied and the wire breaks away from the 2nd Bond leaving a specific tail length.

3. The capillary captures the free Air Ball in the Chamfer Diameter and descends to the Bond Site.

6. Force and Ultrasonic Energy are applied over Time to make the Stitch Bond.

9. The Tail Length after breaking away from the 2nd Bond

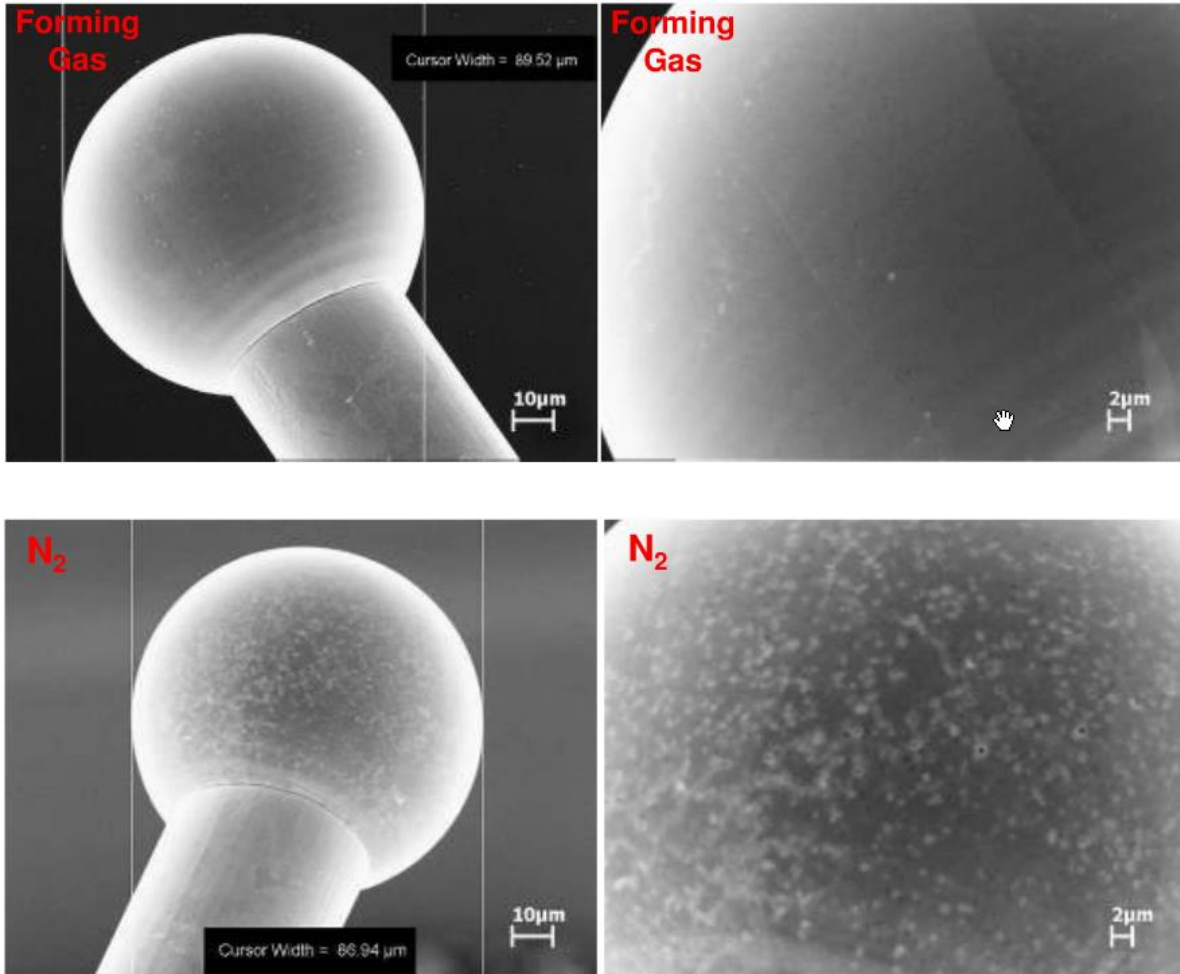
# Forming Gas Reduces Cu Ball Oxide Formation Better than N<sub>2</sub>

- Less Cu Oxide formation with 95% nitrogen/5% hydrogen forming gas

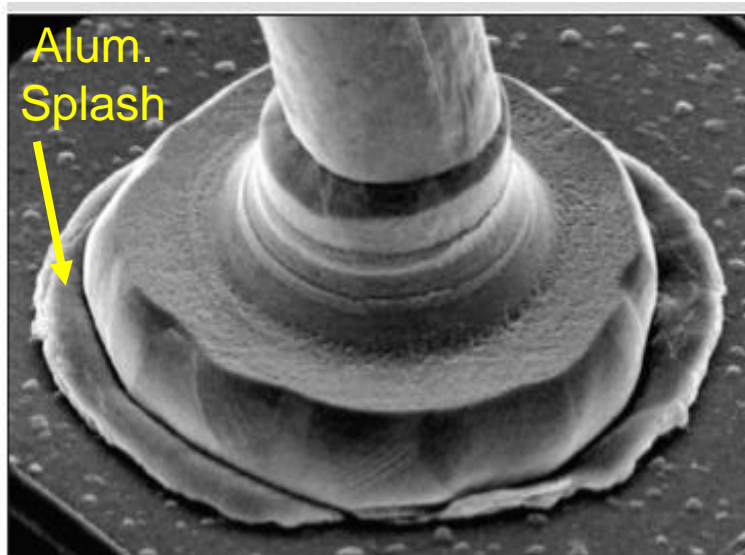
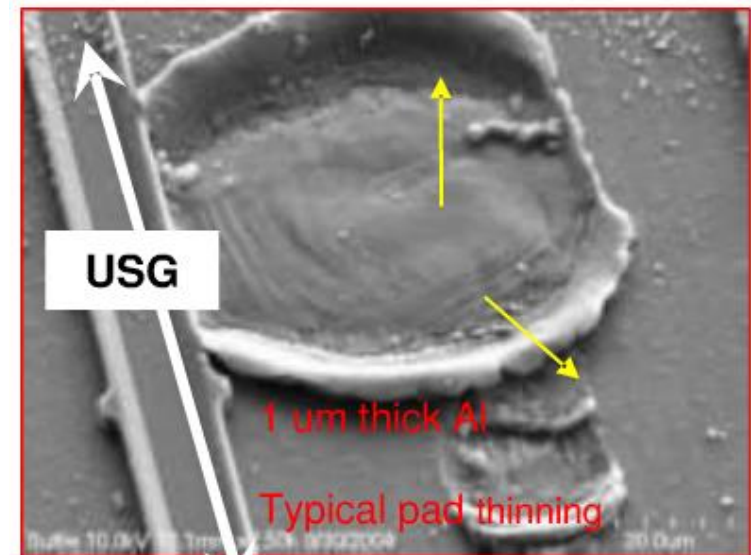
- Preventing pad and die damage & Cu ball bond failure
  - Since CU is harder than gold, more force is required during thermosonic bonding
    - Excessive force can displace bond pad aluminum known as “Aluminum Splash” when bonding forces causes pad aluminum to flow out from under the ball bond or the ball can punch through the pad ”
    - May damage die material or features under the pads.

Risk is that remaining Aluminum on pad is too thin.

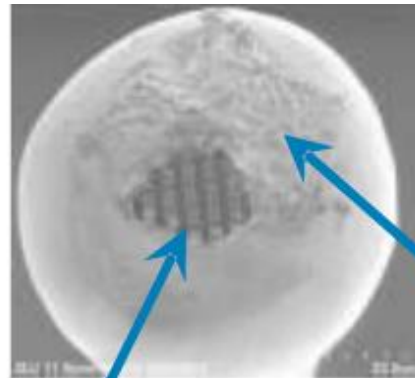
dielectric on bottom of ball

- Cu bonding typically requires higher force and thermosonic vibration, Wearing through the Al Pad risks damage to the underlying Si & .

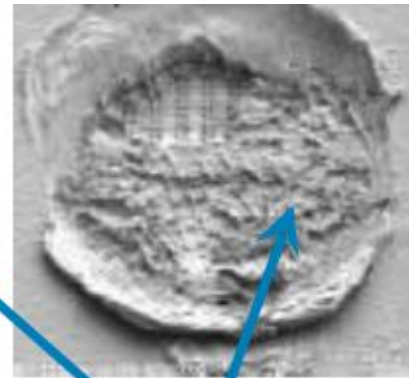
failure mode within aluminum

Si fracture in chip

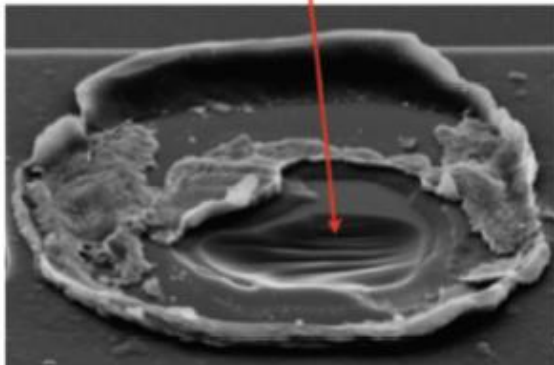
Si from chip

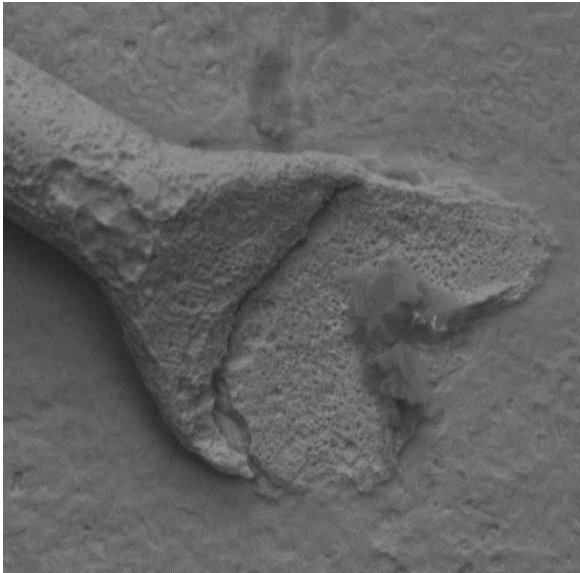
Cu stich broken at a poorly formed “pinched” wedge bond heel (where the wire enter the wedge)

- Cu-WB Module level thermal cycle Issues (known thus far to DfR), have been related to either bond defects or under optimization design issue

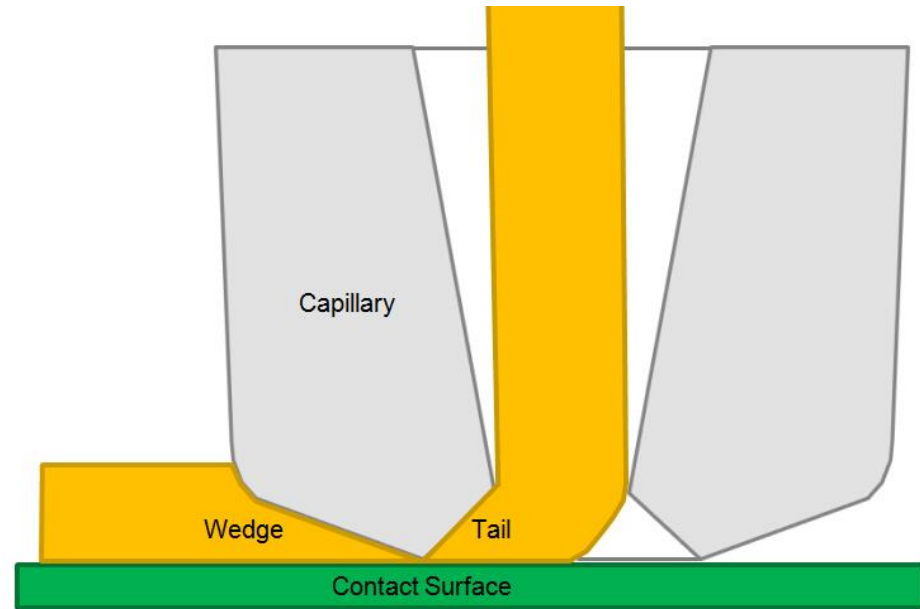
An optimized, non-worn wire bonding capillary head that is sized & shaped to provide an adequate heel weld & a gradual transition back to the wire diameter. Proper calibration & wear monitoring/maintenance is required to prevent excessive flattening & pinch points

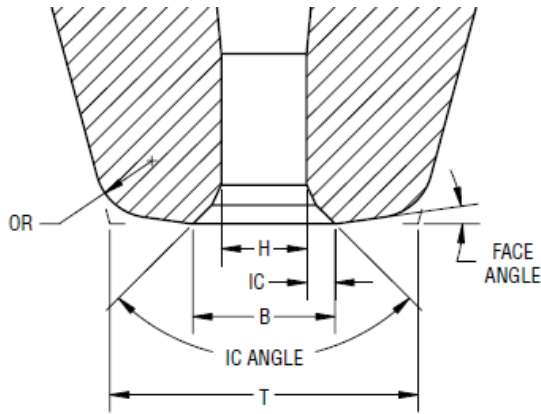
Capillary Tips w/Larger Diameters & Face Angles Keyed to Wire Dia Produce Larger, Stronger, More Durable Wedge Bonds

Similar to IPC Class 1-3 Reliability-Durability Ratings Being Correlated to Solder Joint Size.

- IC Designers typically incorporate the smallest feature possible
- Their desire for small bond pads is contrary to thermal cycling endurance where larger wire bonds result in greater Thermal Cycle durability
  - Wire bond size is determined by capillary head size and geometry
  - Larger bonds require larger bond pads on the IC die

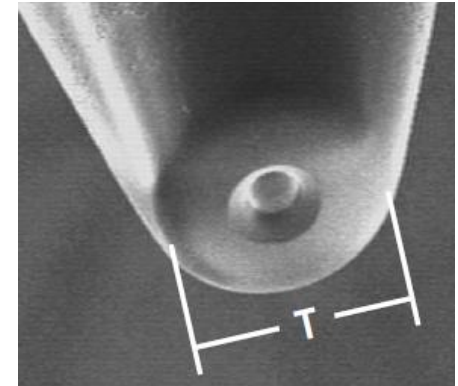
- (T) Tip Diameter ~ Wedge Bond Size
- (H) Hole Diameter ~ Wire Size
- (B) Chamfer Diameter ~ Ball Bond Size
- (IC) Inside Chamfer Length ~ Ball Bond Size
- (IC Angle) Inside Chamfer Angle ~ Ball Bond Size
- (FA) Face Angle ~ Wedge Bond Slope & Heel Thickness
- (OR) Outside Radius – Wedge Bond Size

Full size capillaries for 25-33 $\mu$ m diameter wire have tip diameters from 140-229 $\mu$ m.  
 For tighter packages w/smaller 20 $\mu$ m diameter wire tip diameters as small as 102 $\mu$ m may be needed.  
 With fine pitch applications, tip diameters of 76 $\mu$ m or smaller are available.

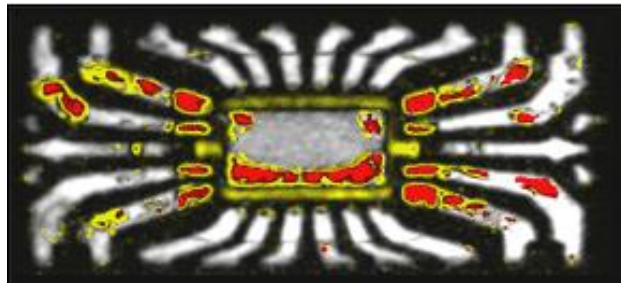
SIOC Package

Scanning Acoustic Microscope Image of IC internal delamination sites shown in red.

- **Delamination**
  - Delamination can occur rapidly during soldering if excessive amounts of moisture were absorbed by the mold compound resulting in popcorning fractures or interfacial fractures during soldering.
  - Delamination can also occur slowly because of swelling from gradual absorption of moisture while in service or thermal expansion mismatch stresses.
    - Delamination can cause fractured or lifted wire bonds that result in open circuits.
    - It can result in cracks in the package that can allow contaminants to enter, leading to corrosion of copper wires or bond pads that results in open circuits
    - Can cause current leakage due to the presence of mobile ions.

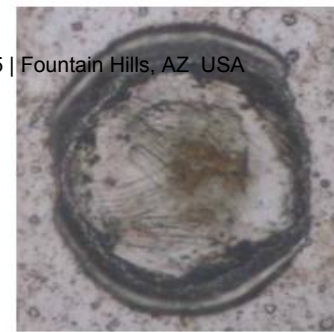
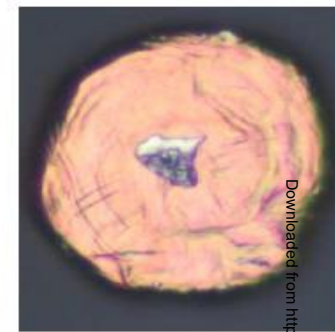
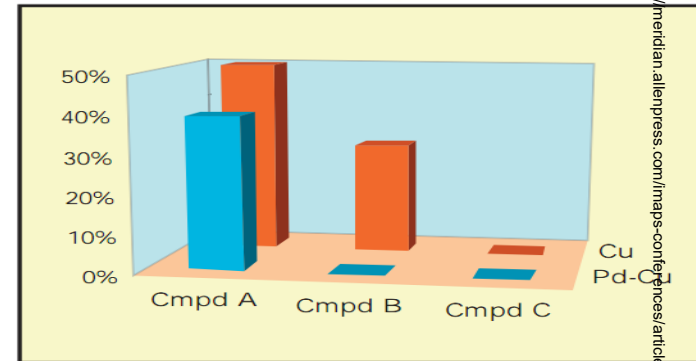
- Autoclave conditions have been found to cause Cu-WB bond separation failure of Cu wire bonds in some over molded packages.
- High Ph & Cl content in the molding compound was a corrosion activator triggering galvanic corrosion between the IMC and the Al pad

- Humidity, temperature & electrical bias drive this failure mechanism.
- When a forward bias is applied, Cl<sup>-</sup> ions are attracted to the positively charged pad causing corrosion that eventually result in bond separation.

- Mechanism is accelerated by the high humidity and temperature conditions automotive electronics are required to endure.
- Using a molding compound with a low pH (4-6) and a low chlorine content <20ppm, (preferably <10ppm) is essential for alleviating corrosion failure risks

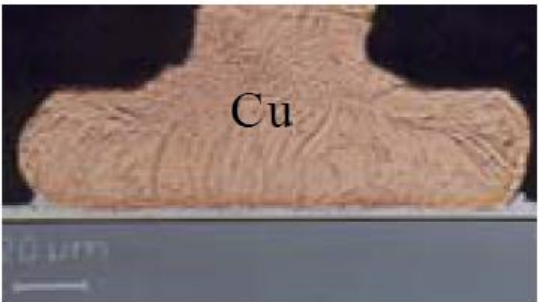
**Intermetallic Penetration - AlSi-Cu Bond**  
(aged 800 hours at 180°C)

- Au-AL and Cu-AL intermetallics continue to grow over time at a rate proportional to elevated temperatures.
  - Excessive Intermetallics can lead to electrical or mechanical failure
- Cu-AL intermetallics grow at a much slower rate than Au-AL
- Molding compound has little effect

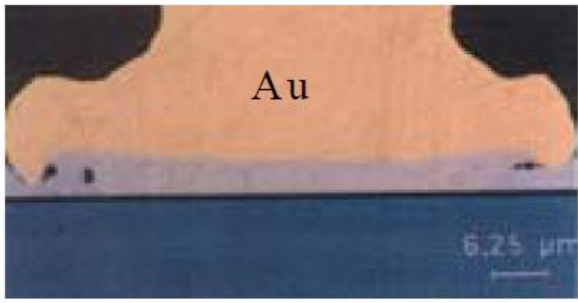
**Intermetallic Penetration - AlSi-Au Bond**  
(aged 200 hours at 200°C)

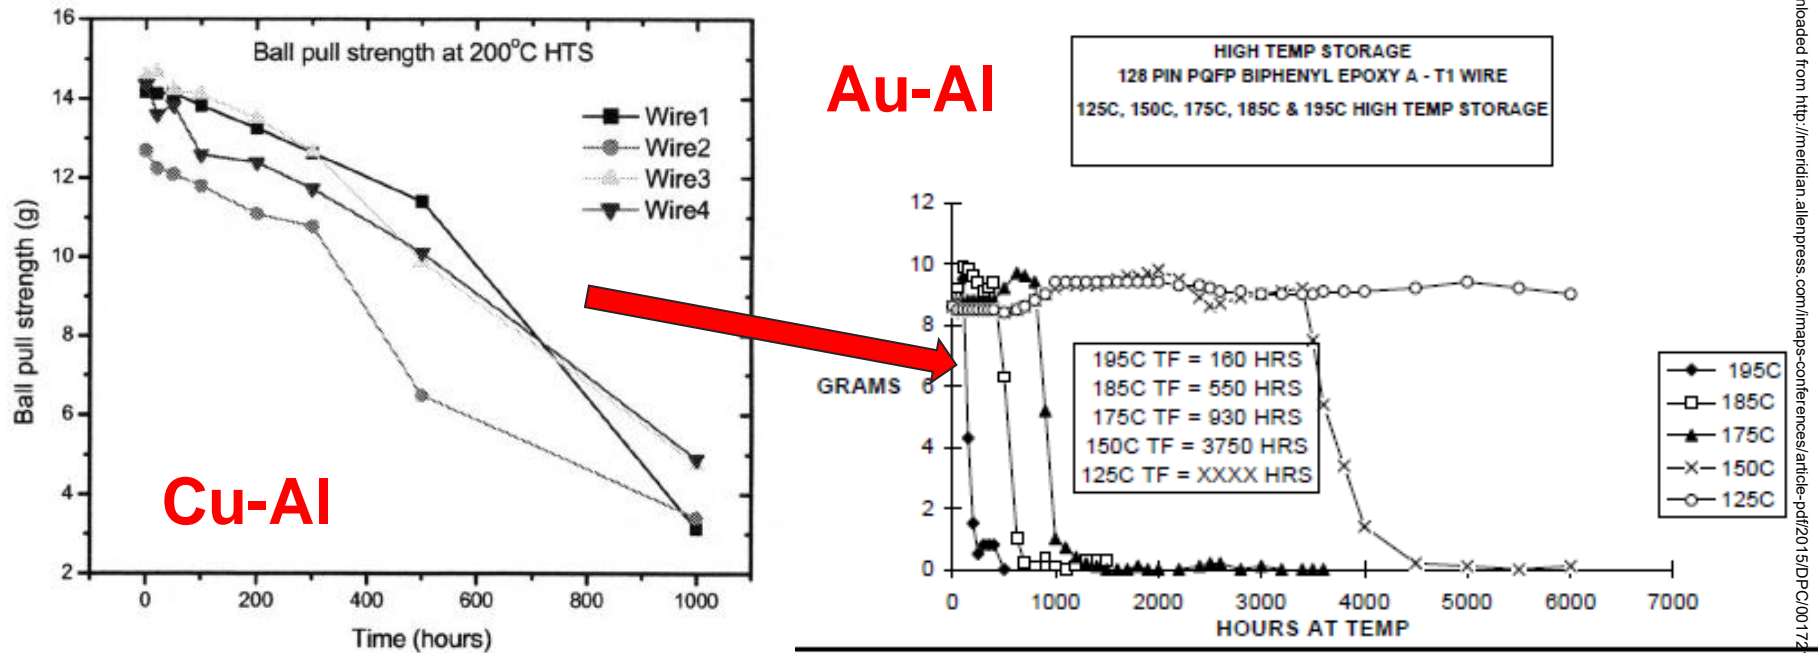
Figure 6. Ball Pull Strength after HTS at 200°C

- **Cu-Al shows improved pull strength over Au-Al at 200C**
  - Different failure mode (gradual vs. sudden)
  - 200C is beyond most automotive temperature ranges but a concern for other application especially down hole oil dripping electronics.

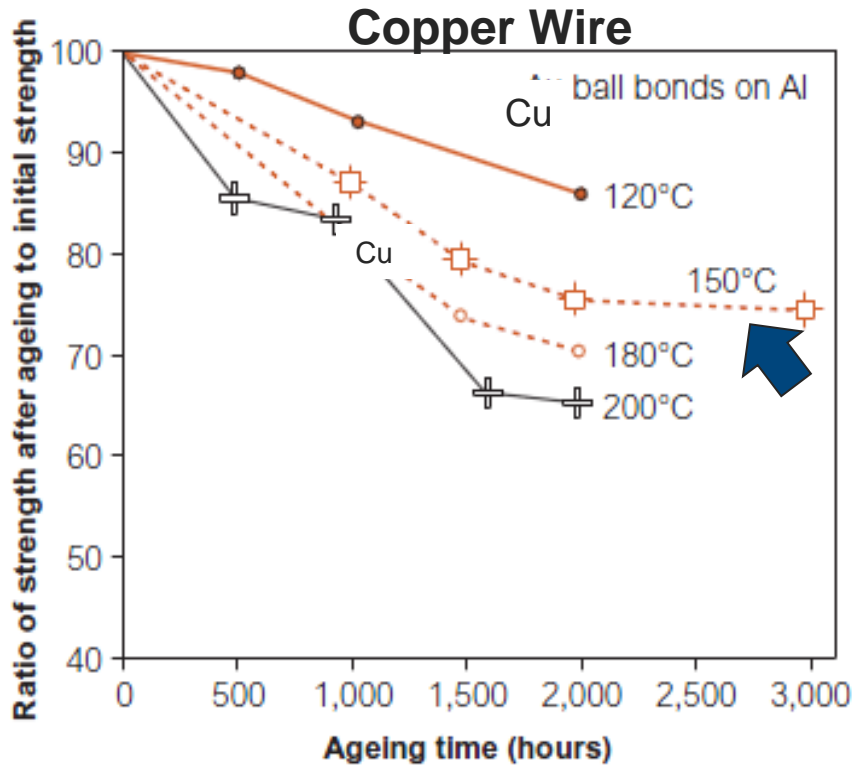
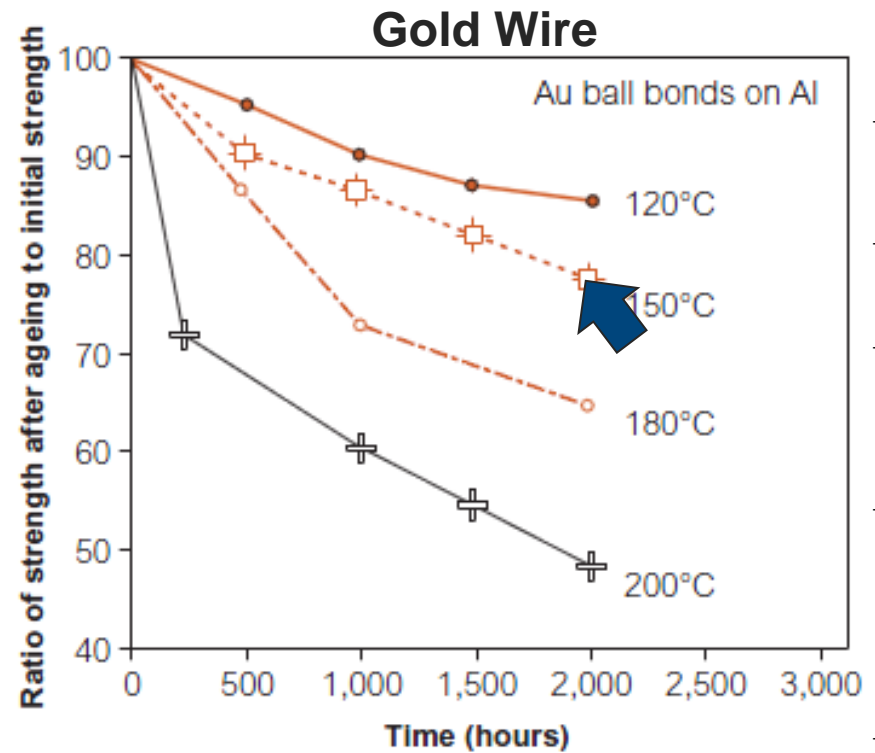
Shear strength of Au and Cu ball bonds on Al pads.  
 At lower temperatures (<150C) they are similar in strength loss.
